**DATE:** June 8, 2022  
**TO:** Heritage Preservation Commission  
**FROM:** Steven Robertson, Senior Planner  
**RE:** PL 22-090, Application for the Demolition of a Contributing Structure to the Duluth Commercial Historic District

## Structural Engineering Report

**Project:** 102 E Superior Street – Bullseye Bldg- Condition Review

### Regarding: Structural and Envelope Condition Review

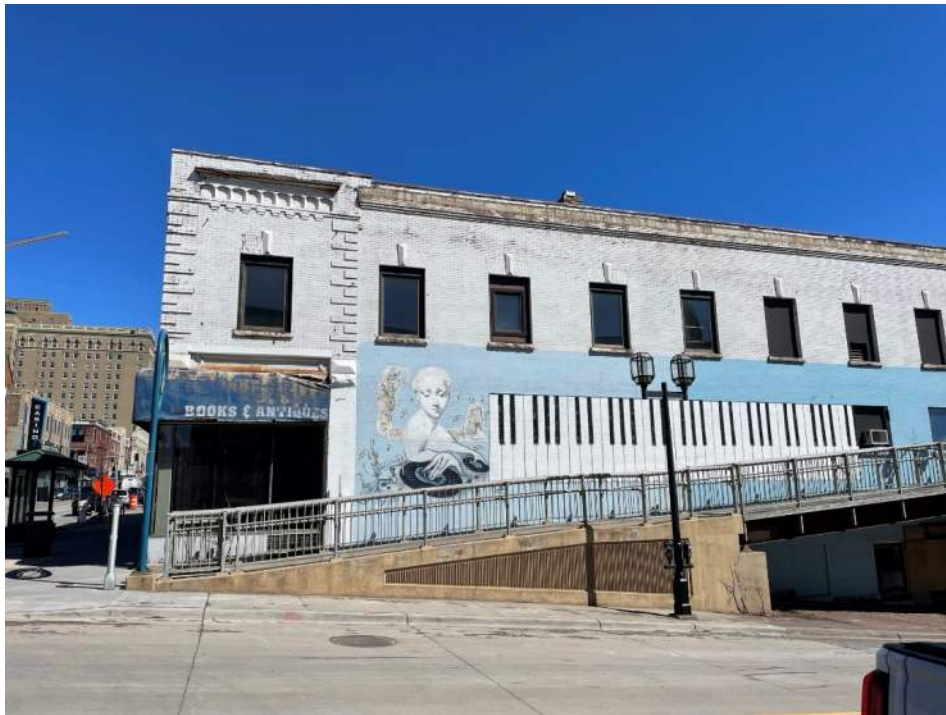
Photo 1: Existing West elevation looking east

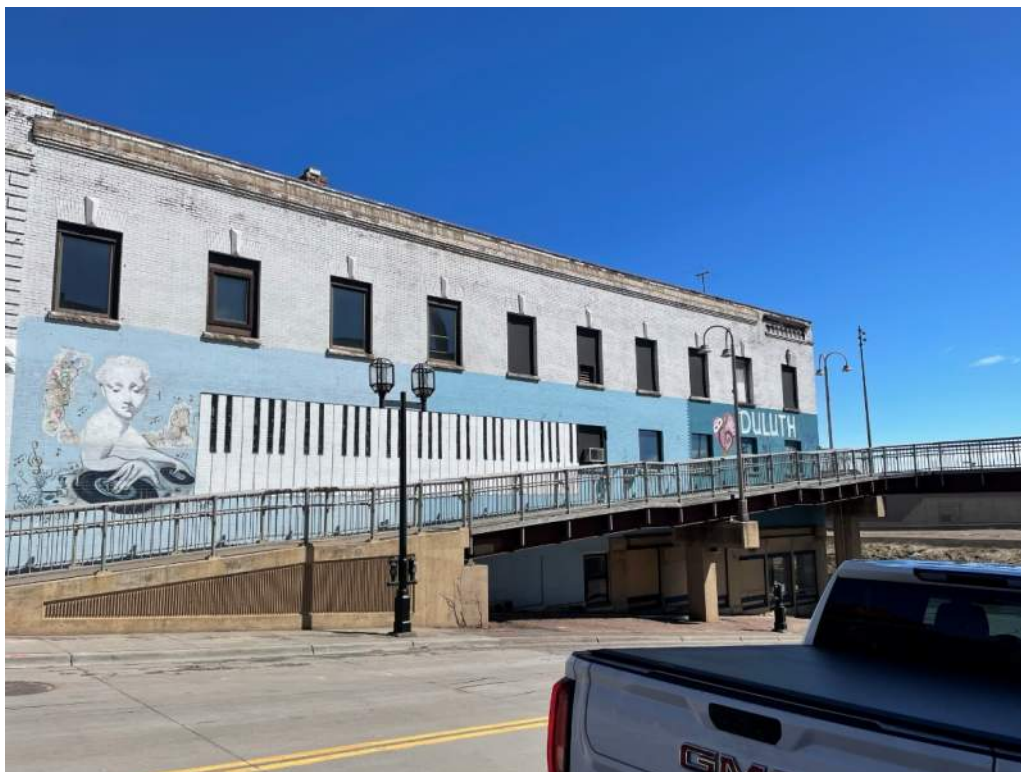
Photo 2: Existing West Elevation looking east

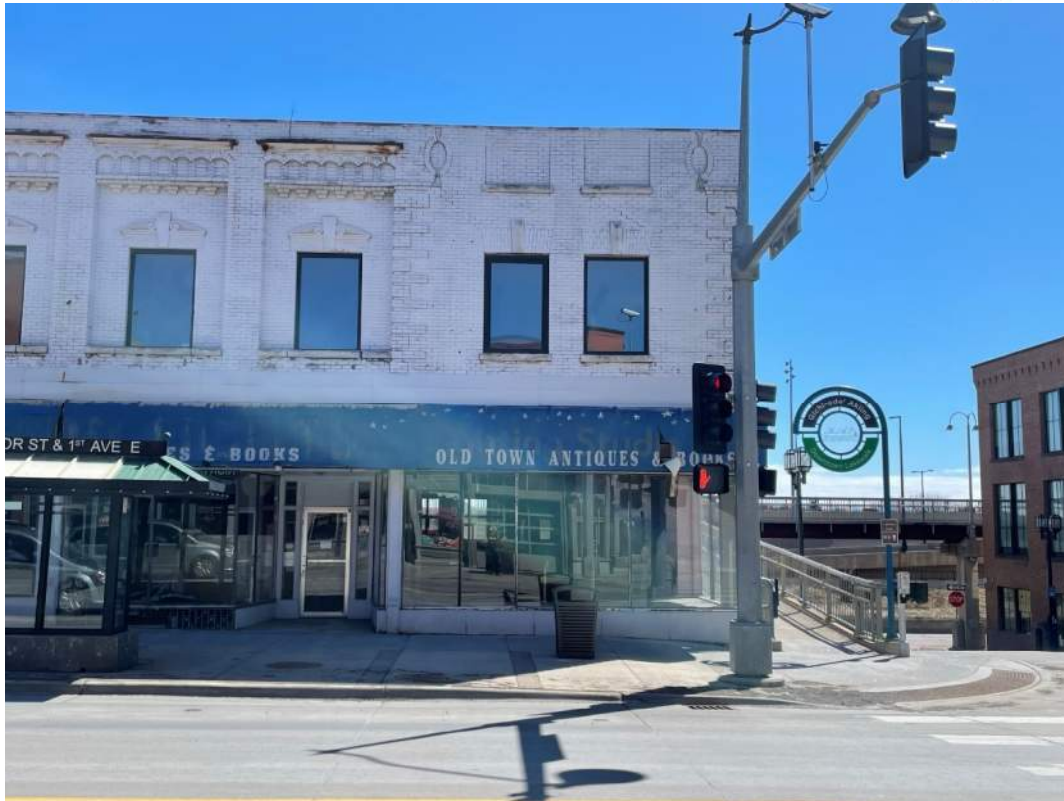
Photo 3: North exterior wall looking south

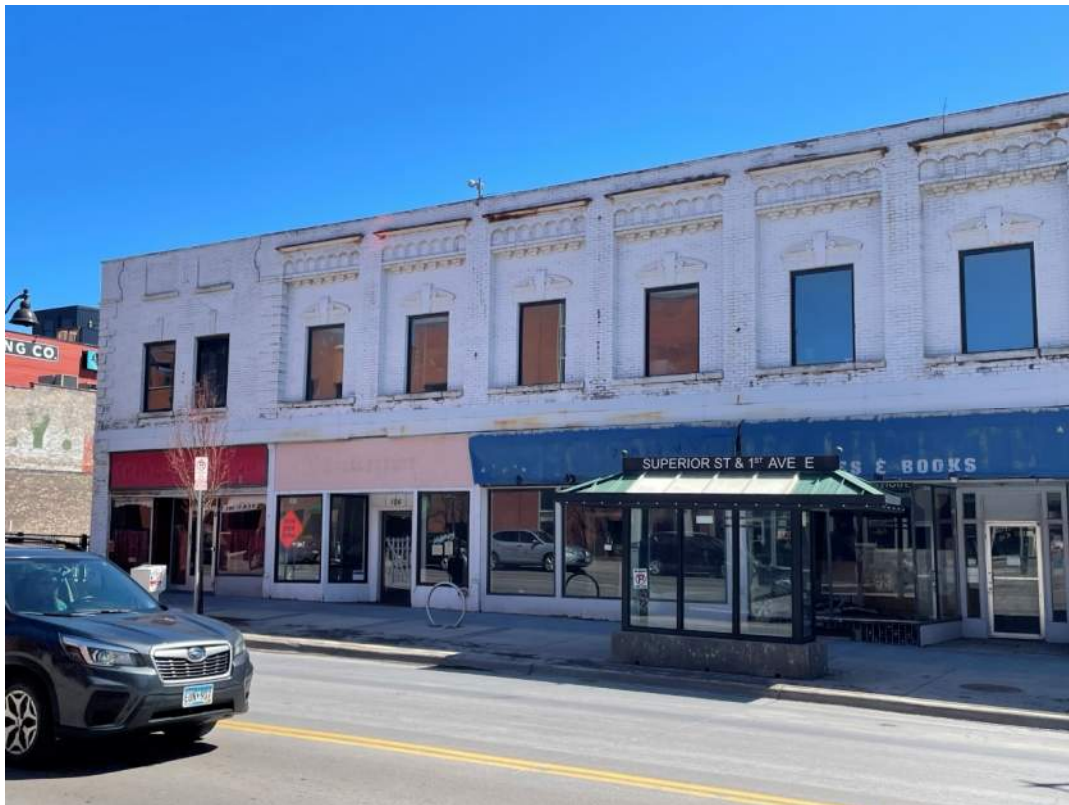
Photo 4: North exterior wall looking south

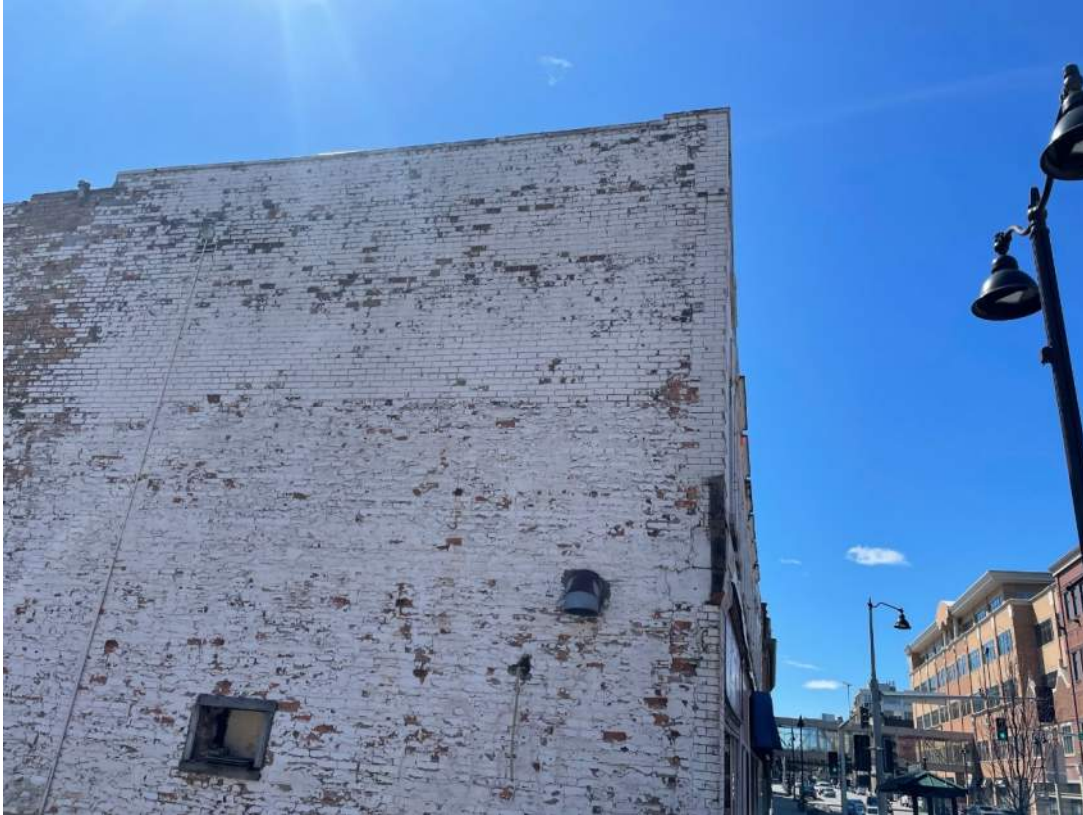
Photo 5: East exterior wall looking west

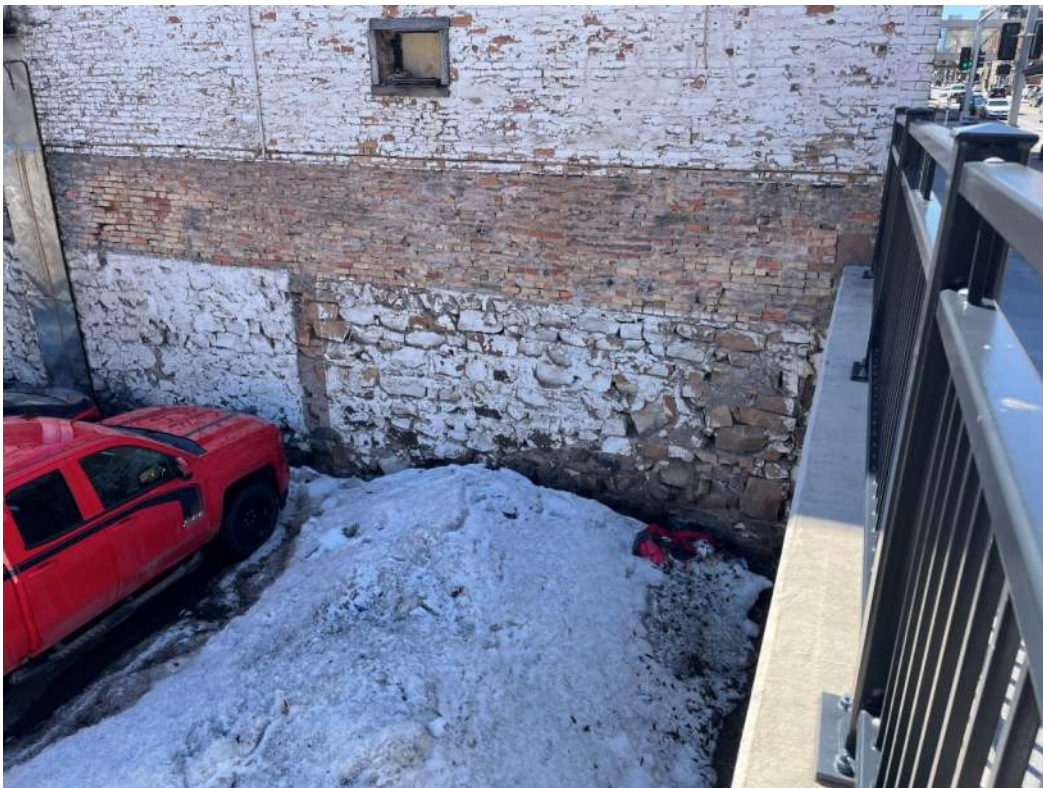
Photo 6: East Exterior wall looking west

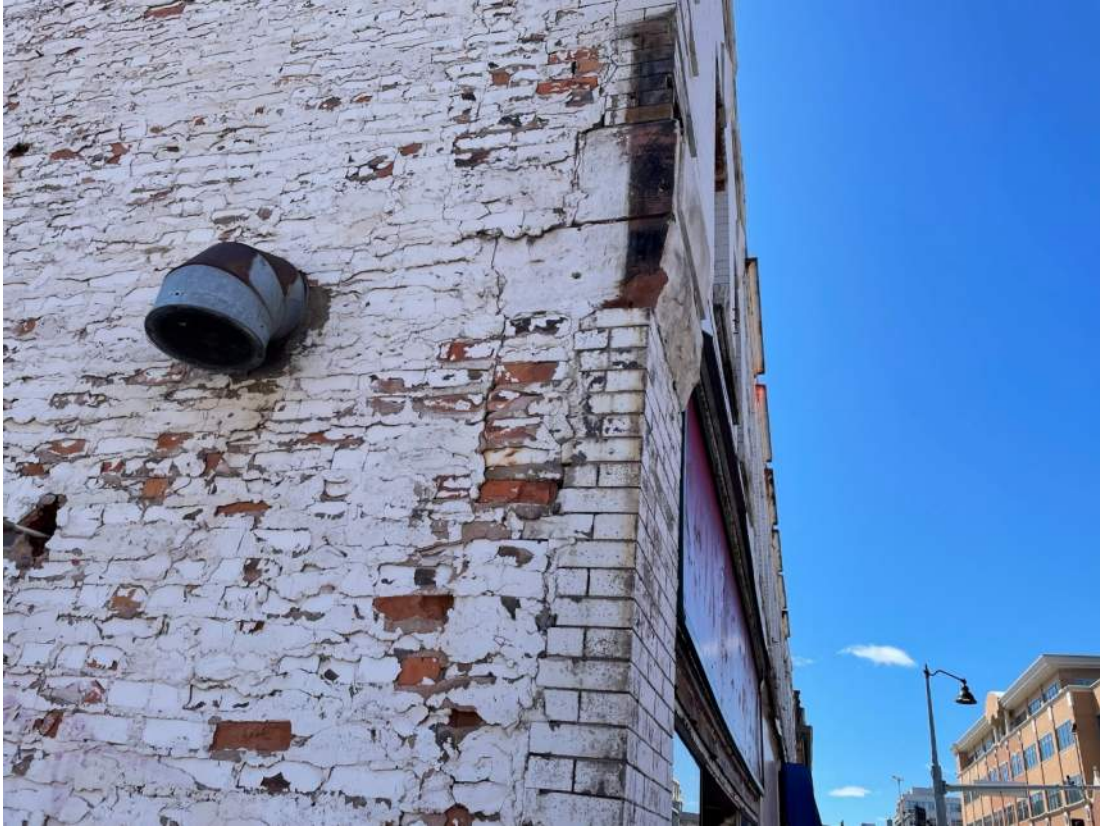
Photo 7: Existing East exterior wall looking west – close-up view of brick conditions

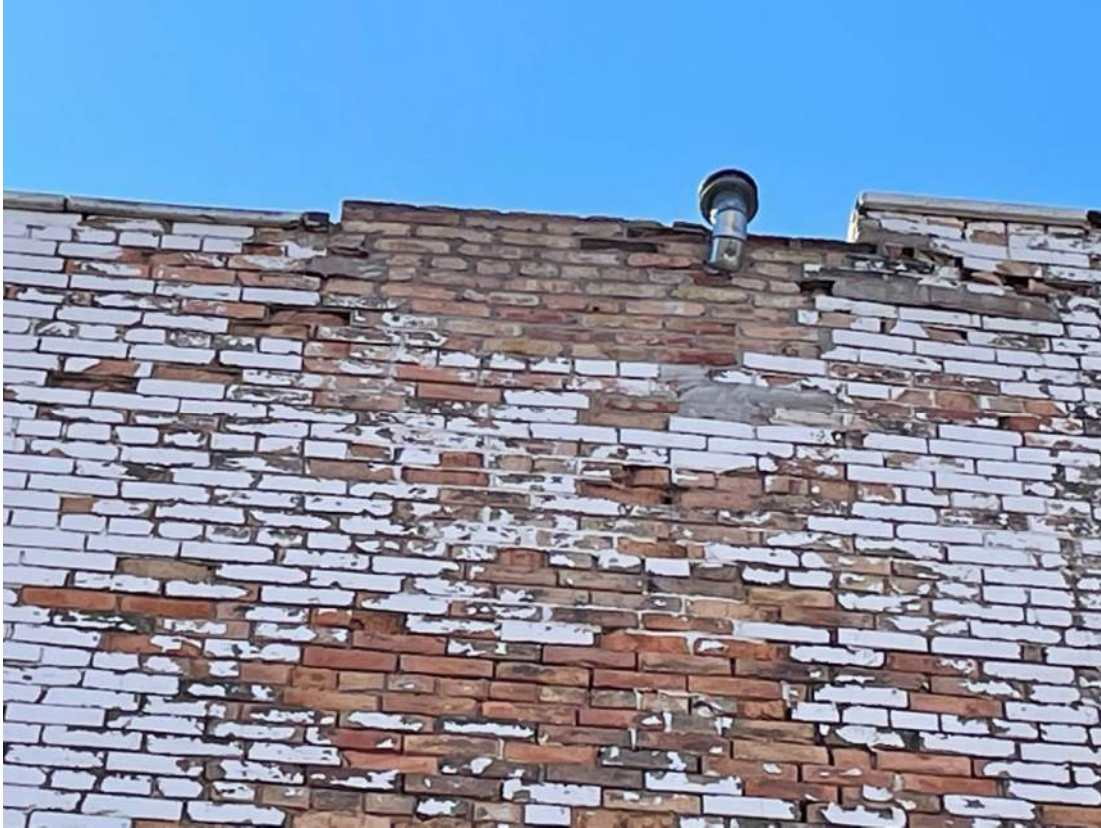
Photo 11: Close-up view of existing east exterior wall masonry condition.

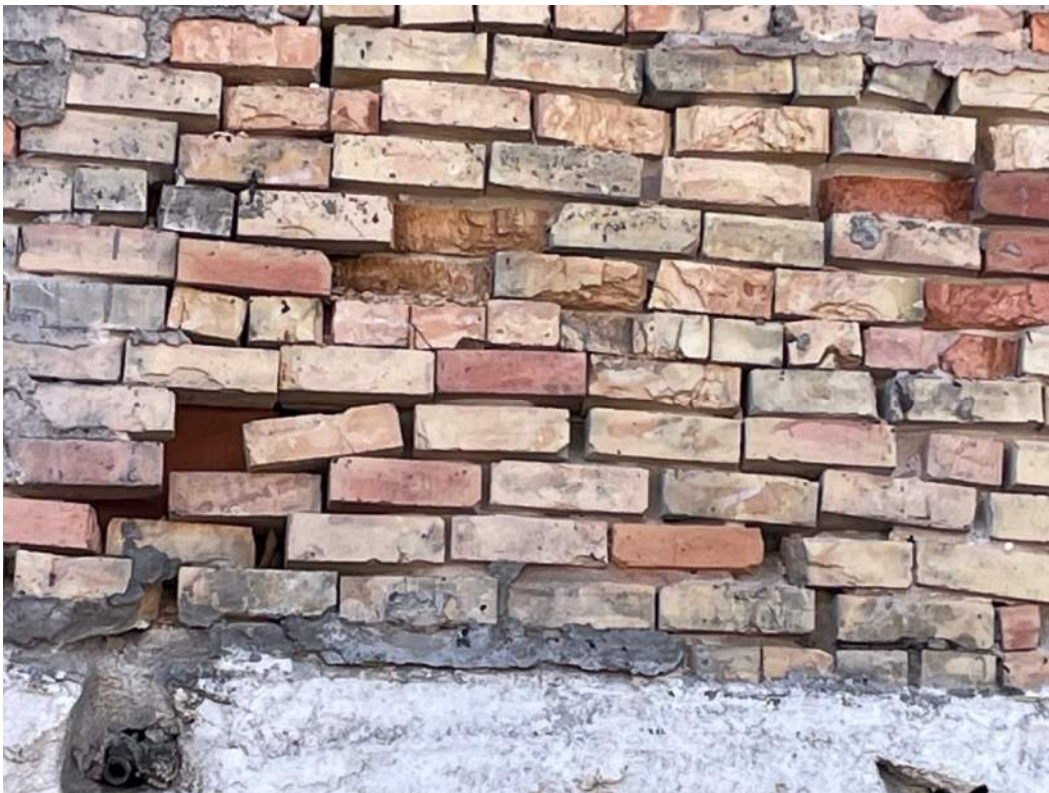
Photo 12: Close-up view of existing east exterior wall masonry condition

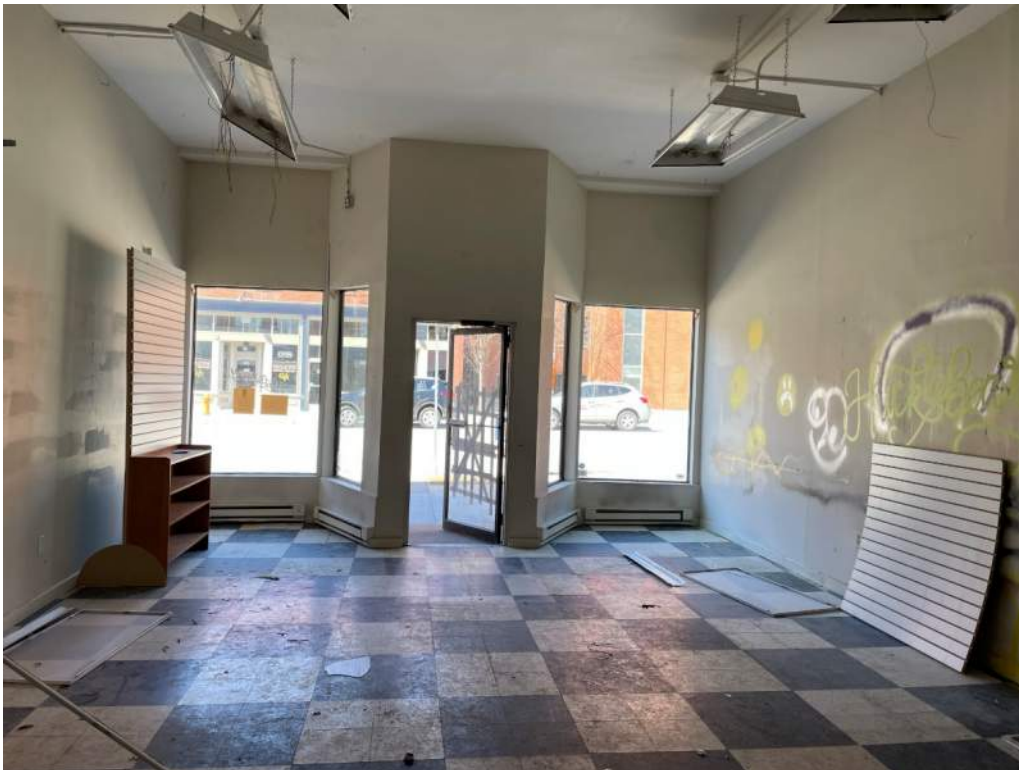
Photo 26: Existing interior finishes are old and need updating.
