**DATE:** June 8, 2022  
**TO:** Heritage Preservation Commission  
**FROM:** Steven Robertson, Senior Planner  
**RE:** PL 22-090, Application for the Demolition of a Contributing Structure to the Duluth Commercial Historic District

## Structural Engineering Report

**Project:** 102 E Superior Street – Bullseye Bldg- Condition Review

### Regarding: Structural and Envelope Condition Review

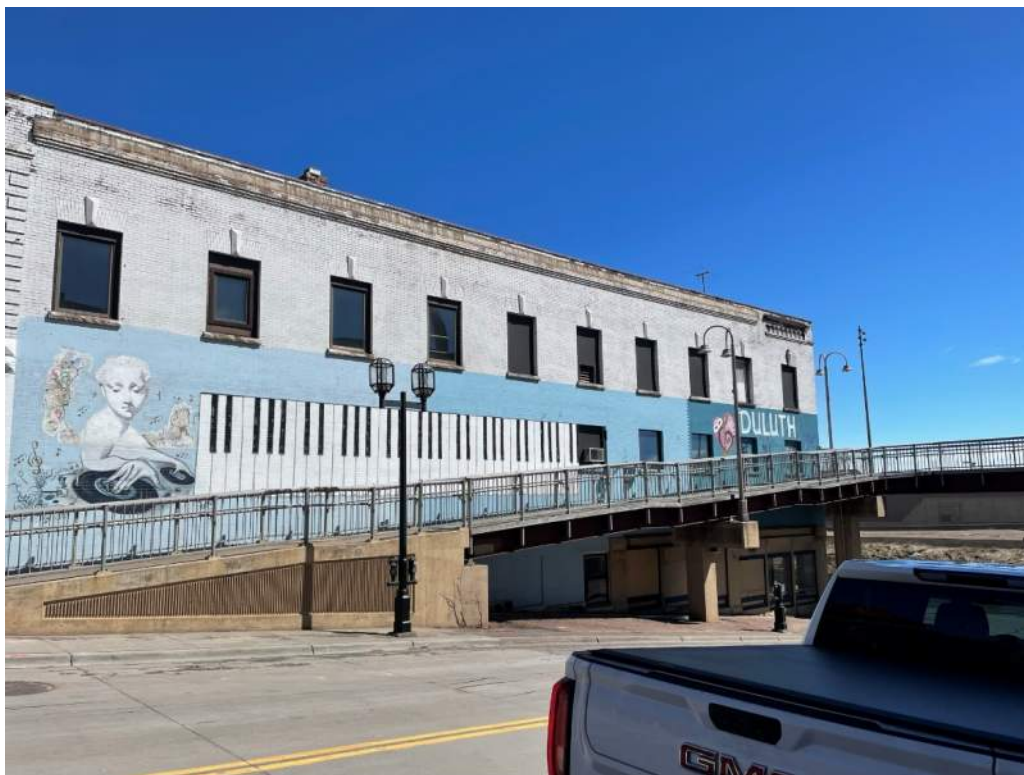
Photo 2: Existing West Elevation looking east

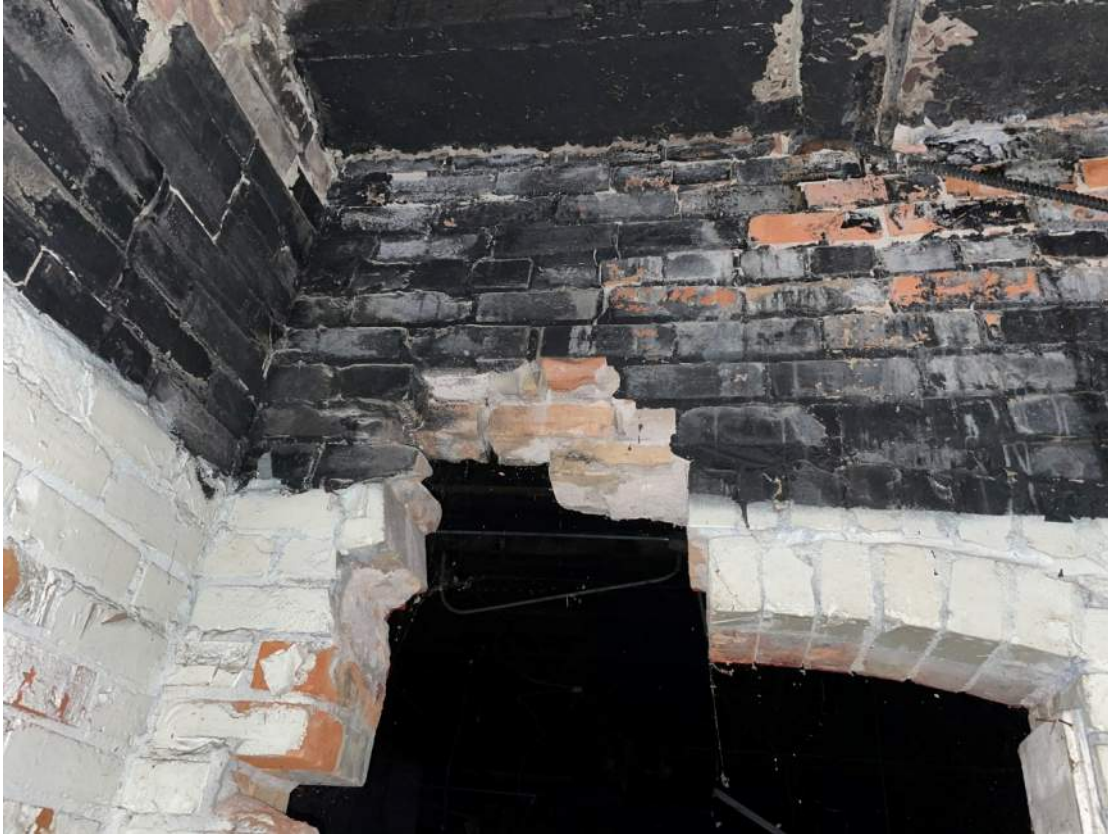
9. The existing sidewalk vault support system at the east end of the building is deteriorated and requires structural repairs.

Photo 15: Existing sidewalk vault support is generally in poor condition

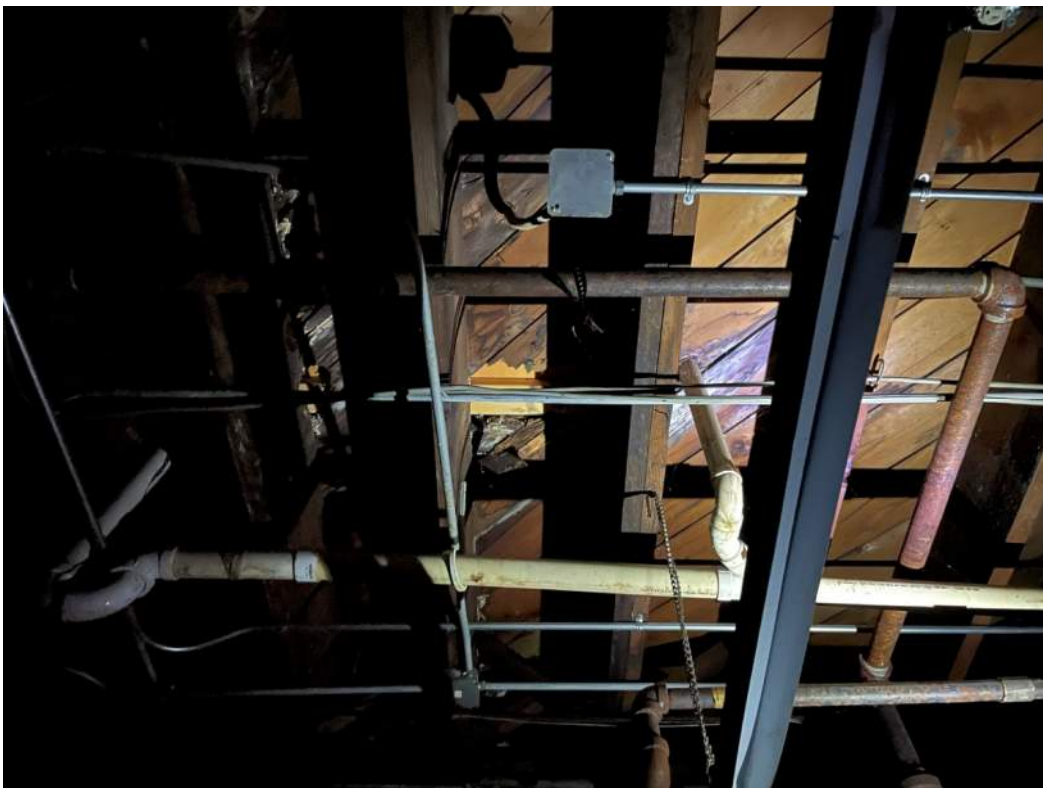
Photo 16: Existing floor framing is damaged by long term plumbing and envelope leaks at several locations inside the building.

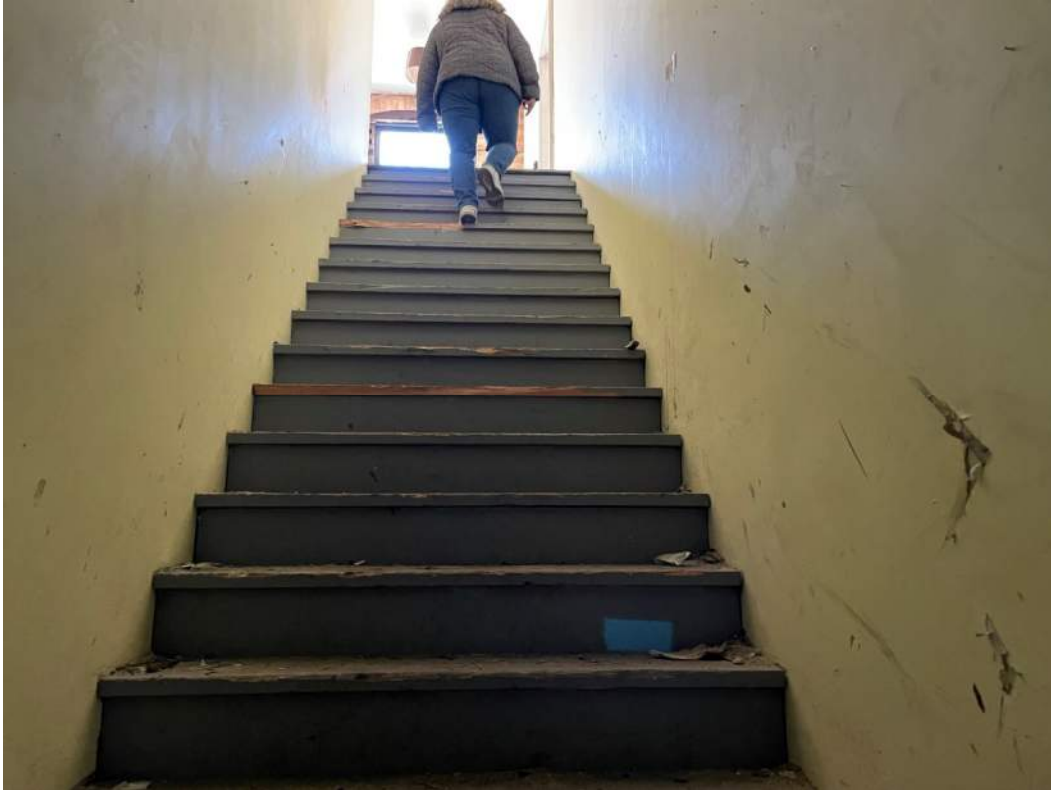
Photo 19: Interior stairs are not to current code rise / run or fire separation issues and would need to be replaced if major renovation were undertaken

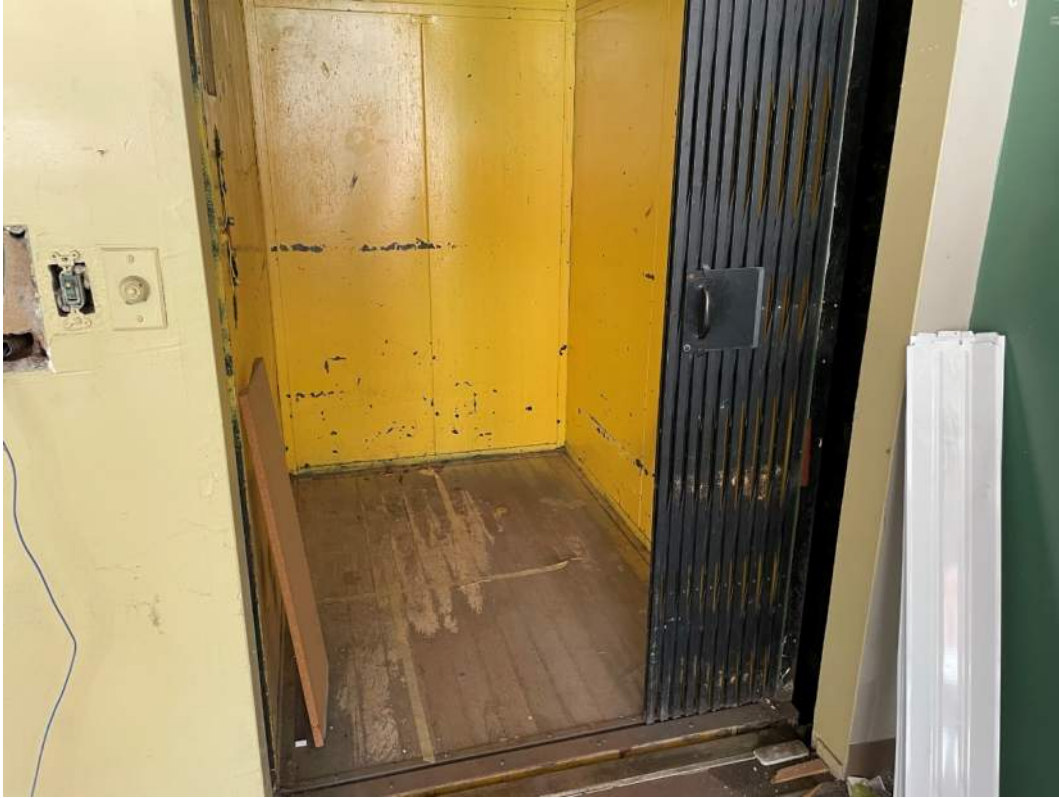
Photo 25: Existing freight elevator, would require significant upgrades or replacement if a significant renovation were to occur.

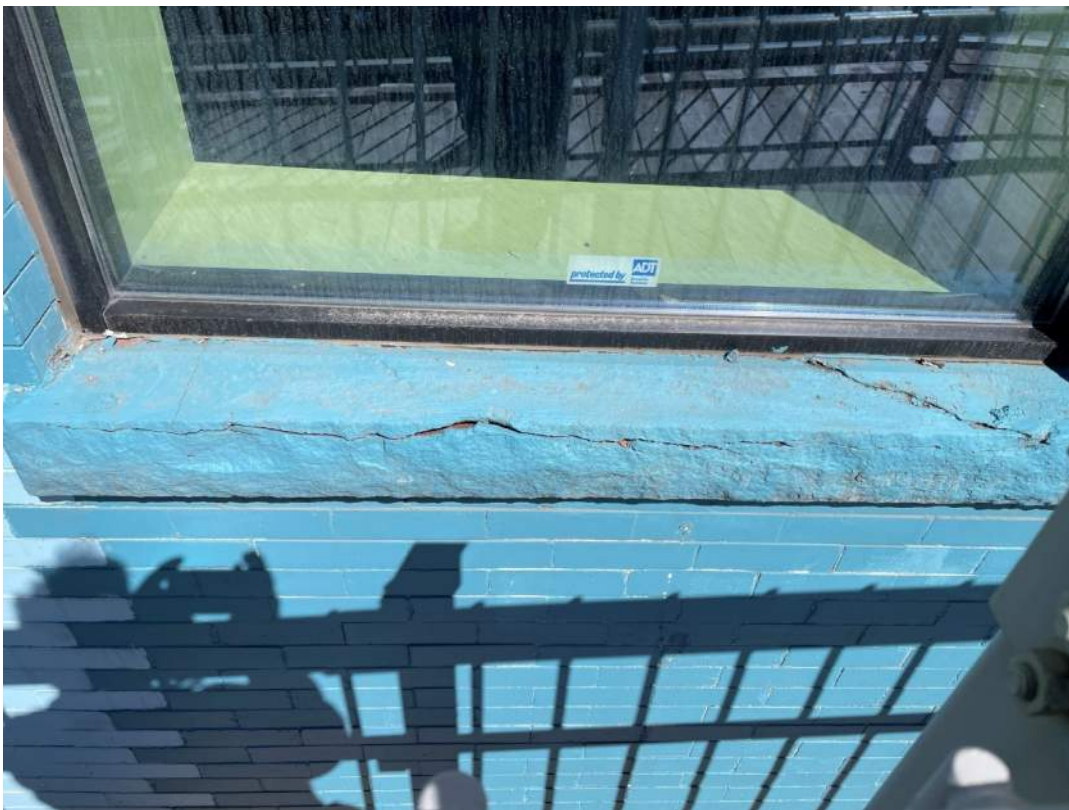
Photo 28: Existing exterior window sill – typical at the perimeter, many are broken and require replacement.

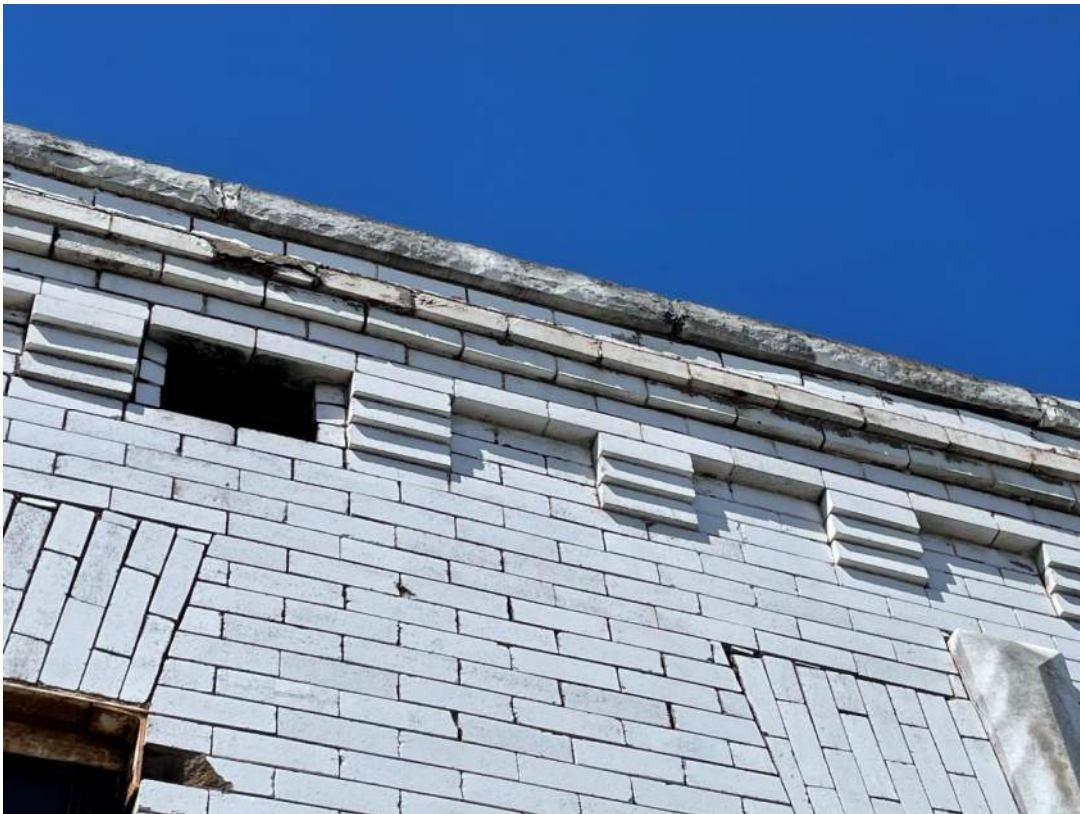
Photo 30: The existing parapets are deteriorated, missing or loose brick and exterior needs tuckpointing to prevent further deterioration.
