Management Report

DEDA
AAR - Duluth Airbus Facility
4600 Stebner Rd., Duluth, MN

Prepared For
DEDA

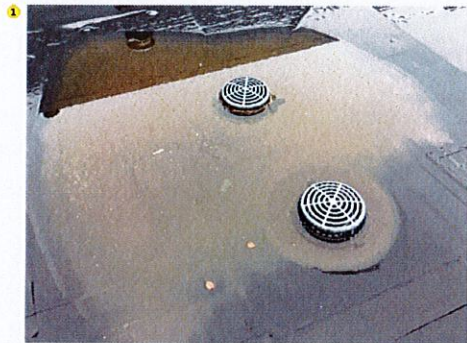
General - Annual Roof Maintenance & Repairs (Remedial)

Roof system is in need of general roof maintenance and repair. We recommend yearly inspections and repairs to prolong the life of the roof system.

Walk entire roof section. Inspect field seams and penetration flashings. Check and clear all drains & scuppers. Clean roof surface of all natures debris (leaves, branches, dirt). Remove and dispose of any foreign debris (screws, trash, filters, belts, etc.) Check and caulk all vent stacks & storm collars as necessary.

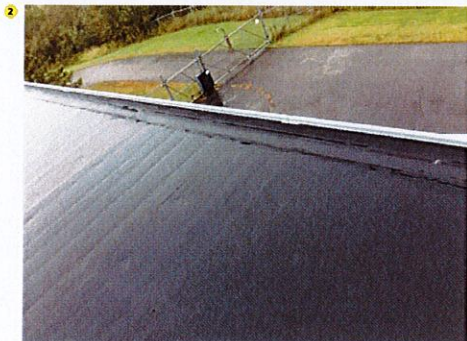
General - Edge Flashing Failure (Remedial)

Roof membrane has separated or deteriorated from the metal edge detail.

Clean and prime area as necessary and install new material to ensure water tightness.

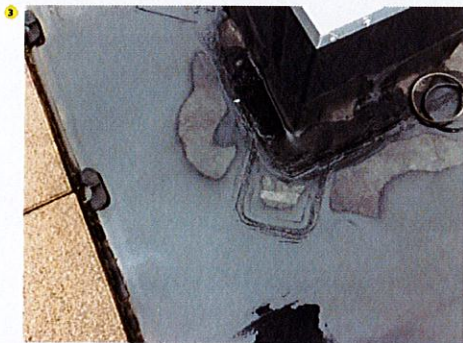
General - Deteriorated Curb Flashing (Remedial)

Flashing details are starting to deteriorate and should be reinforced before they fail completely.

Strip in flashing with new pressure sensitive cover tape to ensure a long term watertight condition.

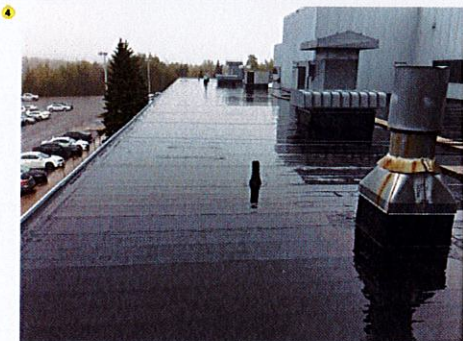
General - New Fluid Applied Membrane Budget (Remedial)

Roof system is over 20 years old.

Furnish and install a new fluid applied membrane

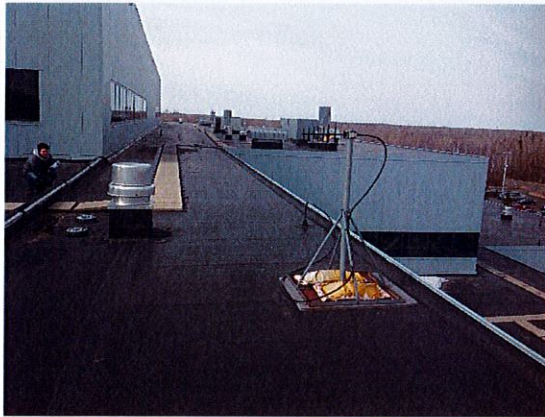
Observation #1
Most of the field seams have been overlaid. There are still quite a few curbs and edge flashing to address

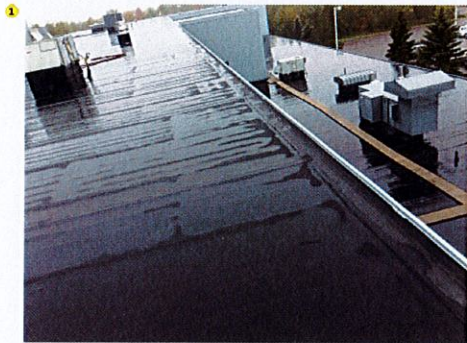
General - Deteriorated Edge Flashing (Remedial)

Roof membrane is starting to separate from the metal edge detail.

Clean and prime area as necessary and install new material to ensure water tightness.

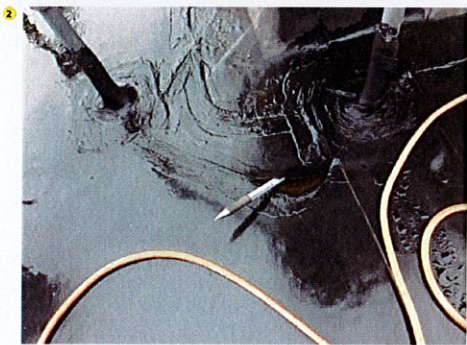
General - Deteriorated Curb Flashing (Remedial)

Flashing details are starting to deteriorate and should be reinforced before they fail completely.

Strip in flashing with new pressure sensitive cover tape to ensure a long term watertight condition.

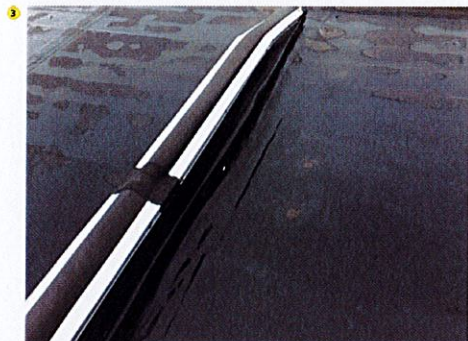
General - Loose Wall Flashing (Remedial)

Wall flashing is no longer adhered to the expansion joint

Membrane would be cut and re-adhered to wall. New cover tape will be installed where membrane is cut.

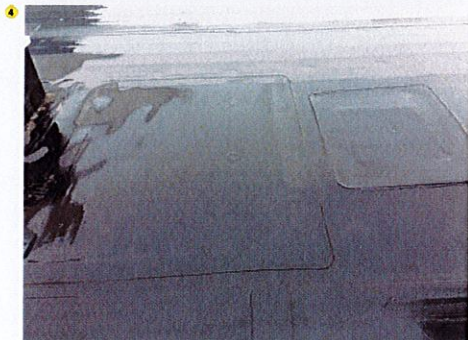
General - Misc. Field Repairs (Remedial)

As a maintenance item, we strongly recommend you strip in field seams that are glued. Installing EPDM cover tape material over seams will greatly extend the service life of your roof system.

Clean and prime seam. Install and roll cover tape material to ensure water tight condition.

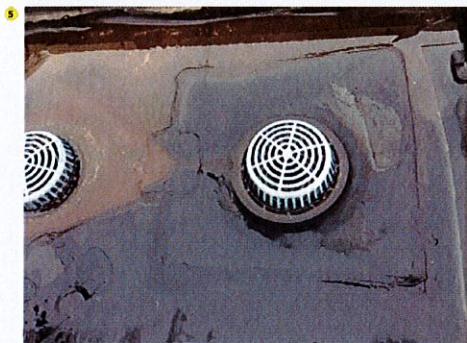
General - Annual Roof Maintenance & Repairs (Remedial)

Roof system is in need of general roof maintenance and repair. We recommend yearly inspections and repairs to prolong the life of the roof system.

Walk entire roof section. Inspect field seams and penetration flashings. Check and clear all drains & scuppers. Clean roof surface of all nature's debris (leaves, branches, dirt). Remove and dispose of any foreign debris (screws, trash, filters, belts, etc.) Check and caulk all vent stacks & storm collars as necessary.

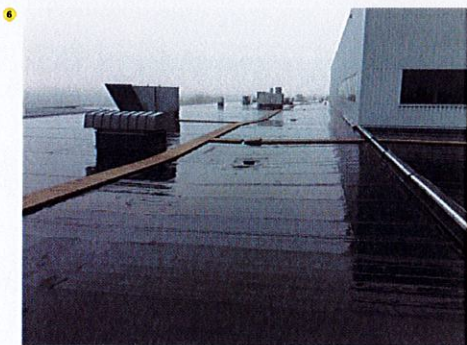
General - New Fluid Applied Membrane Budget (Remedial)

Roof system is over 20 years old

Furnish and install a new fluid applied membrane

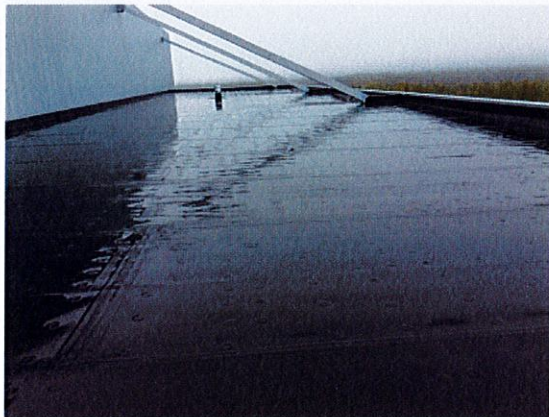
Observation #1

All the field seams have been stripped in on this section

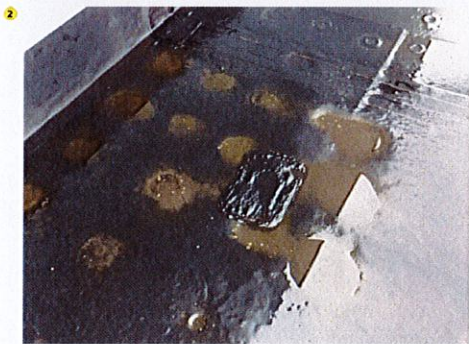
General - Wet/Deteriorated Insulation (Remedial)

Insulation has become saturated do to water infiltration.

Remove entire area of damaged insulation. Install new insulation an waterproofing membrane to maintain a watertight condition.

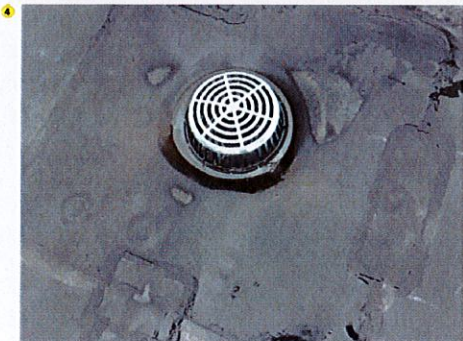
General - Annual Roof Maintenance & Repairs (Remedial)

Roof system is in need of general roof maintenance and repair. We recommend yearly inspections and repairs to prolong the life of the roof system.

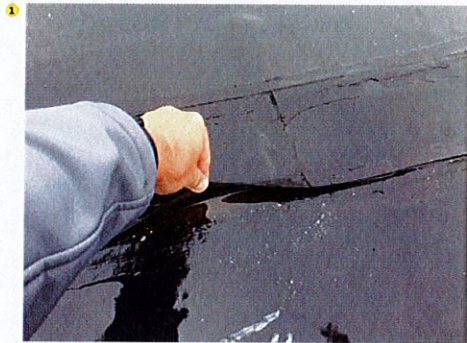
1 General - Delaminated Field Seams (Remedial)

Open seams in the waterproofing membrane are typically caused by failing seam adhesives coupled with membrane shrinkage and stress on the seams. The area where the Logo is painted on the roof has been deducted from the LF

The area surrounding the open seam must be cleaned. A new piece of waterproofing membrane would be installed and sealed per industry standards.

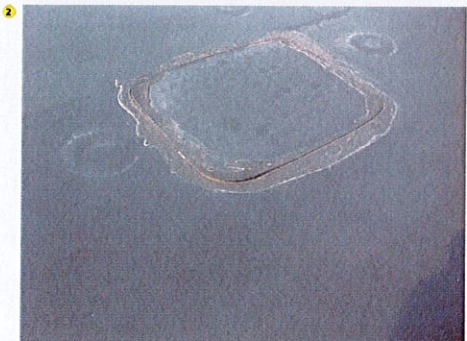
2 General - Delaminated field patching (Remedial)

Previous patchwork is peeling up and needs to be reinforced. This condition is around the roof drains as well

We will remove the existing repair, clean and prime area and install new patch to ensure water tightness.

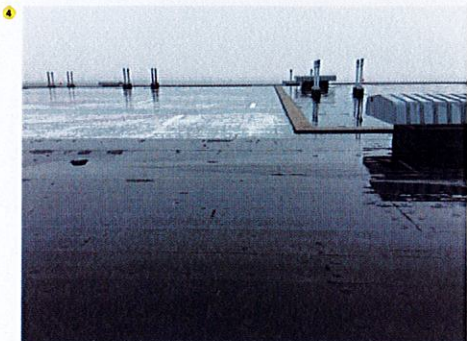
General - New Fluid Applied Membrane Budget (Remedial)

Maintenance has been deferred on this section but the substrate is still dry. We recommend installing a fluid applied membrane

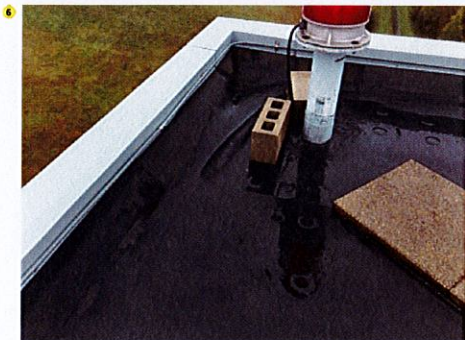
General - Loose Wall Flashing (Remedial)

Wall flashing is no longer adhered to the wall. This could have been caused by wind, moisture in the wall, or treated plywood. The base attachment appears to still be in place and functional.

Cut loose wall and allow it to relax. Install new termination bar at loose wall details. New cover tape will be installed over the term bar

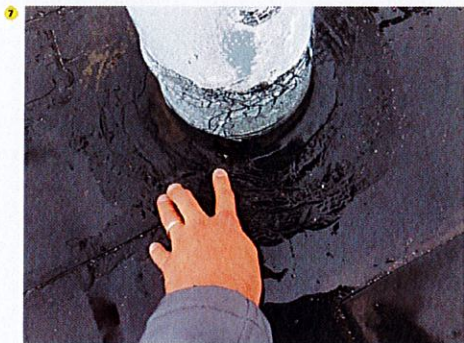
General - Annual Roof Maintenance & Repairs (Remedial)

Roof system is in need of general roof maintenance and repair. We recommend yearly inspections and repairs to prolong the life of the roof system.

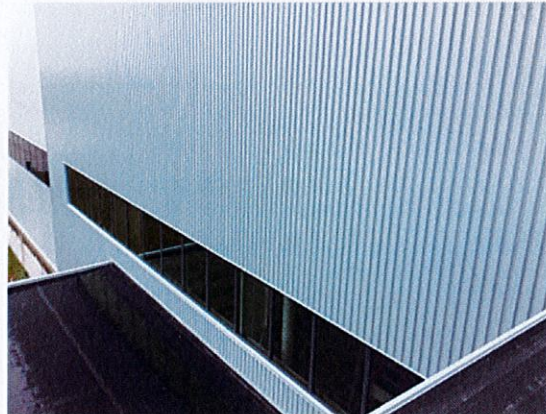
New wall panels have been installed

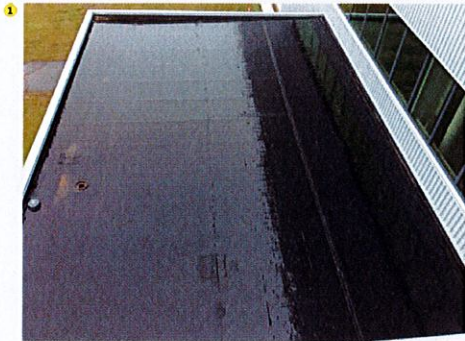
General - Roof Maintenance Program (Remedial)

We highly recommend starting an annual Roof Maintenance Program. Routine roof maintenance helps prolong the life of the roof system.

Visually inspect the entire roof. Repair minor deficiencies as necessary. Check and clear all drains & scuppers. Clean roof surface of all nature's debris (leaves, branches, dirt). Remove and dispose of any foreign debris (screws, trash, filters, belts, etc.) Check and caulk all vent stacks & storm collars as necessary. If any major issues are found, we will provide a proposal for repair.
