Management Report

DEDA
AAR - Duluth Airbus Facility
4600 Stebner Rd., Duluth, MN

Prepared For
DEDA

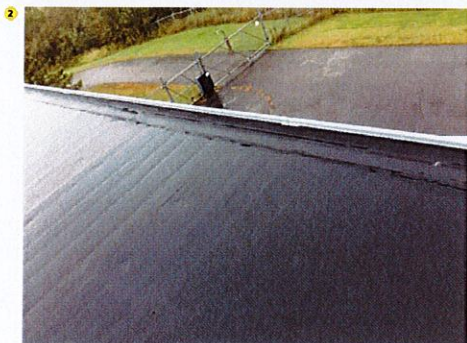
General - Edge Flashing Failure (Remedial)

Roof membrane has separated or deteriorated from the metal edge detail.

Clean and prime area as necessary and install new material to ensure water tightness.

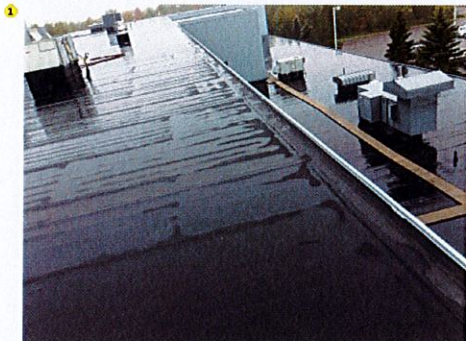
General - Deteriorated Edge Flashing (Remedial)

Roof membrane is starting to separate from the metal edge detail.

Clean and prime area as necessary and install new material to ensure water tightness.

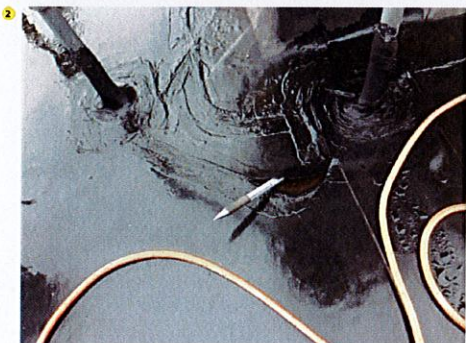
General - Deteriorated Curb Flashing (Remedial)

Flashing details are starting to deteriorate and should be reinforced before they fail completely.

Strip in flashing with new pressure sensitive cover tape to ensure a long term watertight condition.

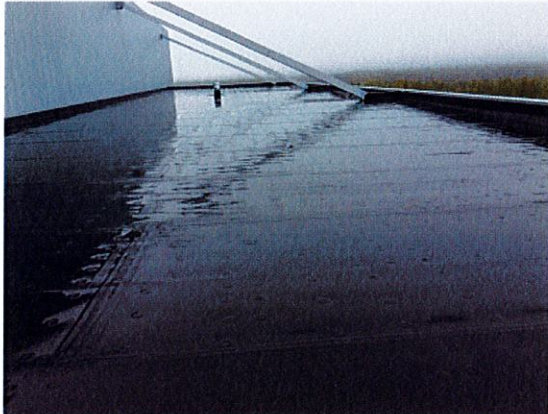
Observation #1
All the field seams have been stripped in on this section

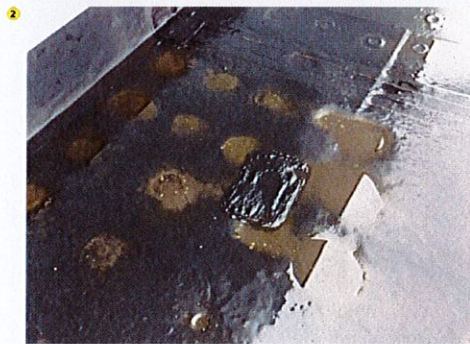
General - Wet/Deteriorated Insulation (Remedial)

Insulation has become saturated do to water infiltration.

Remove entire area of damaged insulation. Install new insulation an waterproofing membrane to maintain a watertight condition.

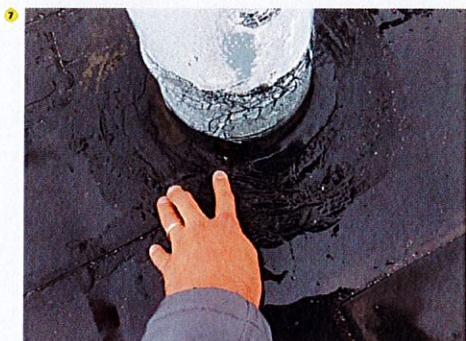
General - Annual Roof Maintenance & Repairs (Remedial)

Roof system is in need of general roof maintenance and repair. We recommend yearly inspections and repairs to prolong the life of the roof system.

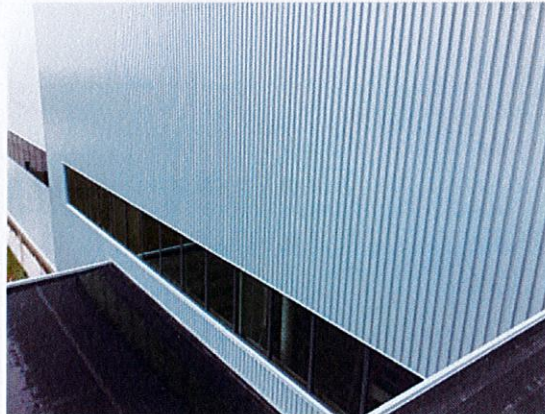
New wall panels have been installed

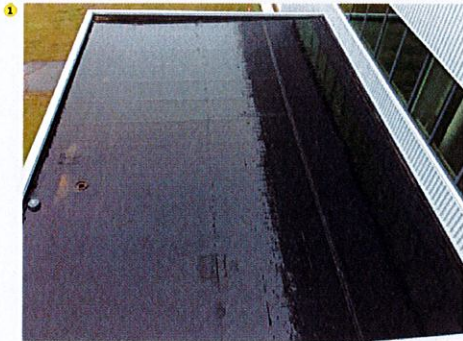
General - Roof Maintenance Program (Remedial)

We highly recommend starting an annual Roof Maintenance Program. Routine roof maintenance helps prolong the life of the roof system.

Visually inspect the entire roof. Repair minor deficiencies as necessary. Check and clear all drains & scuppers. Clean roof surface of all natures debris (leaves, branches, dirt). Remove and dispose of any foreign debris (screws, trash, filters, belts, etc.) Check and caulk all vent stacks & storm collars as necessary. If any major issues are found, we will provide a proposal for repair.
