DATE: June 8, 2022
TO: Heritage Preservation Commission
FROM: Steven Robertson, Senior Planner
RE: PL 22-090, Application for the Demolition of a Contributing Structure to the Duluth Commercial Historic District

Structural Engineering Report

Project: 102 E Superior Street – Bullseye Bldg- Condition Review

Regarding: Structural and Envelope Condition Review

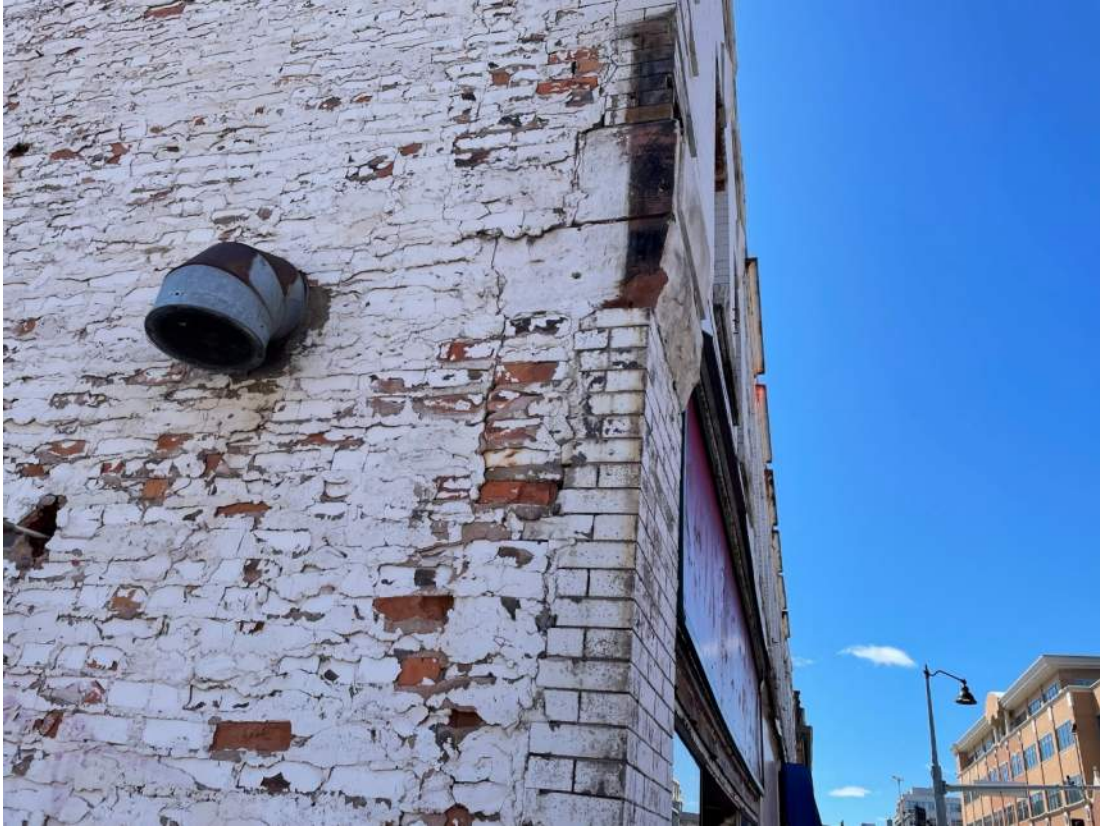
Photo 7: Existing East exterior wall looking west – close-up view of brick conditions

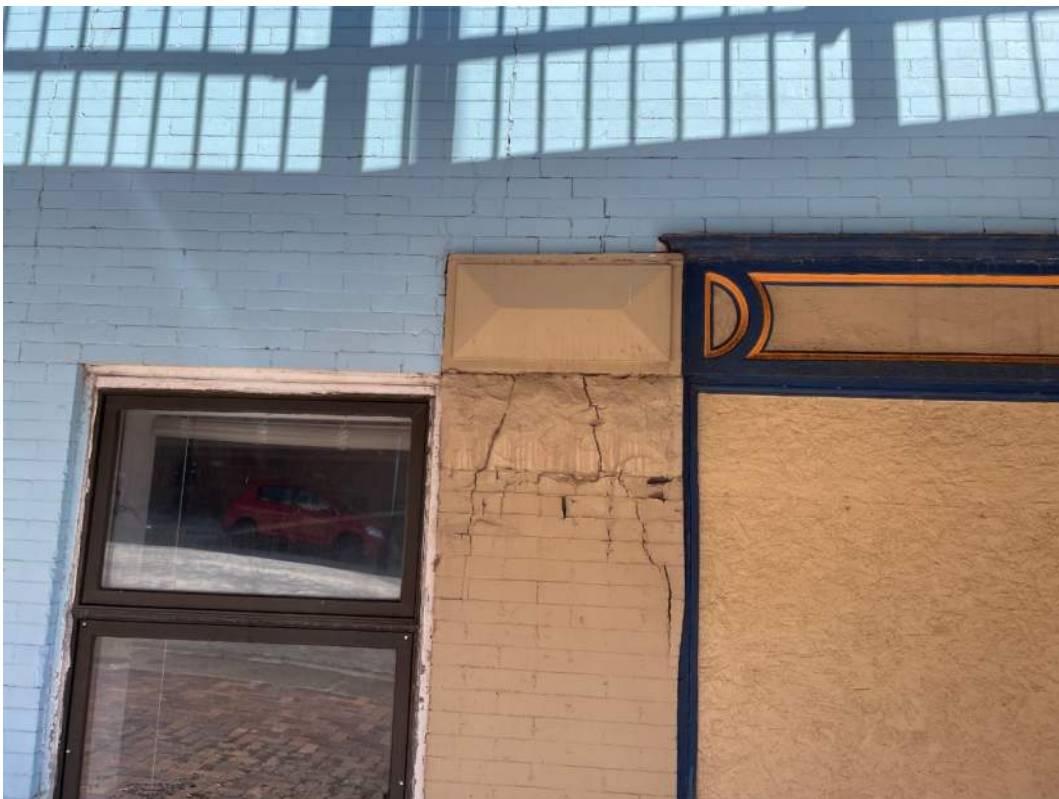
Photo 8: Close-up view of brick condition on west exterior wall looking east

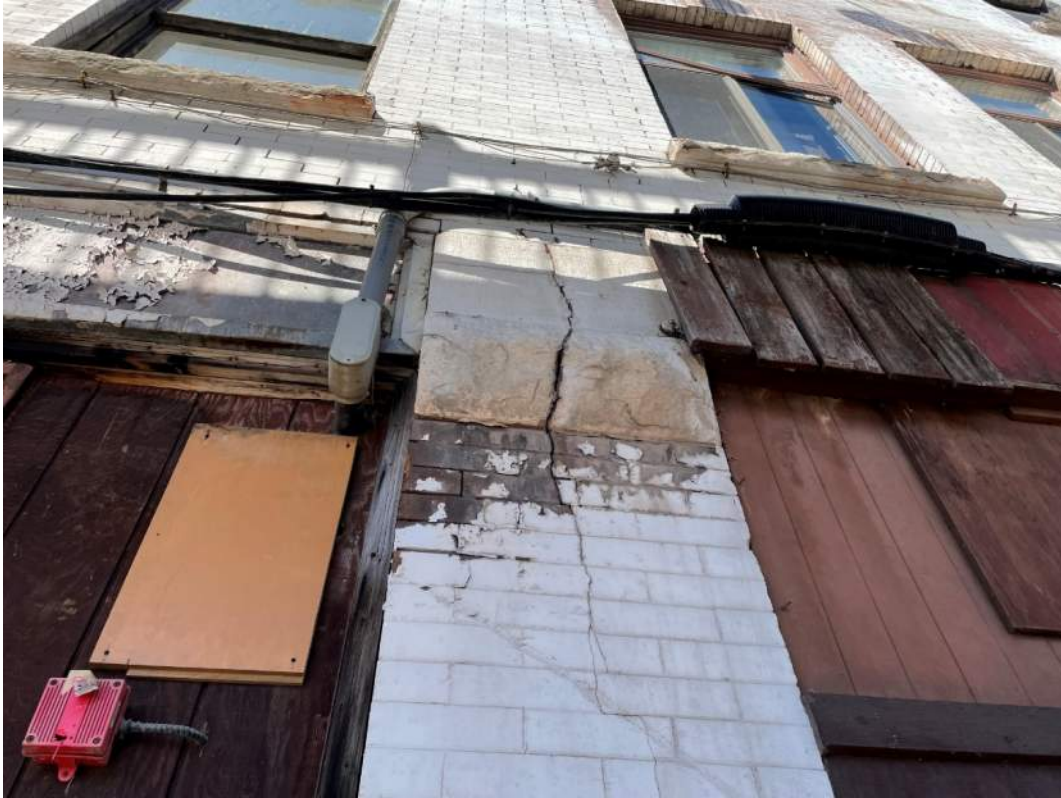
Photo 9: Close-up view of masonry condition at south elevation looking north

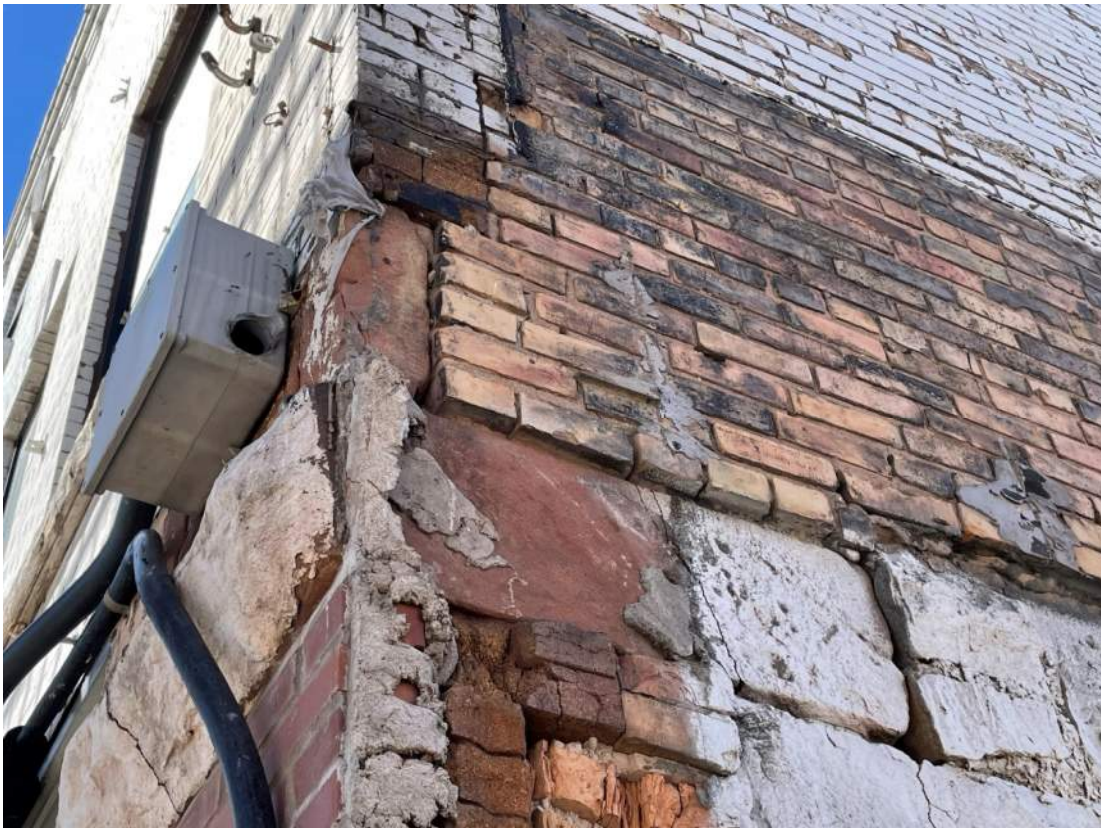
Photo 10: Close-up view of masonry condition at southeast corner of the exterior.

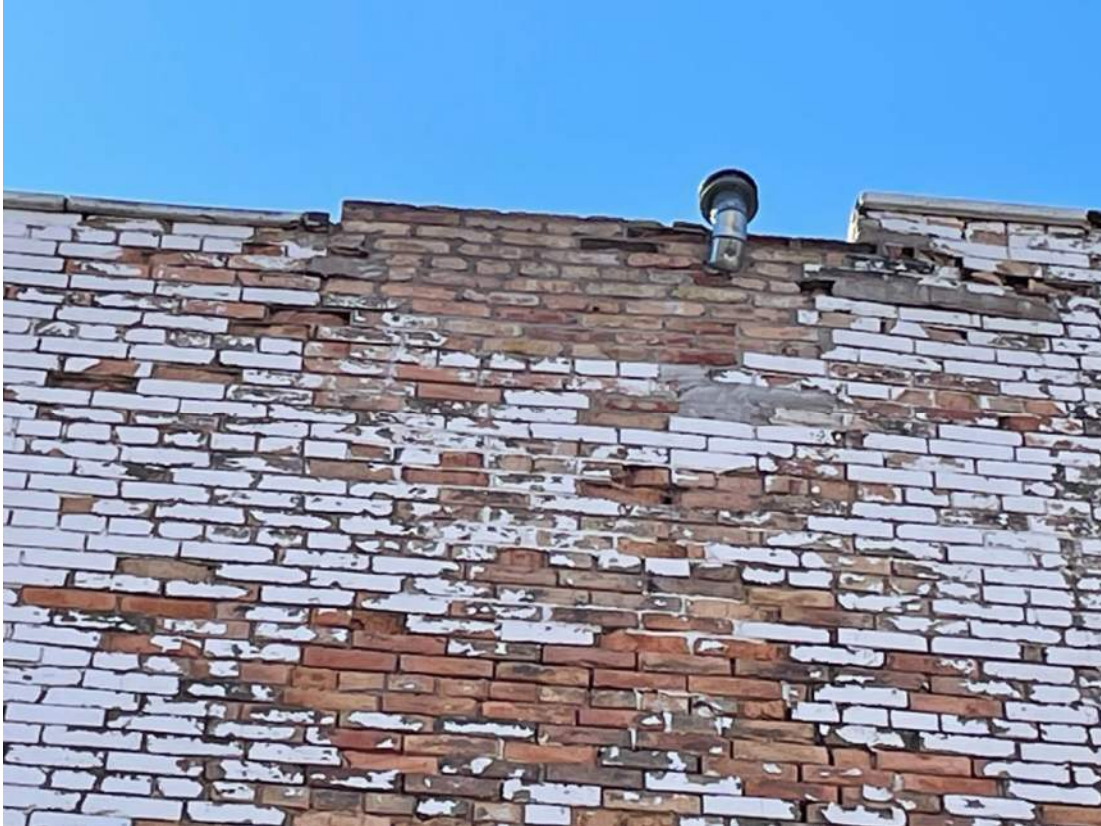
Photo 11: Close-up view of existing east exterior wall masonry condition.

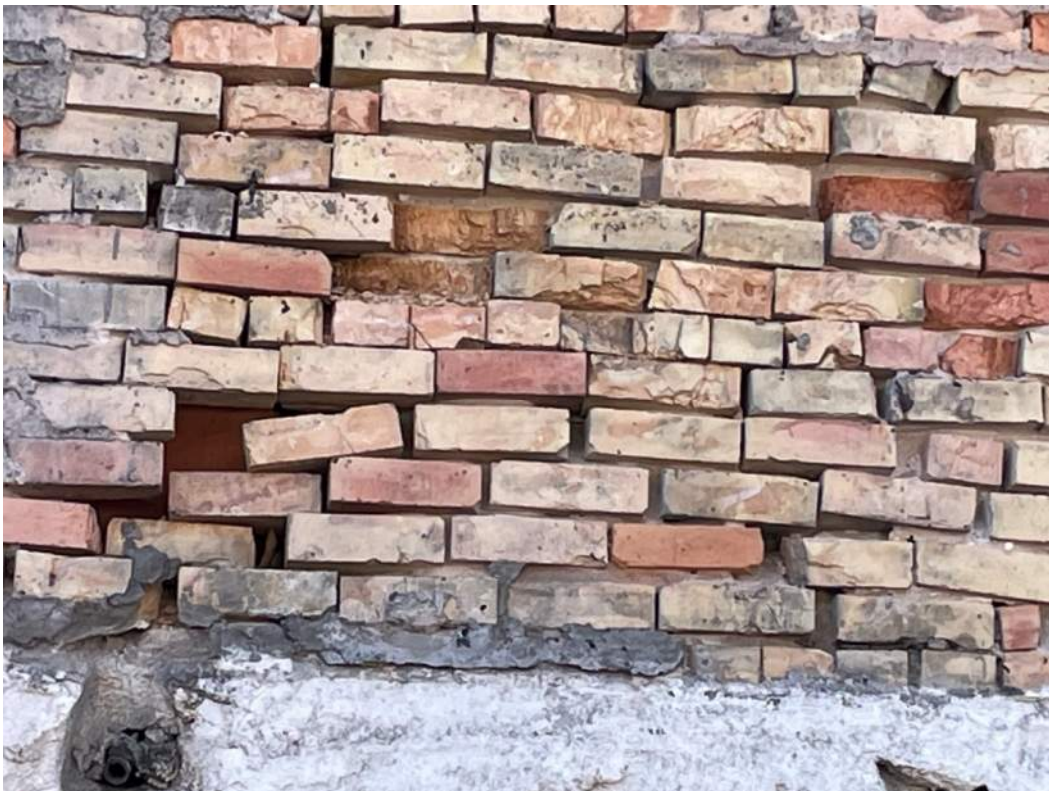
Photo 12: Close-up view of existing east exterior wall masonry condition

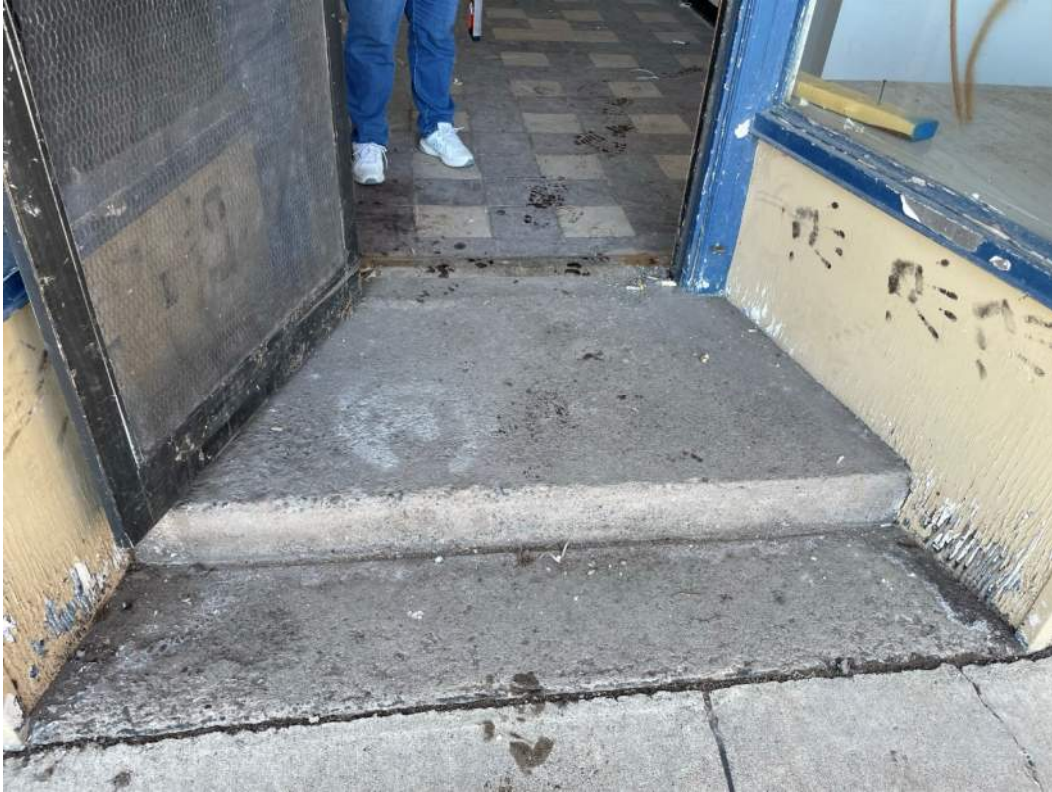
Photo 13: Rear (south side) is not ADA accessible.

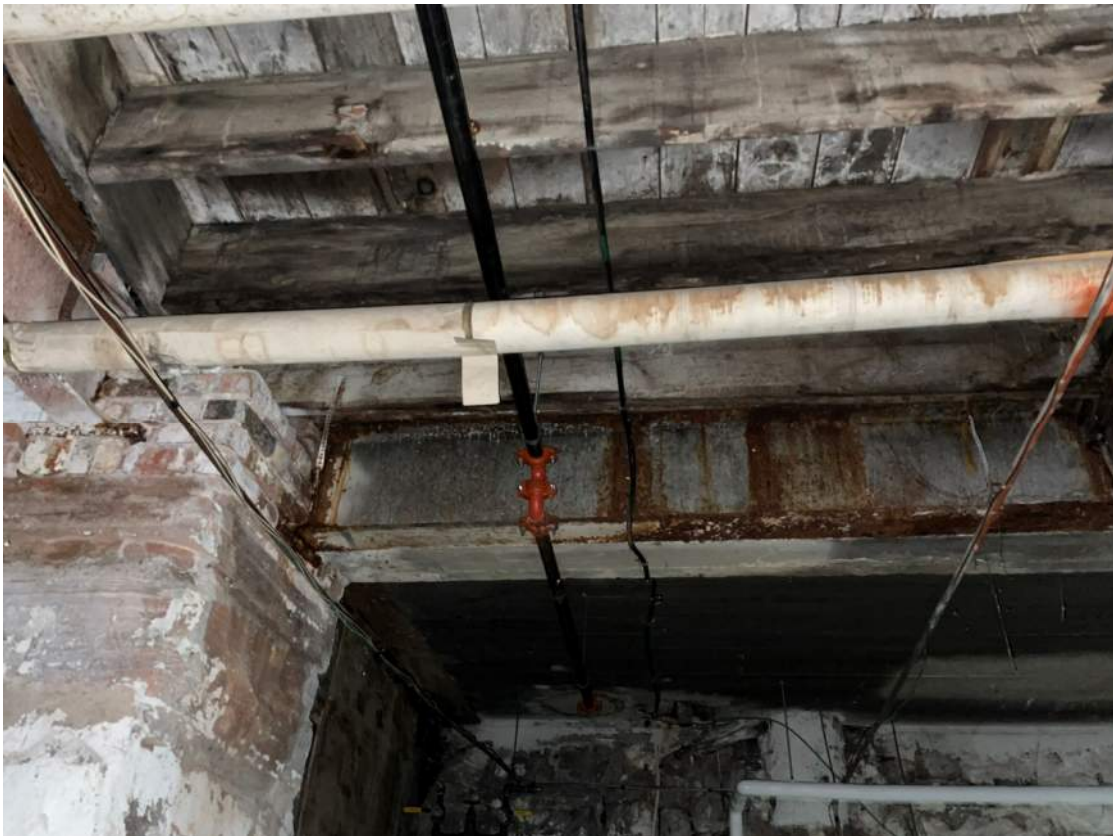
9. The existing sidewalk vault support system at the east end of the building is deteriorated and requires structural repairs.

Photo 14: Existing sidewalk vault support and existing wood floor framing near entrances is generally in poor condition

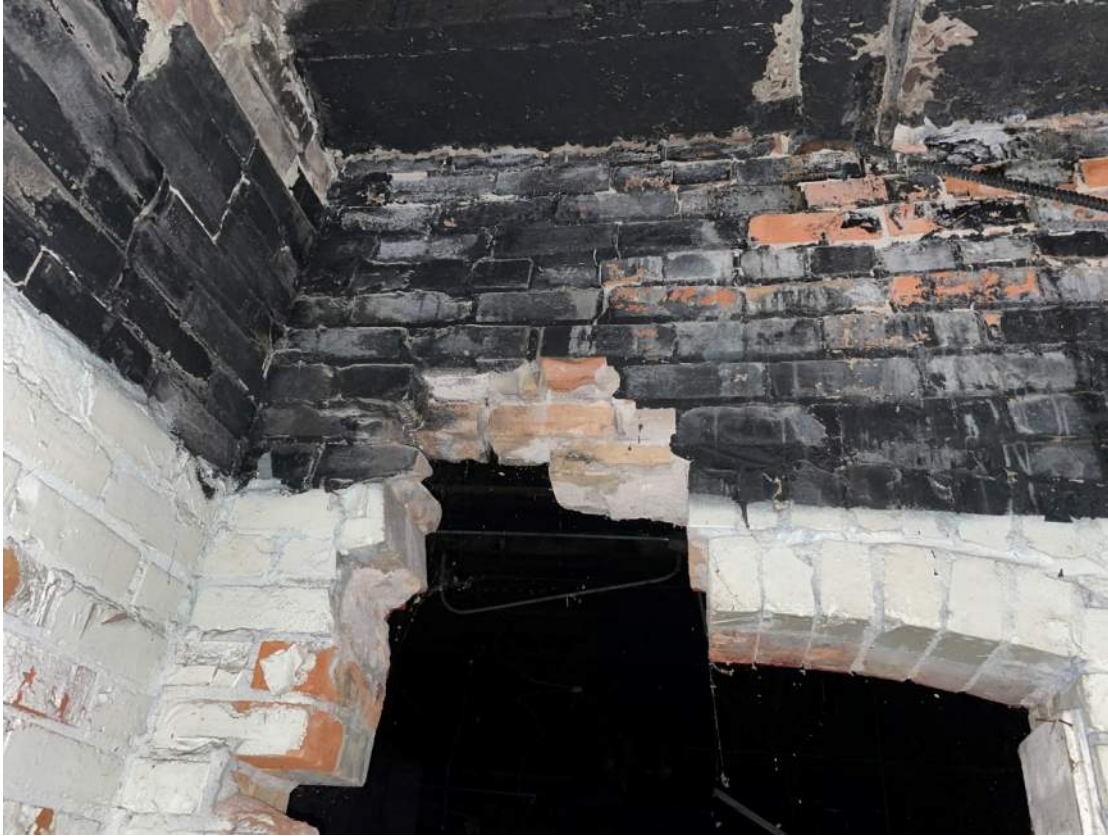
Photo 15: Existing sidewalk vault support is generally in poor condition

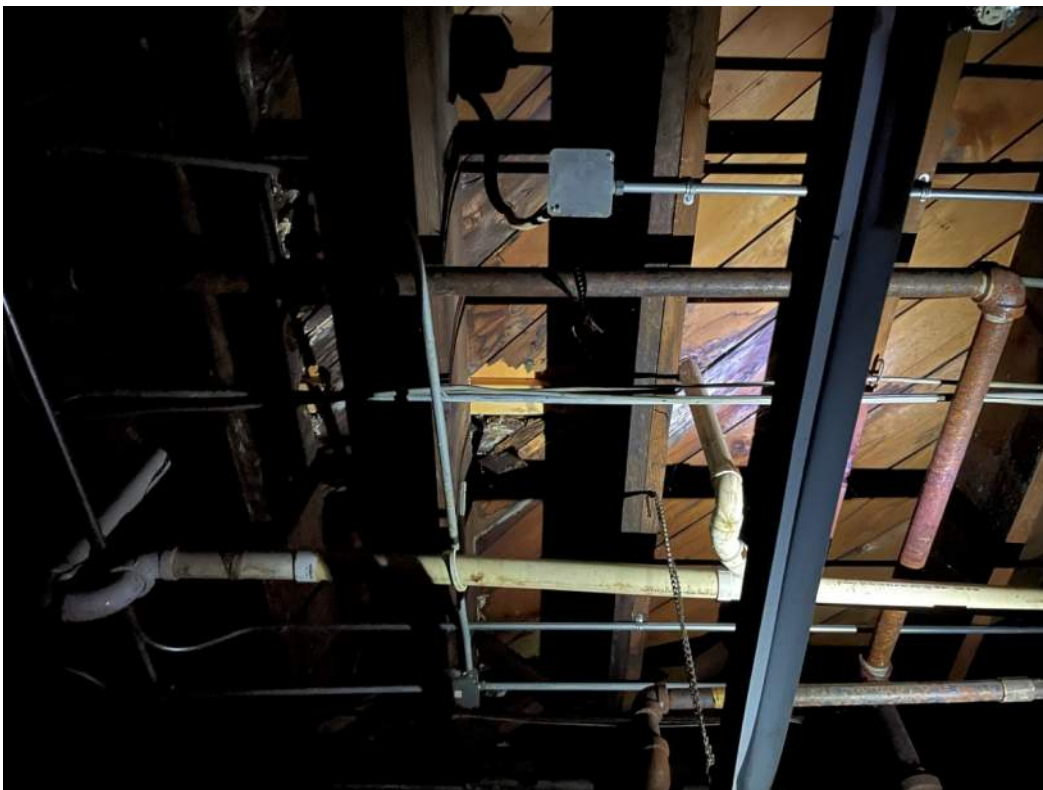
Photo 16: Existing floor framing is damaged by long term plumbing and envelope leaks at several locations inside the building.

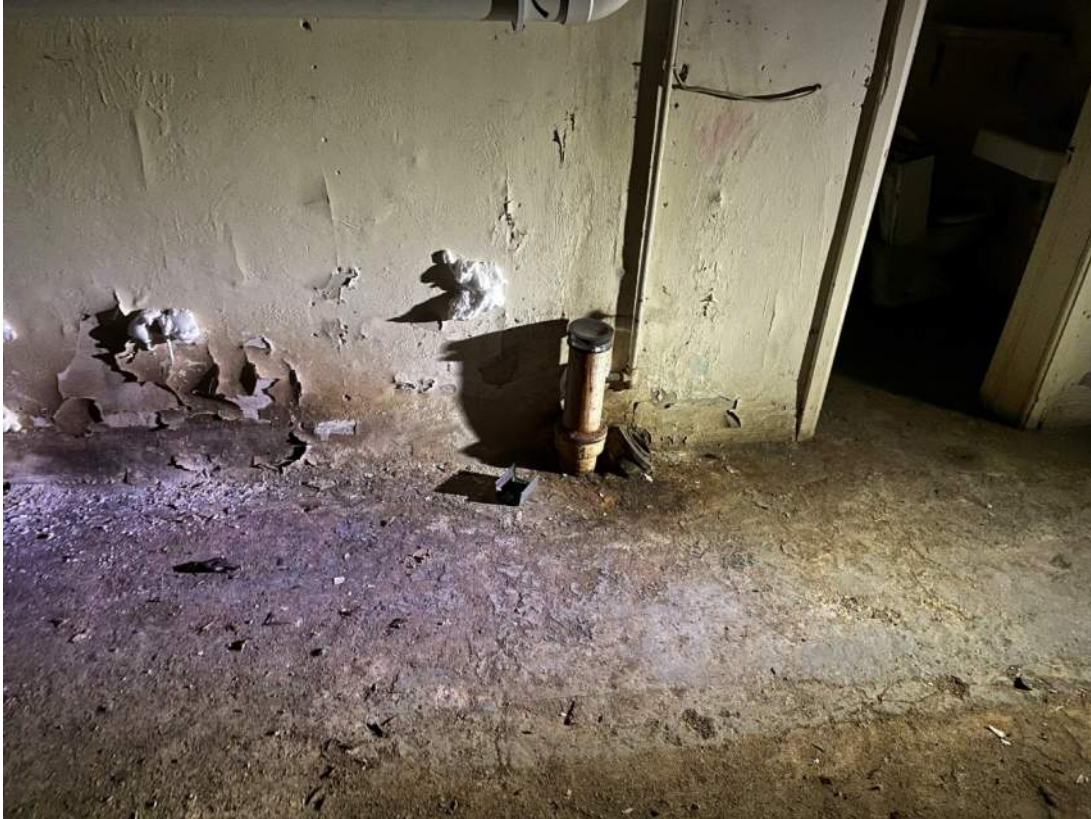
Photo 17: Based on our discussions, the sewer connection to the street is in need of excavation and replacement

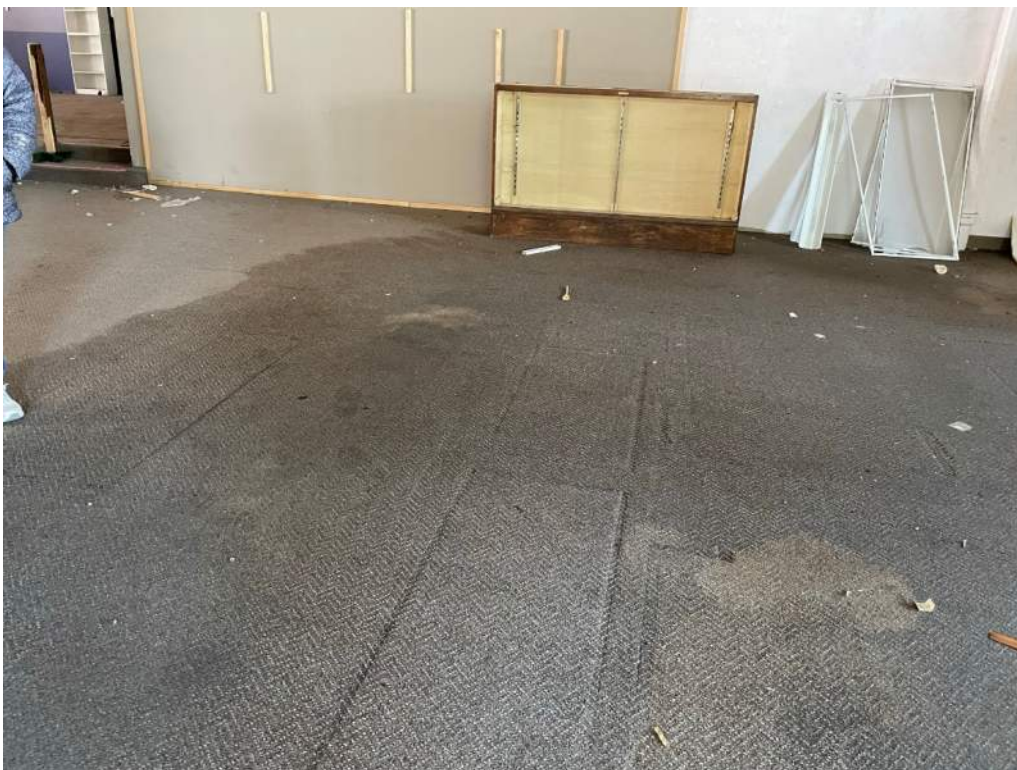
Photo 18: Rainwater on the upper floor level due to deteriorated roofing.

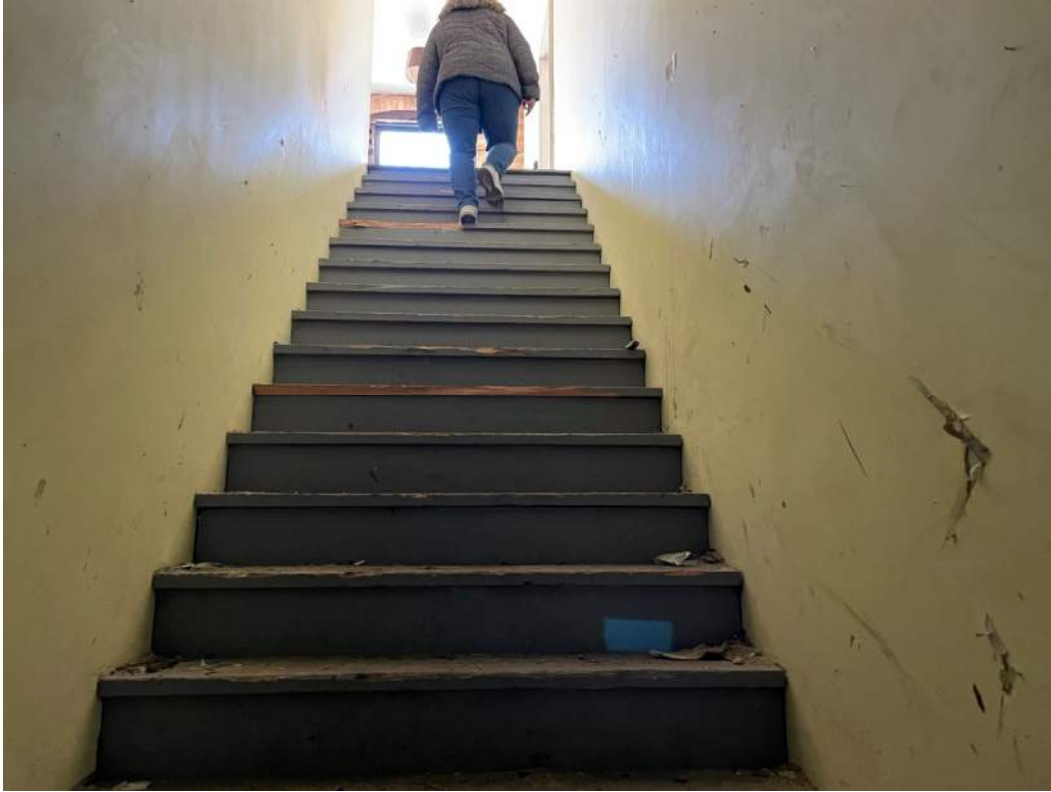
Photo 19: Interior stairs are not to current code rise / run or fire separation issues and would need to be replaced if major renovation were undertaken

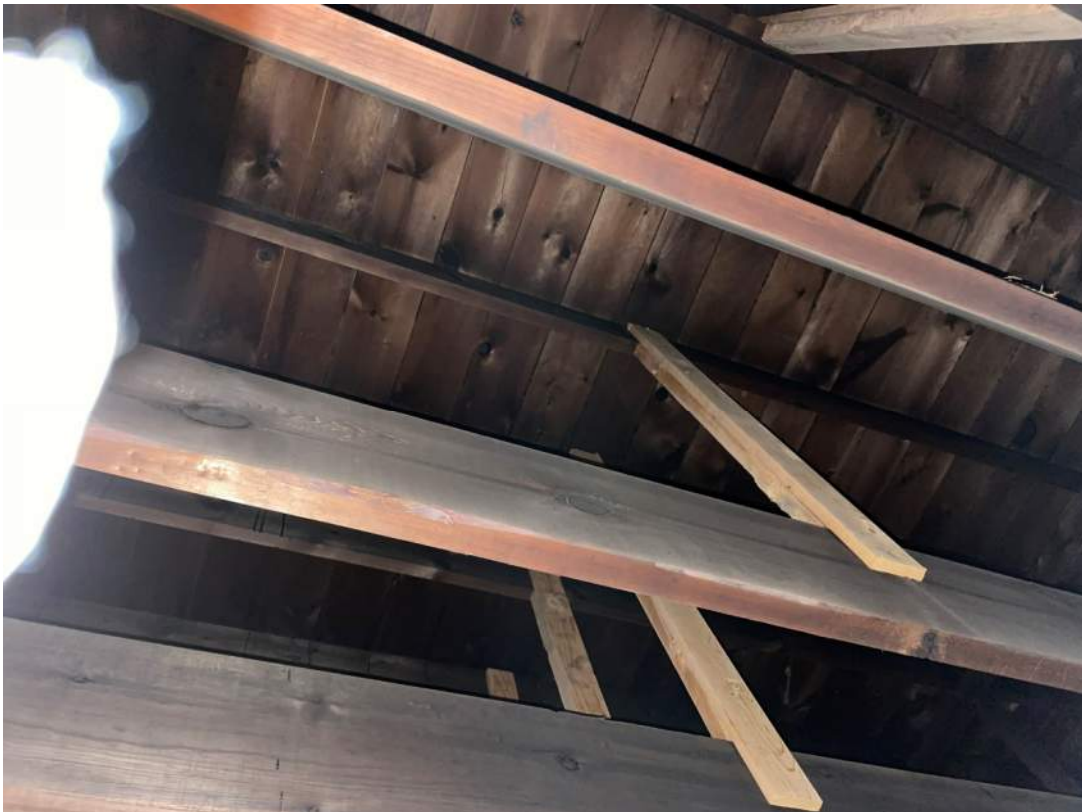
Photo 20: Existing ceiling joist and roof joist system does not meet current code for snow load, is currently not insulated.

2. The roofing system requires replacement and would need insulation to be added if the building were to be renovated. However, to add insulation, the roof would likely need to be reinforced to meet the MN Conservation Code for existing buildings.
3. The floor capacity is acceptable for residential, or office uses on both levels, however the Superior Street level would require reinforcing if retail or restaurant uses were desired per current MN Conservation code.
4. A new elevator and internal stairs would be needed if the building were to be renovated.

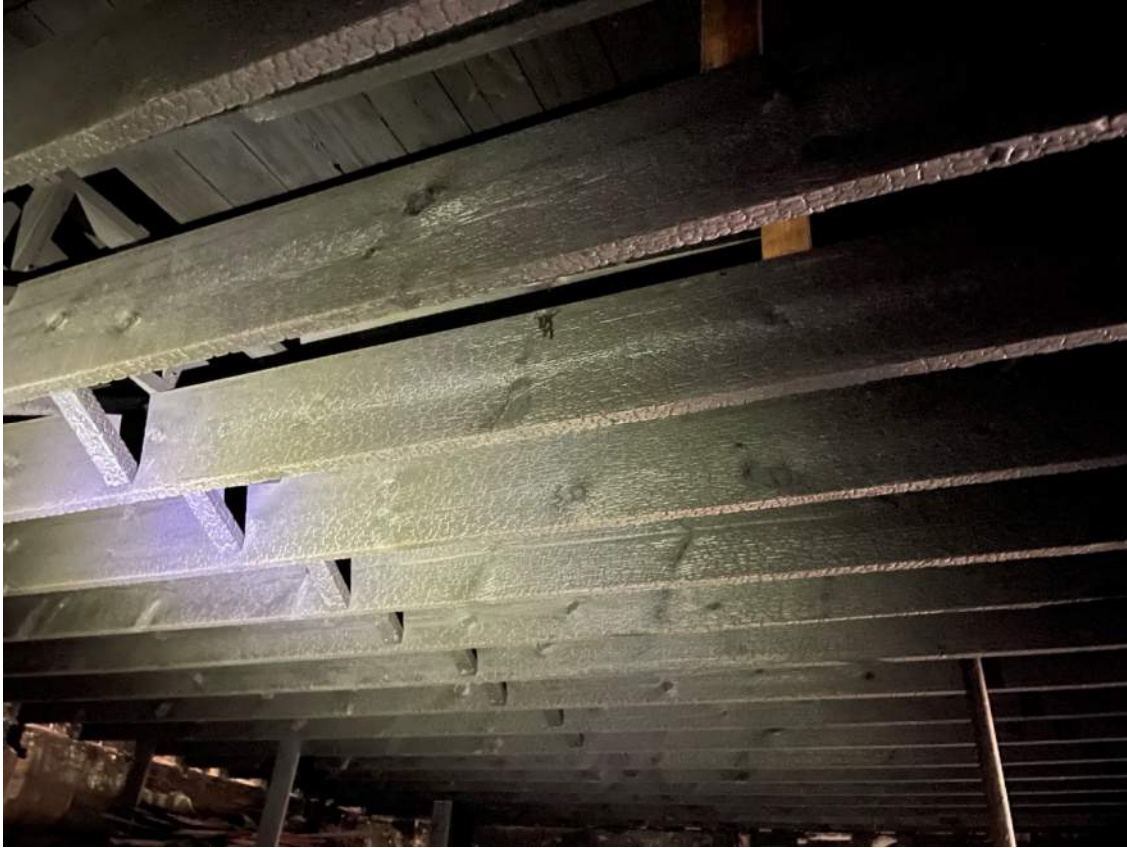
4. The roof framing generally consists of 2x12 wood ceiling framing and 2x6 roof framing built-up from the ceiling to form a roof slope. The south-east corner of the building has experienced a significant fire which damaged a large portion of the roof framing and a small portion of the floor framing in that corner.

Photo 21: Existing roof joists that have been severely damaged due to fire.

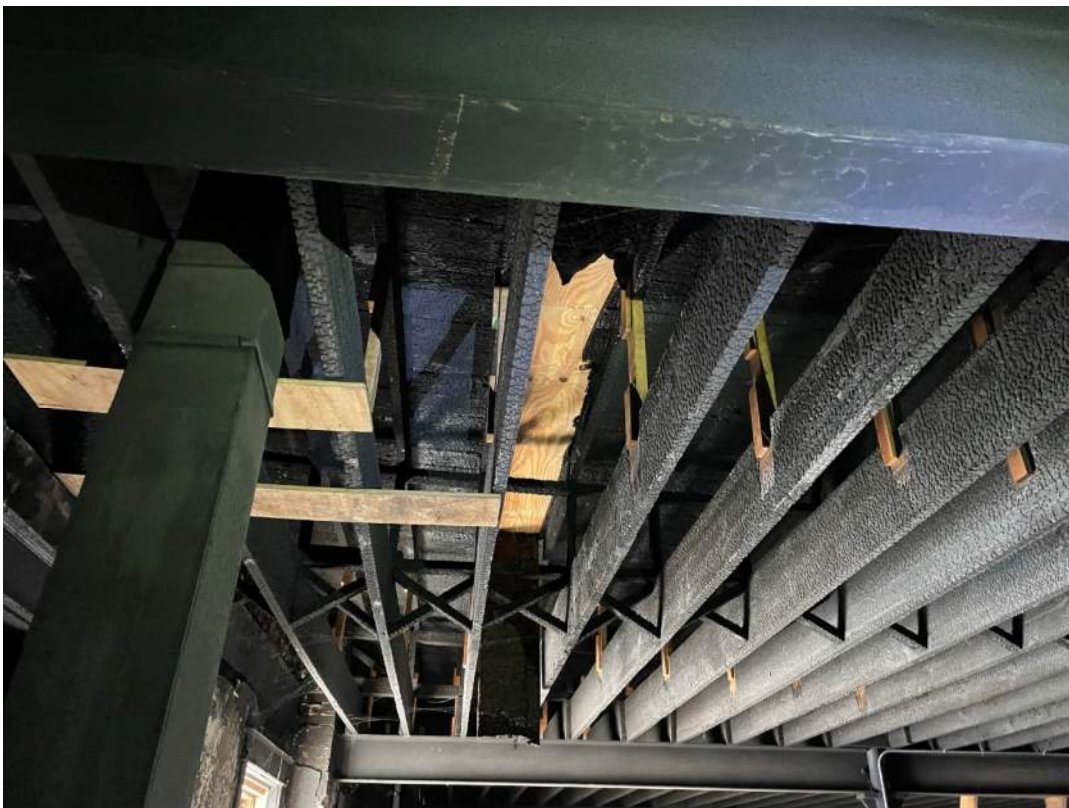
Photo 22: Existing roof joist framing severely damaged due to fire.

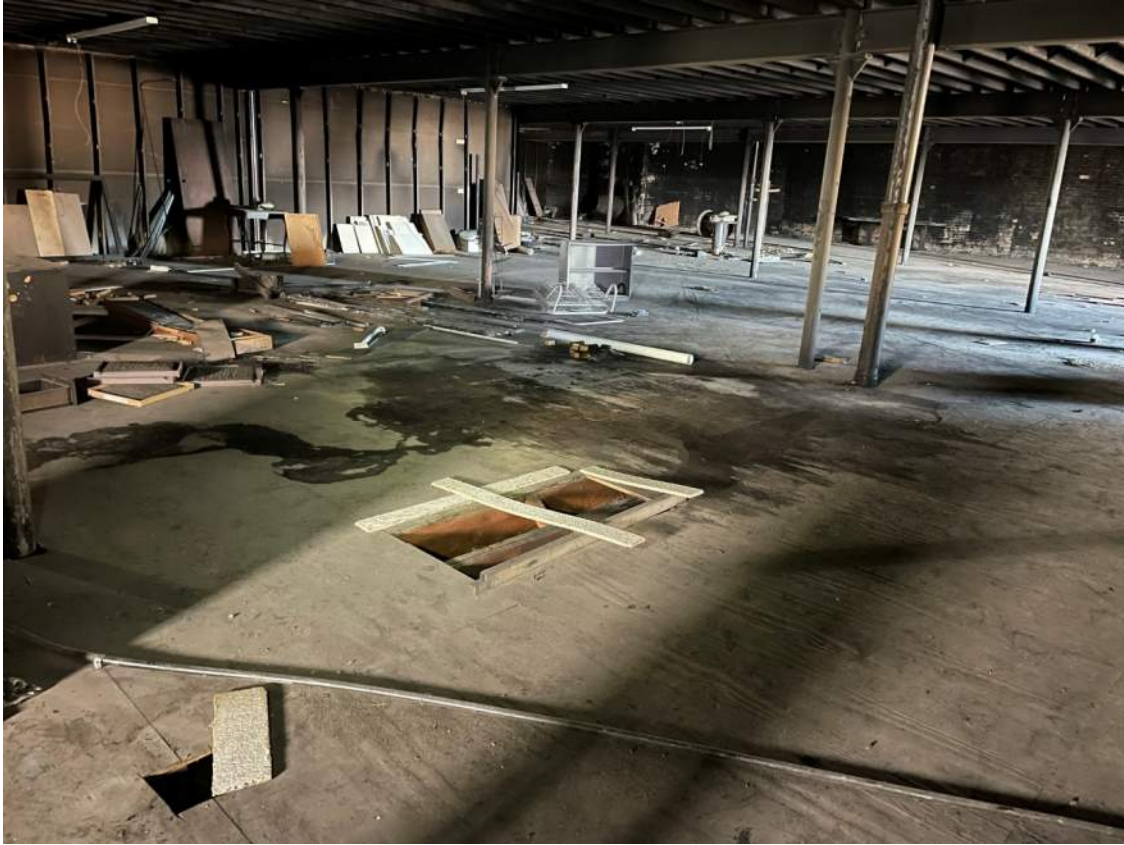
Photo 23: Existing wet flooring on the upper level due to roof leaks.

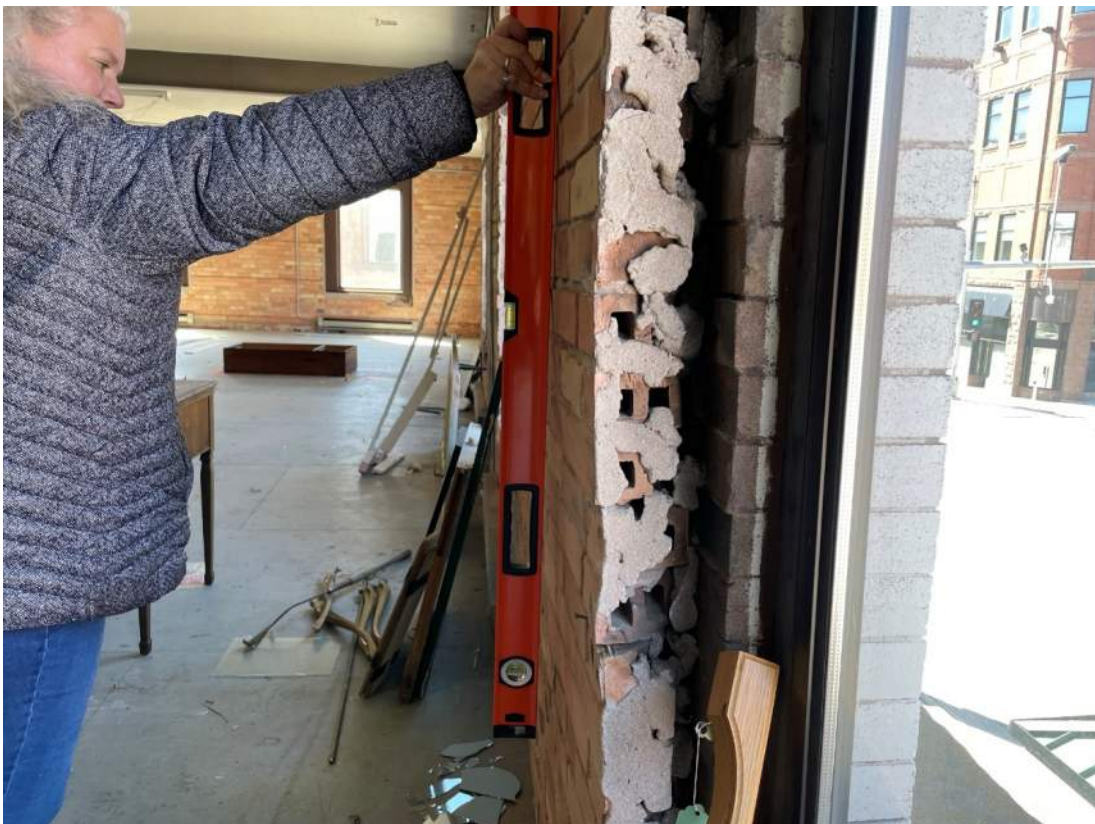
7. The existing elevator is freight use only and likely not in accordance with current code for people.
8. The second level, superior street side brick wall is bowed inward at one location and should be repaired.

Photo 24: Existing north wall is bowed inward due to poor construction methods and water infiltration.

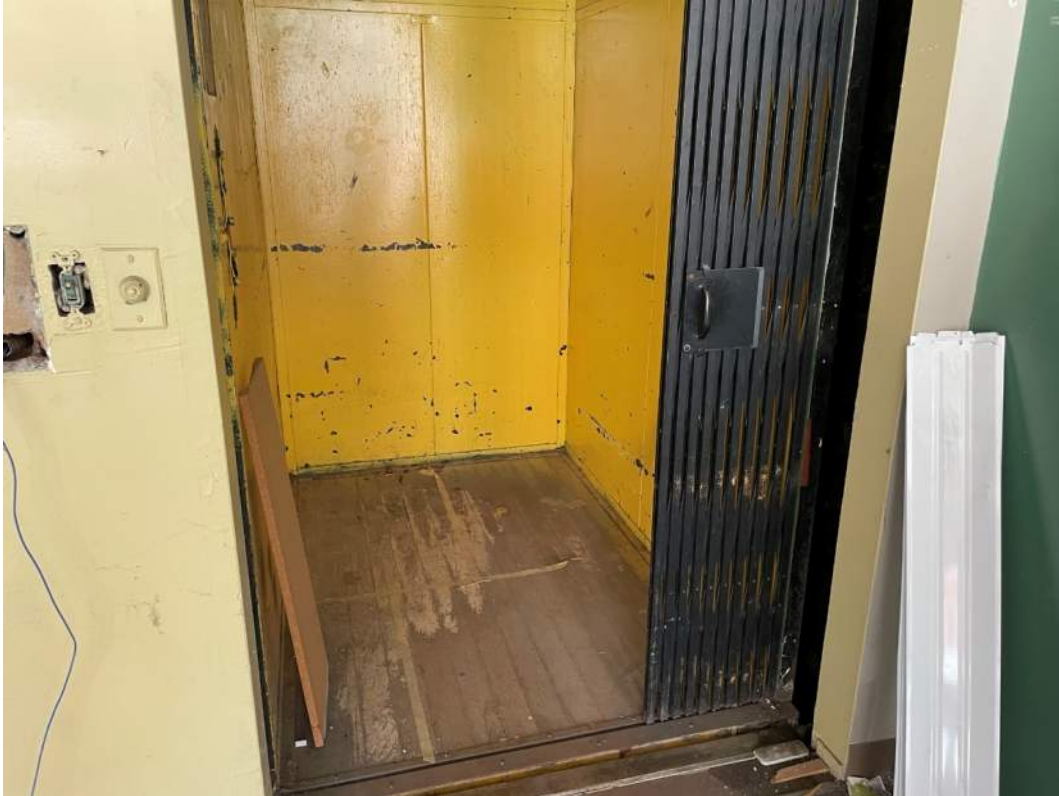
Photo 25: Existing freight elevator, would require significant upgrades or replacement if a significant renovation were to occur.

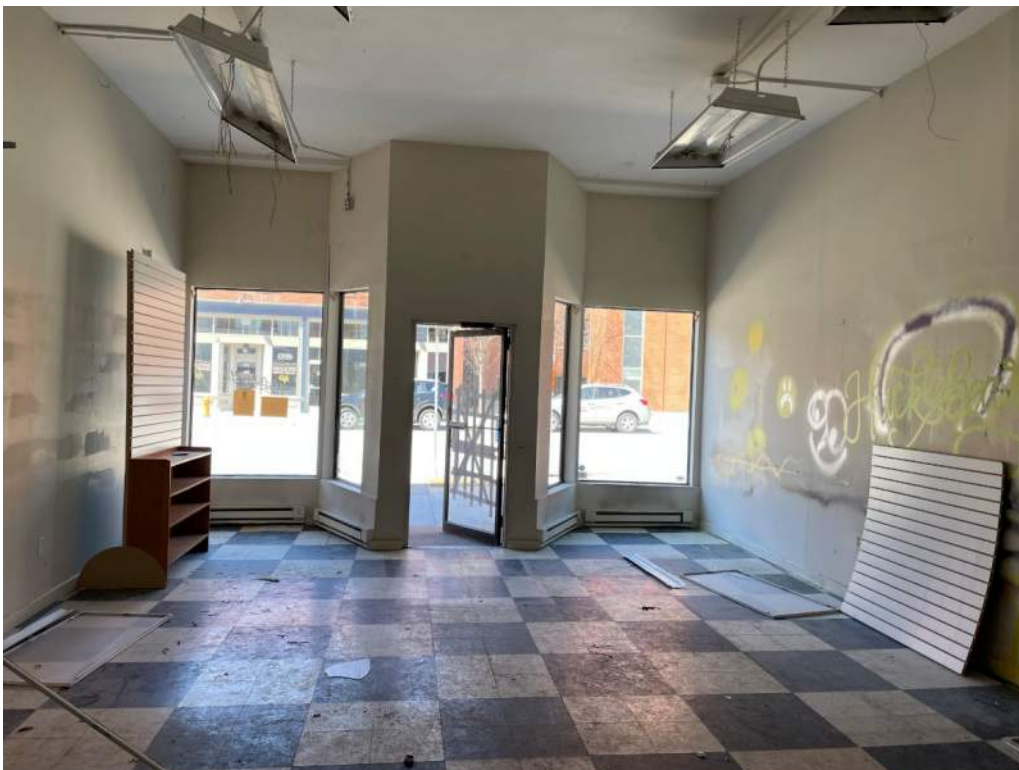
Photo 26: Existing interior finishes are old and need updating.

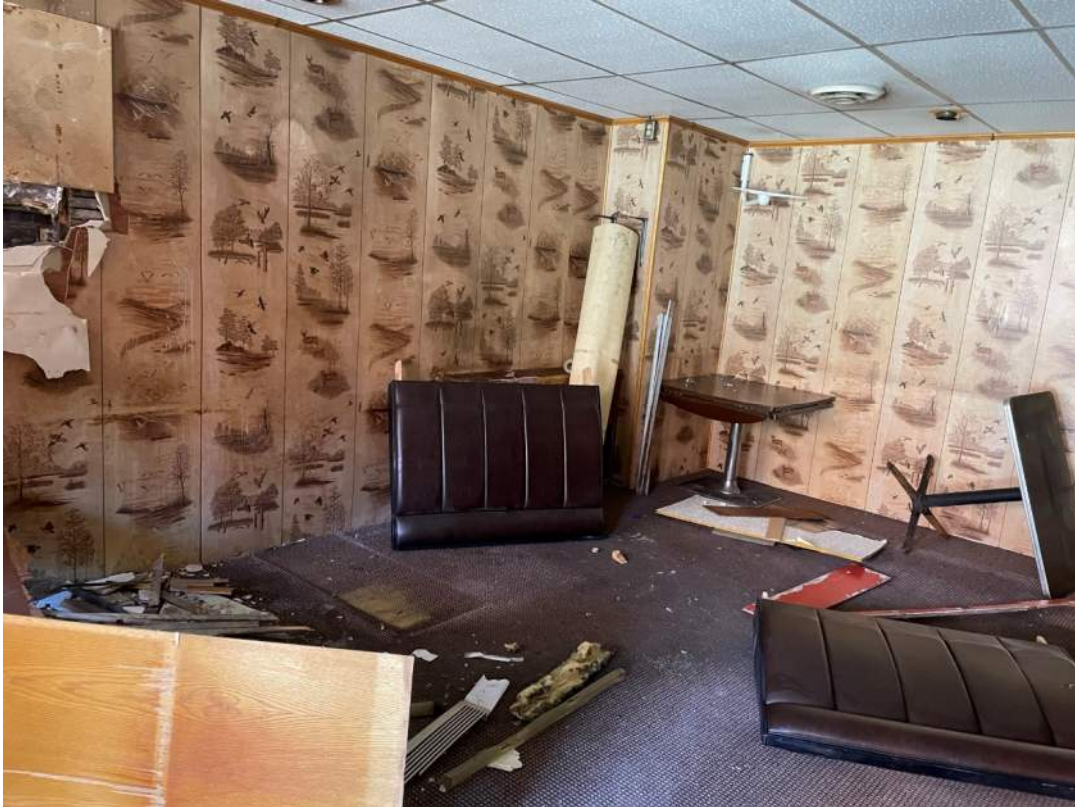
Photo 27: Existing interior finishes are old and require updating.

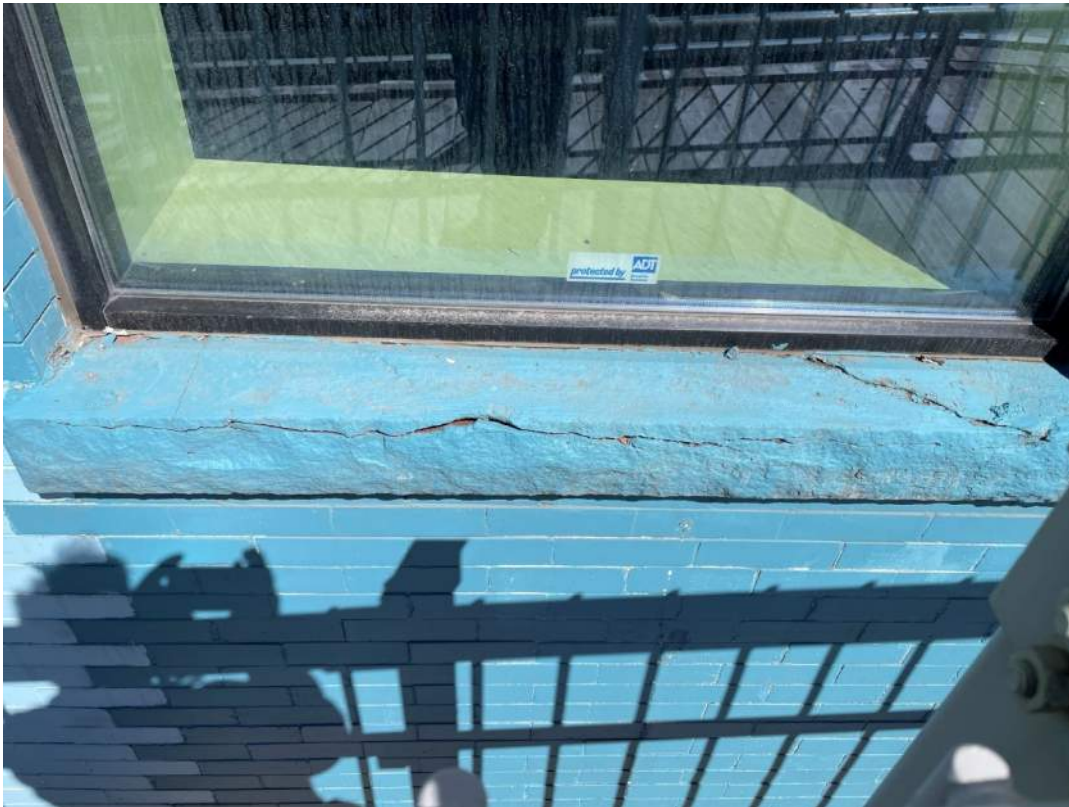
Photo 28: Existing exterior window sill – typical at the perimeter, many are broken and require replacement.

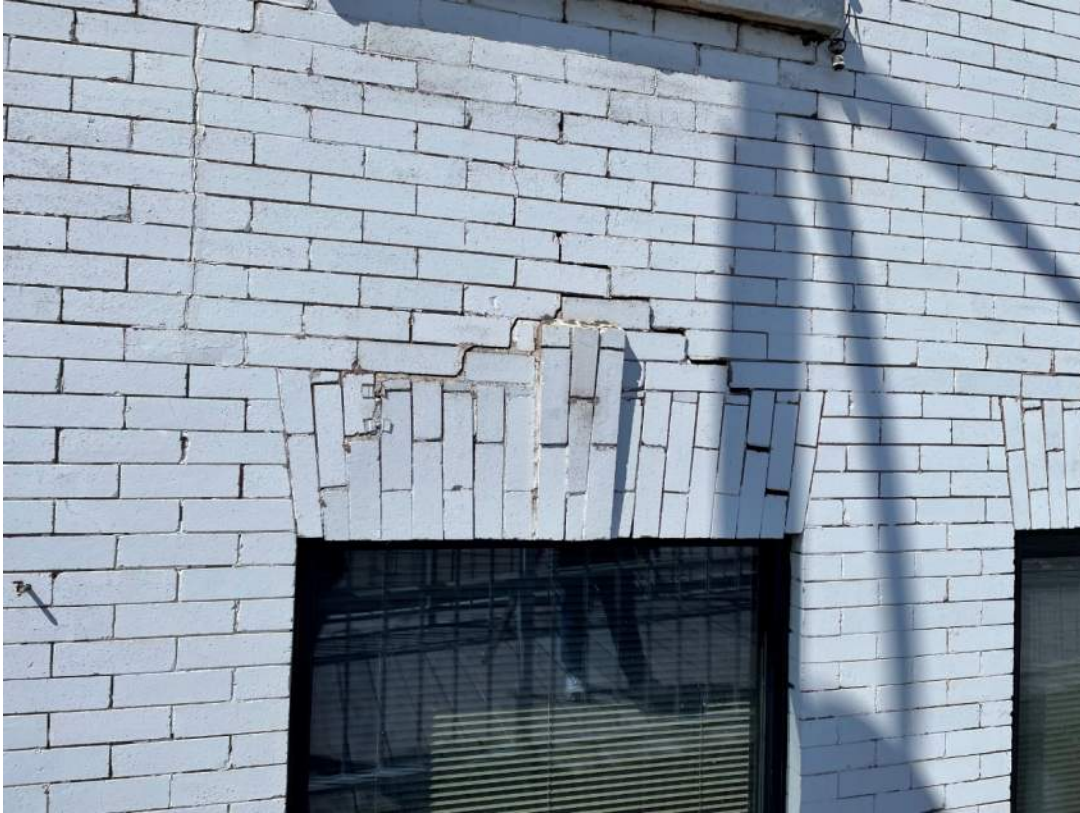
Photo 29: Typical exterior lintels are loose and failing and require replacement

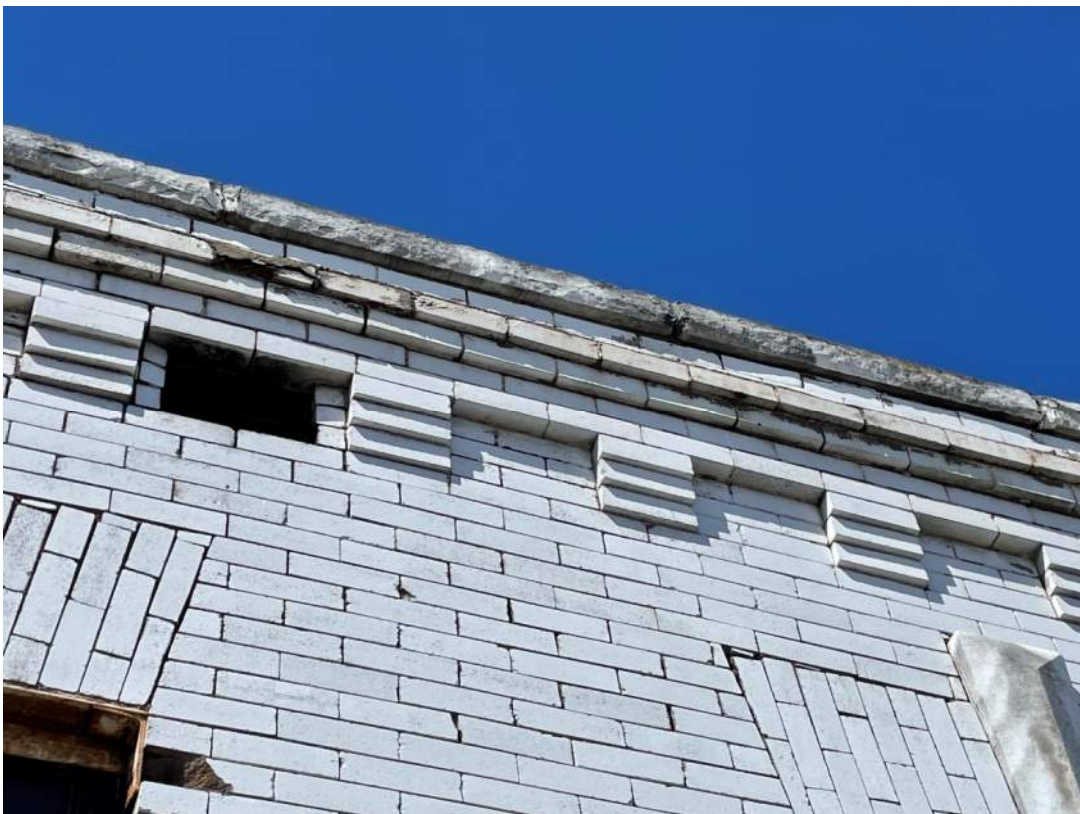
Photo 30: The existing parapets are deteriorated, missing or loose brick and exterior needs tuckpointing to prevent further deterioration.

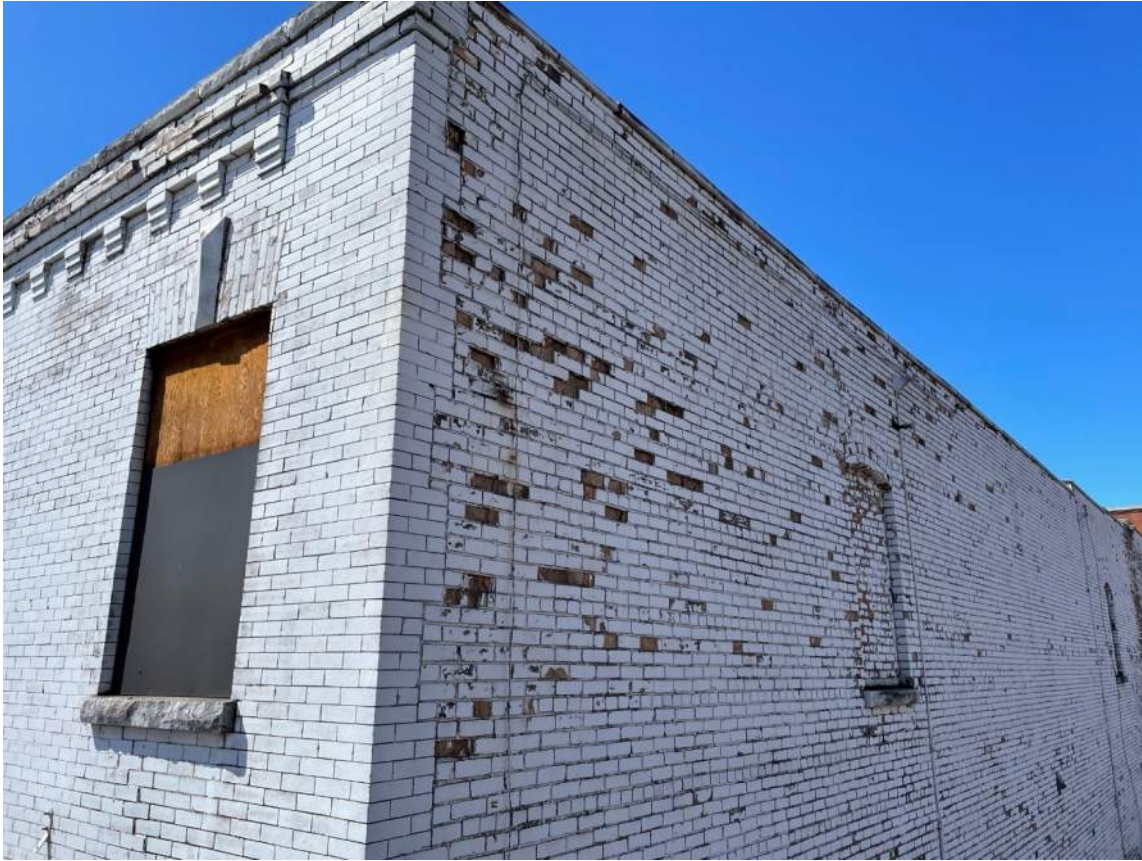
Photo 31: Exterior southeast corner – note the spalling brick due to moisture intrusion, freeze thaw cycles causes a spall, which falls to the ground.
