New Garrick Reuse – Preliminary Structural Demolition Narrative

May 21, 2024

PRELIMINARY STRUCTURAL BUILDING DESCRIPTION:

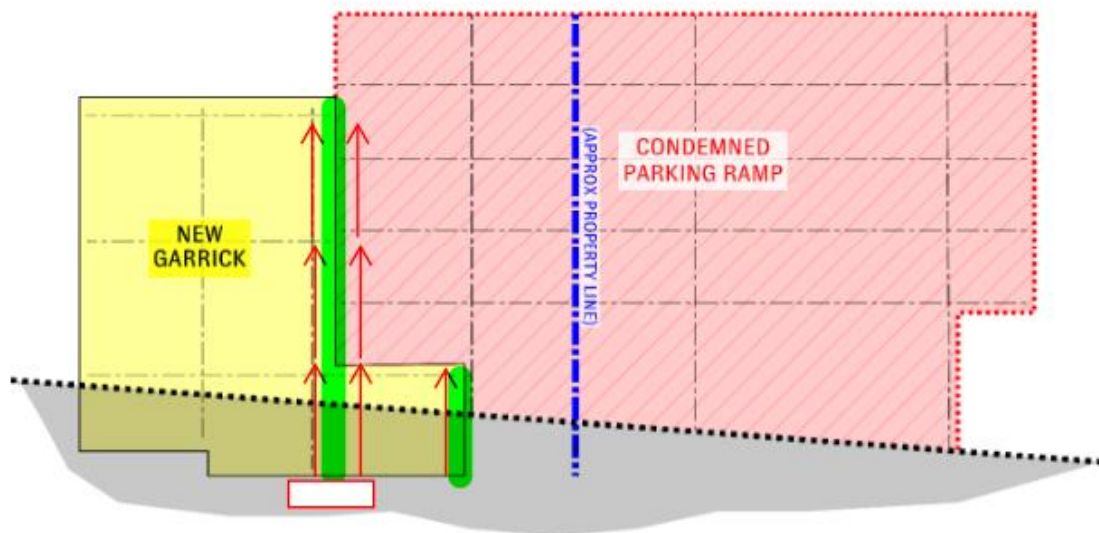
Based on the visual observations and the description noted above, it is our understanding that the north edge of the existing parking ramp supports the south edge of the New Garrick. Grid 3 is the bearing line for the second floor and roof of the New Garrick, with the 1st Street floor extending one bay further south (Grid 4 in the structural markups). Our observations suggest the following:

- At both Grid 3 and 4, it appears the existing New Garrick building, specifically the steel/iron girders that span north-south, were shored during construction of the existing parking ramp. Following temporary shoring existing girders were cut back to their current length.

- After the cast in place parking ramp was in place, a CMU wall was installed between each level of the existing parking ramp. This created an "exterior wall" between the New Garrick and parking ramp.

- The existing steel/iron girders for the New Garrick (which were temporarily shored during construction of the ramp) were then fastened to the concrete beam or CMU wall of the ramp. We observed these connections at several locations. This connection generally consists of a seat bolted into the CMU/concrete as well as a bolted angle connection between girder web and CMU/concrete.

The diagram below is from a study conducted by New History (provided to MBJ by Chad Ronchetti). New History's report is titled "Building Review for Reuse – New Garrick Building" and dated January 22, 2024. This figure can be found on page 7 of 17 in their full document. We are including this diagram to illustrate the relationship between New Garrick and existing parking ramp, specifically how the New Garrick floor structure "tucks" below the existing parking ramp.

Figure 5: Diagrammatic section of New Garrick Building and parking ramp interface (grids indicate column lines and levels)

Prior to the execution of any parking ramp demolition, on the north and south side of Grid 3, full height shoring must be installed. On the north side, shoring will need to extend from basement level to underside of the New Garrick roof structure. On the south side, shoring will need to extend from basement level to the uppermost concrete parking deck. A third line of shoring will need to be installed north of Grid 4 to stabilize the south edge of the floor of the New Garrick. This is the portion of floor that "tucks" below the existing parking ramp (see New History diagram above).

Following demolition (but prior to removal of shoring), the New Garrick will need to be re-supported on a new exterior wall and foundation. MBJ assumes a new CMU bearing wall will be constructed at approximately Grid 3 for the full height of New Garrick, re-supporting all existing structure to the north. This wall will require a new footing (Geotechnical study will be necessary). Building envelope will also need to be considered (Architectural input will be necessary). This scope of work is preliminary only and will be fully documented in a future phase.
