Modification to the Development Program for Development District No. 17

Tax Increment Financing District No. 31: Voyageur Lakewalk Inn (a redevelopment district)

Report of Inspection Procedures and Results for Determining Qualifications of a Tax Increment Financing District as a Redevelopment District

Duluth Voyageurs TIF District Duluth, Minnesota

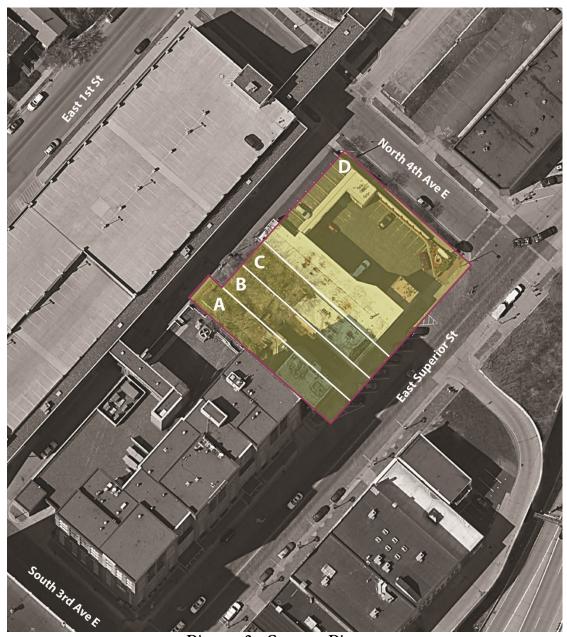
Diagram 2 – Coverage Diagram

The proposed TIF District met the coverage test under *Minnesota Statutes, Section 469.174, Subdivision 10(e)*, which resulted in parcels consisting of 100 percent of the area of the proposed TIF District being occupied by buildings, streets, utilities, paved or gravel parking lots, or other similar structures (Diagram 2). This exceeds the 70 percent area coverage requirement for the proposed TIF District under *Minnesota Statutes, Section 469.174, Subdivision (a) (1)*.

Shaded green area depicts a parcel more than 15 percent occupied by buildings, streets, utilities, paved or gravel parking lots or other similar structures

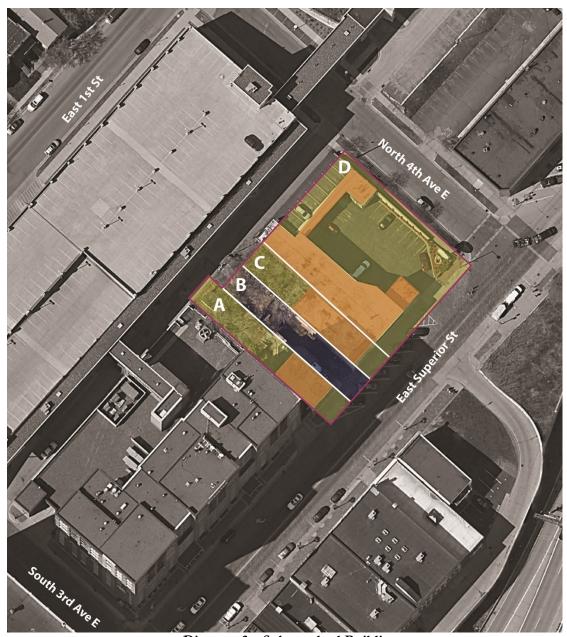
The parcels with substandard buildings are reasonably distributed compared to all parcels that contain buildings.

Diagram 3 – Substandard BuildingsShaded green area depicts parcels with buildings.
Shaded orange area depicts substandard buildings.
