WESTERN WATERFRONT HABITAT RESTORATION PROJECT

WESTERN WATERFRONT HABITAT RESTORATION PROJECT	
DULUTH	MINNESOTA
CLIENT NO.	MSA NO.

TITLE SHEET

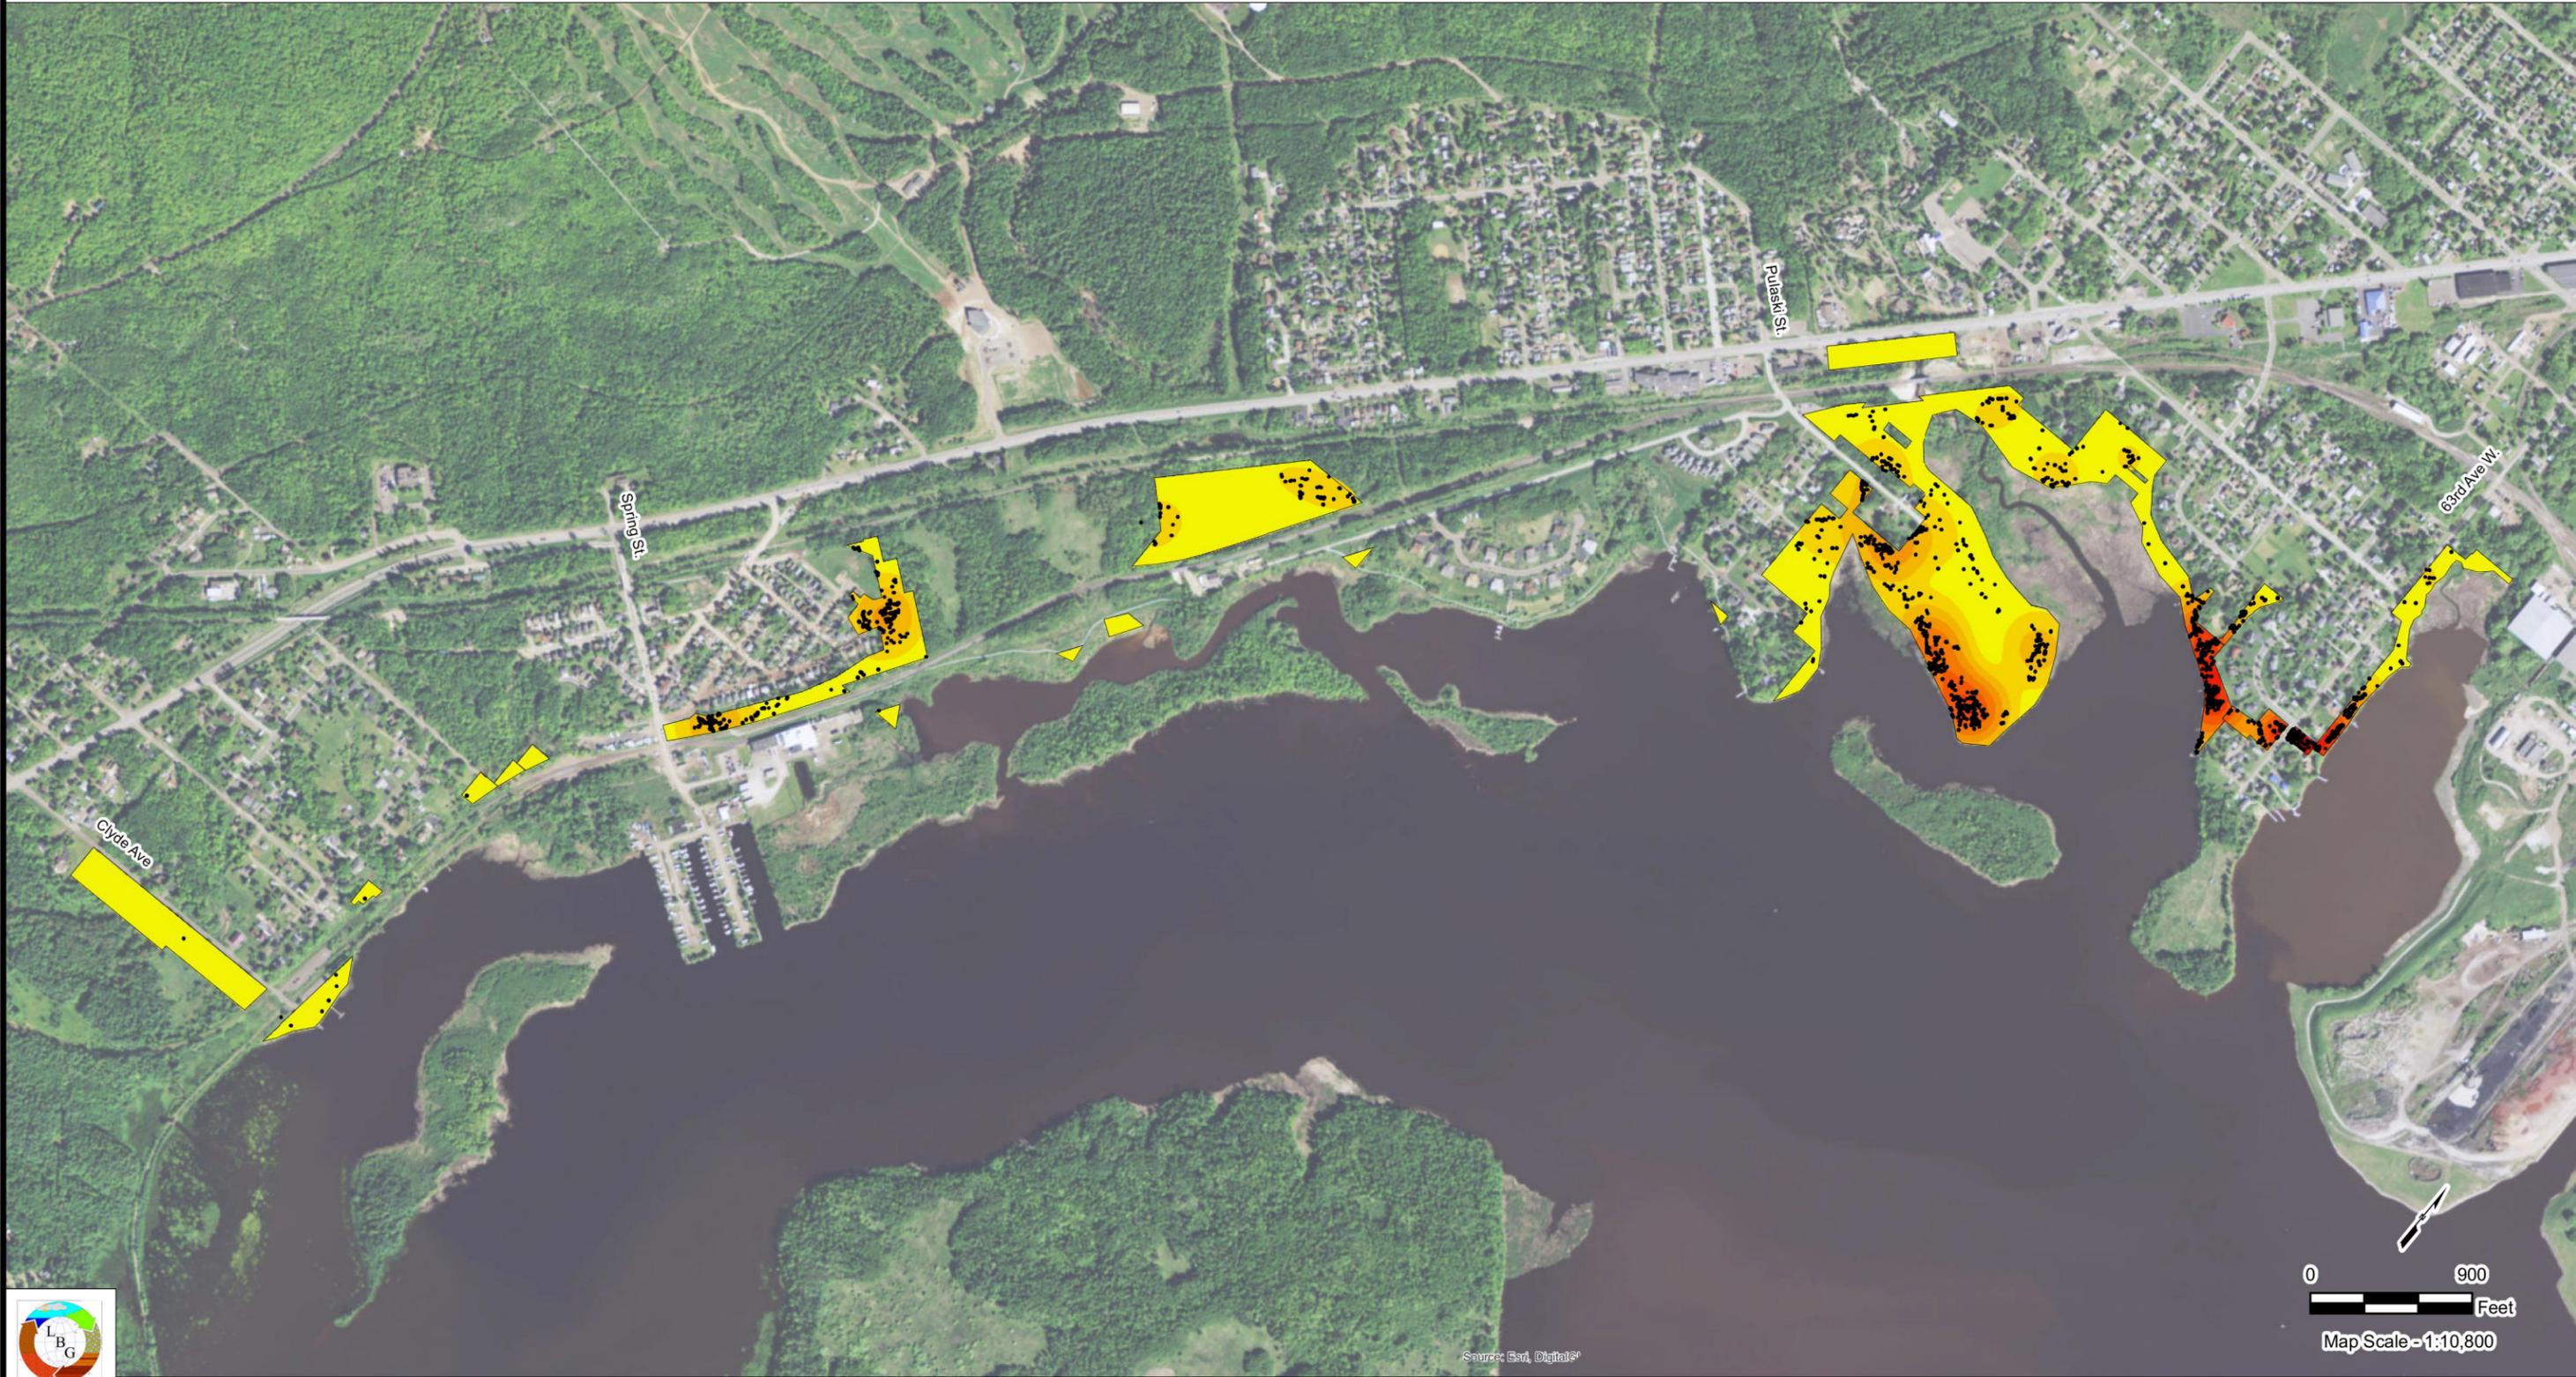
BUCKTHORN DENSITY

● GPS Located Mature Seed Bearing Common Buckthorn Trees, August - October 2015

Low Buckthorn Density
 Medium Buckthorn Density
 High Buckthorn Density

GPS data collected by LBG, Inc. and Duluth Invaders, August - October 2015

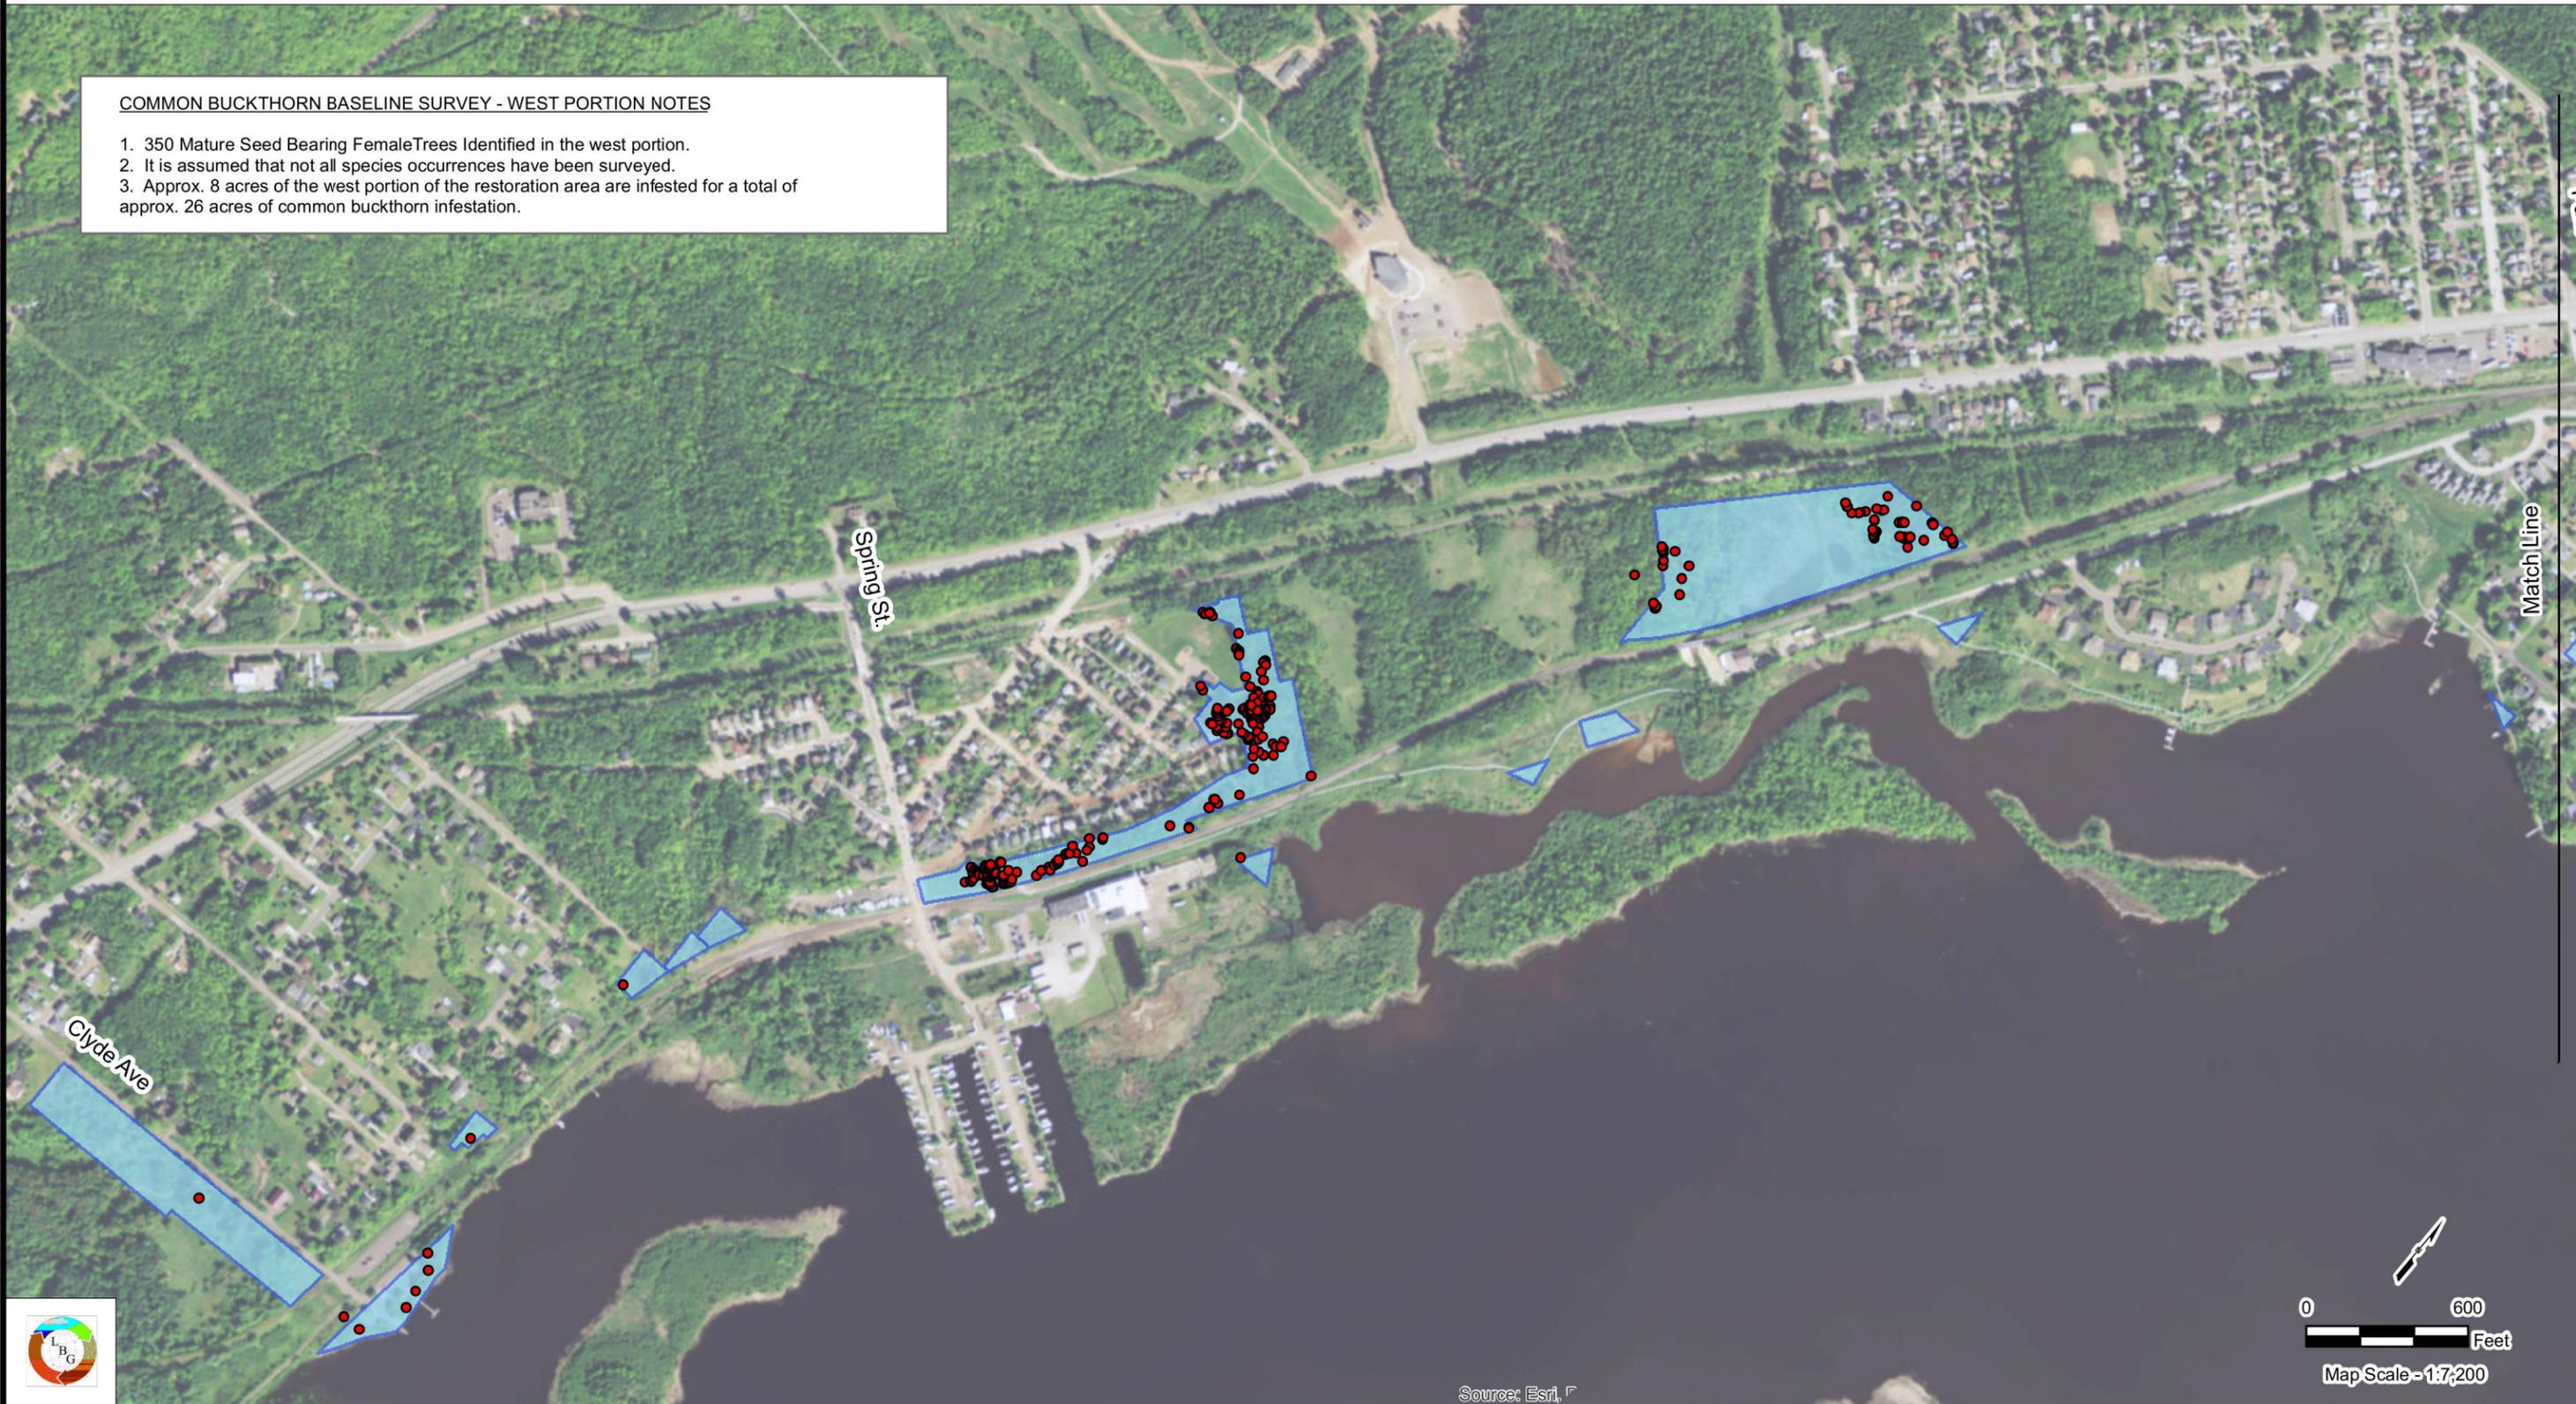
BUCKTHORN REMOVAL - WEST

COMMON BUCKTHORN BASELINE SURVEY - WEST PORTION NOTES

1. 350 Mature Seed Bearing Female Trees Identified in the west portion.
2. It is assumed that not all species occurrences have been surveyed.
3. Approx. 8 acres of the west portion of the restoration area are infested for a total of approx. 26 acres of common buckthorn infestation.

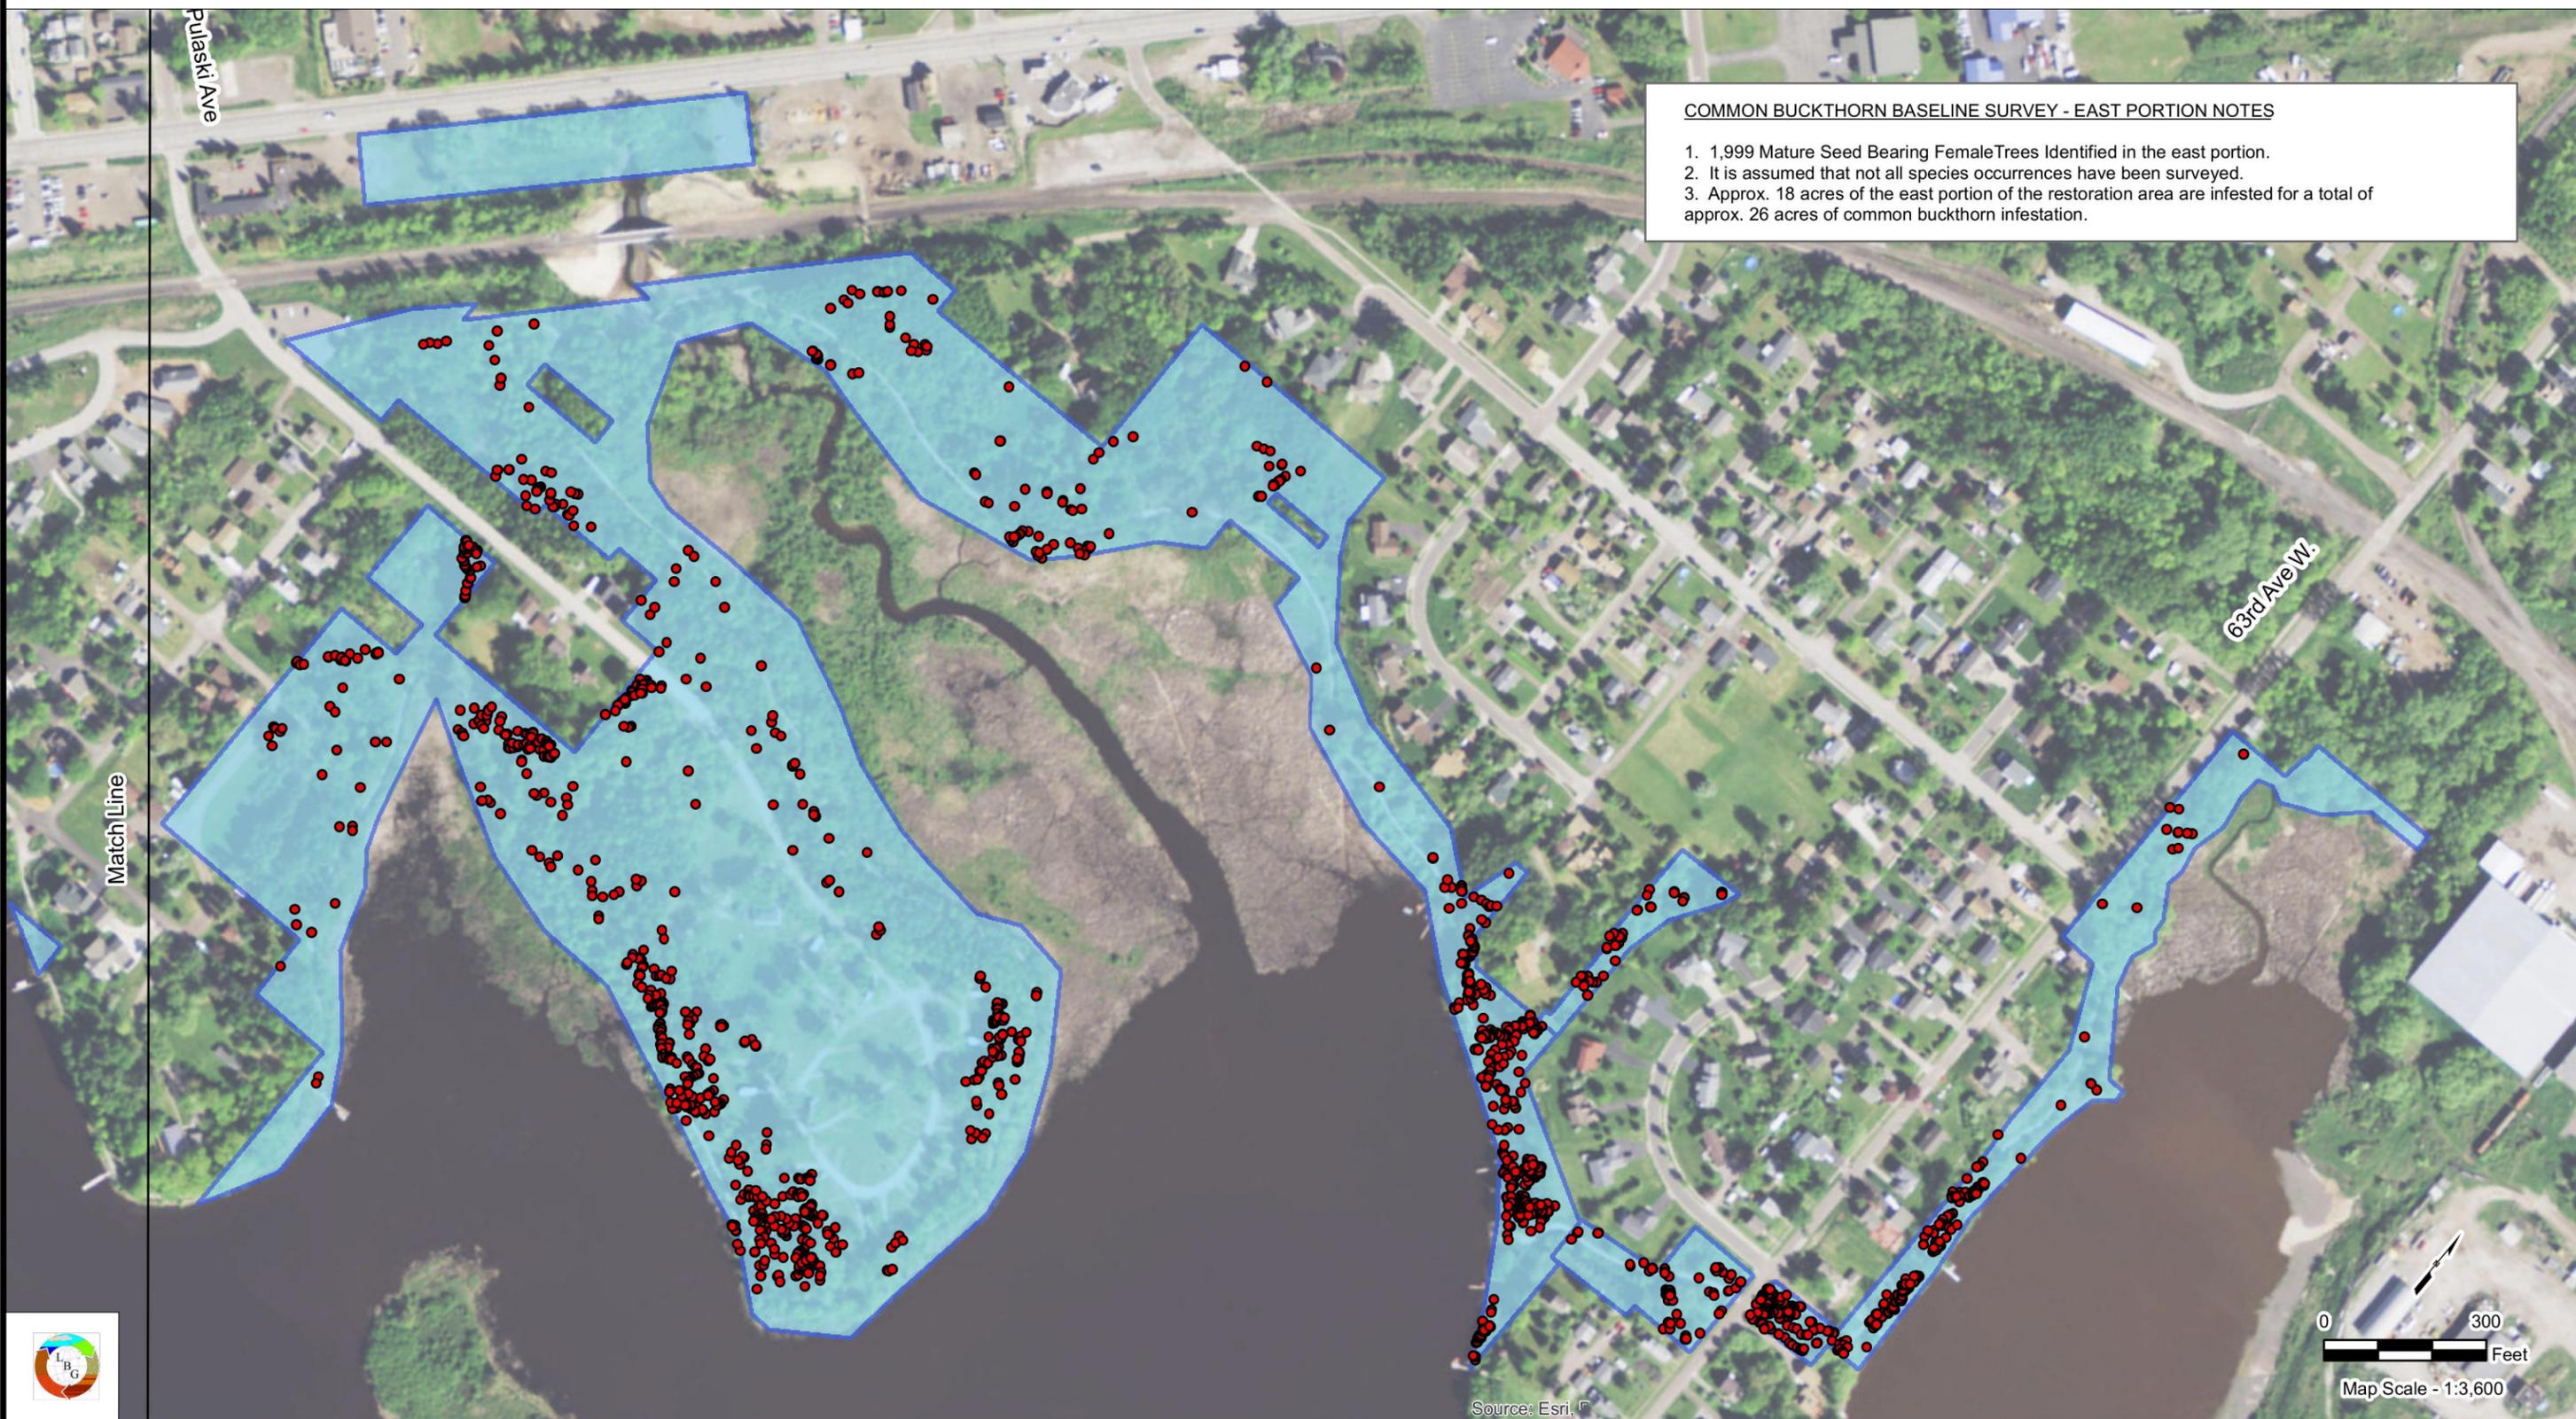
BUCKTHORN REMOVAL - EAST

COMMON BUCKTHORN BASELINE SURVEY - EAST PORTION NOTES

- 1,999 Mature Seed Bearing Female Trees Identified in the east portion.
- It is assumed that not all species occurrences have been surveyed.
- Approx. 18 acres of the east portion of the restoration area are infested for a total of approx. 26 acres of common buckthorn infestation.

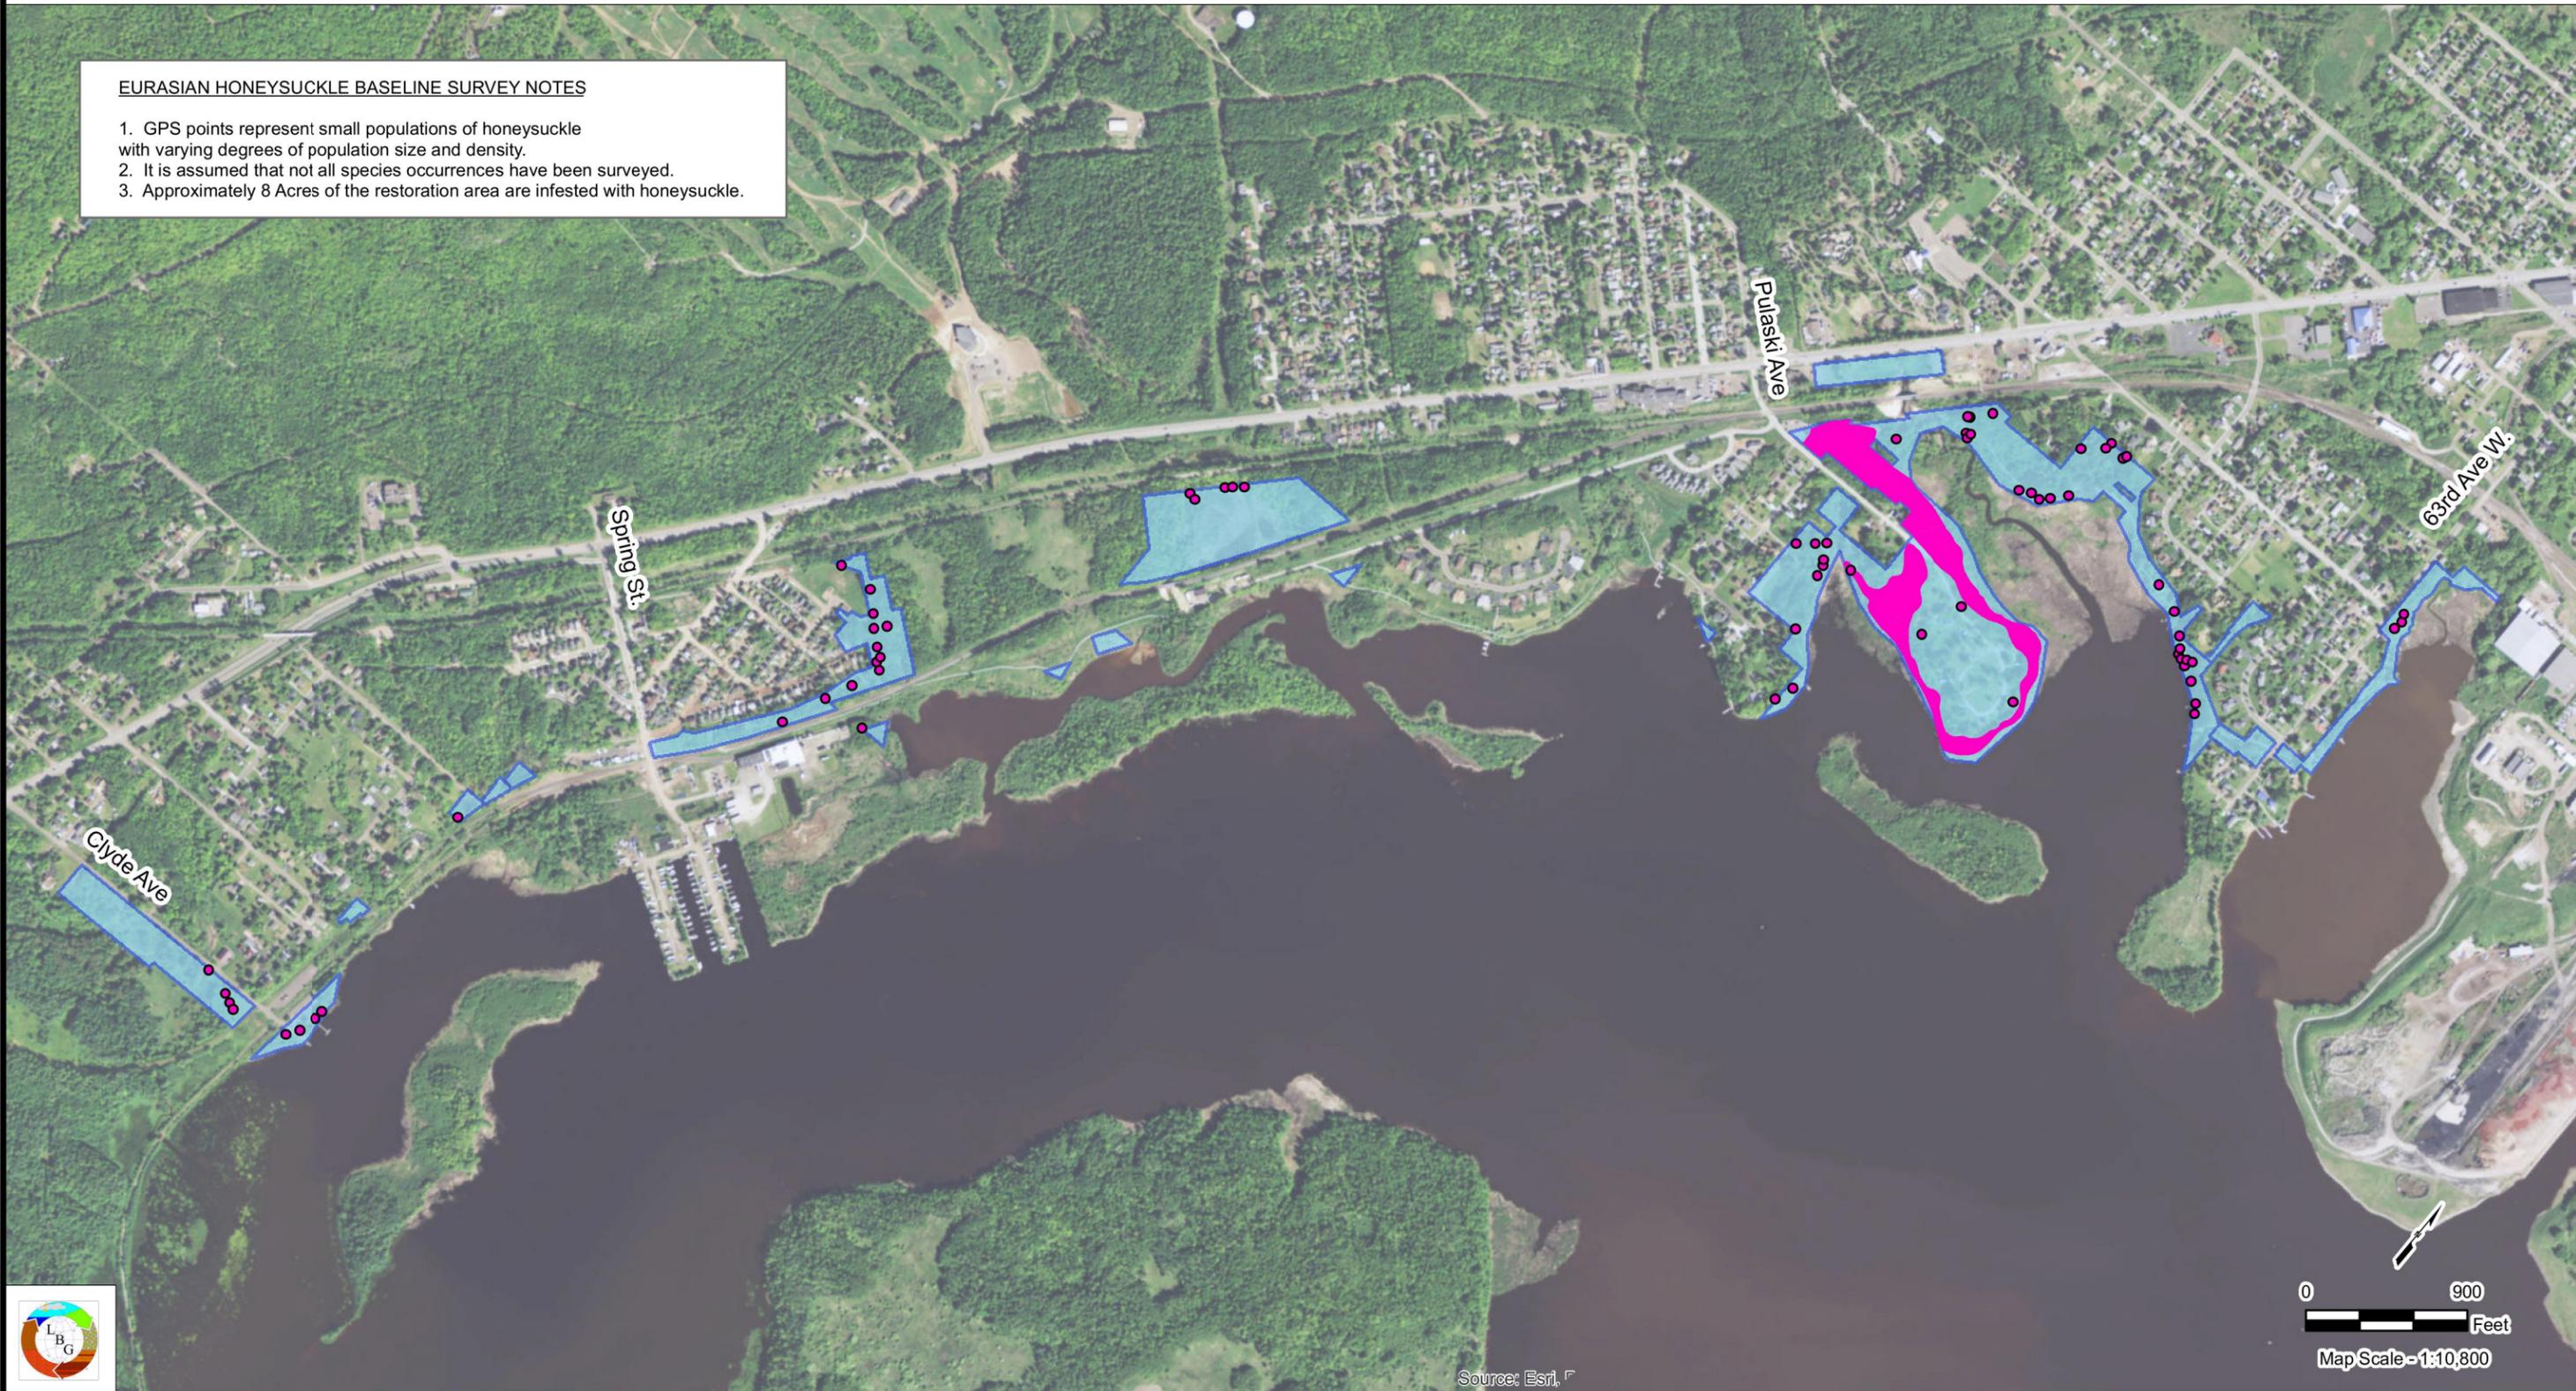
HONEYSUCKLE REMOVAL

- GPS Located Mature Eurasian Honeysuckle Shrubs, August - October 2015
- Greatest Honeysuckle Infestation
- Western Waterfront Restoration Area

EURASIAN HONEYSUCKLE BASELINE SURVEY NOTES

1. GPS points represent small populations of honeysuckle with varying degrees of population size and density.
2. It is assumed that not all species occurrences have been surveyed.
3. Approximately 8 Acres of the restoration area are infested with honeysuckle.

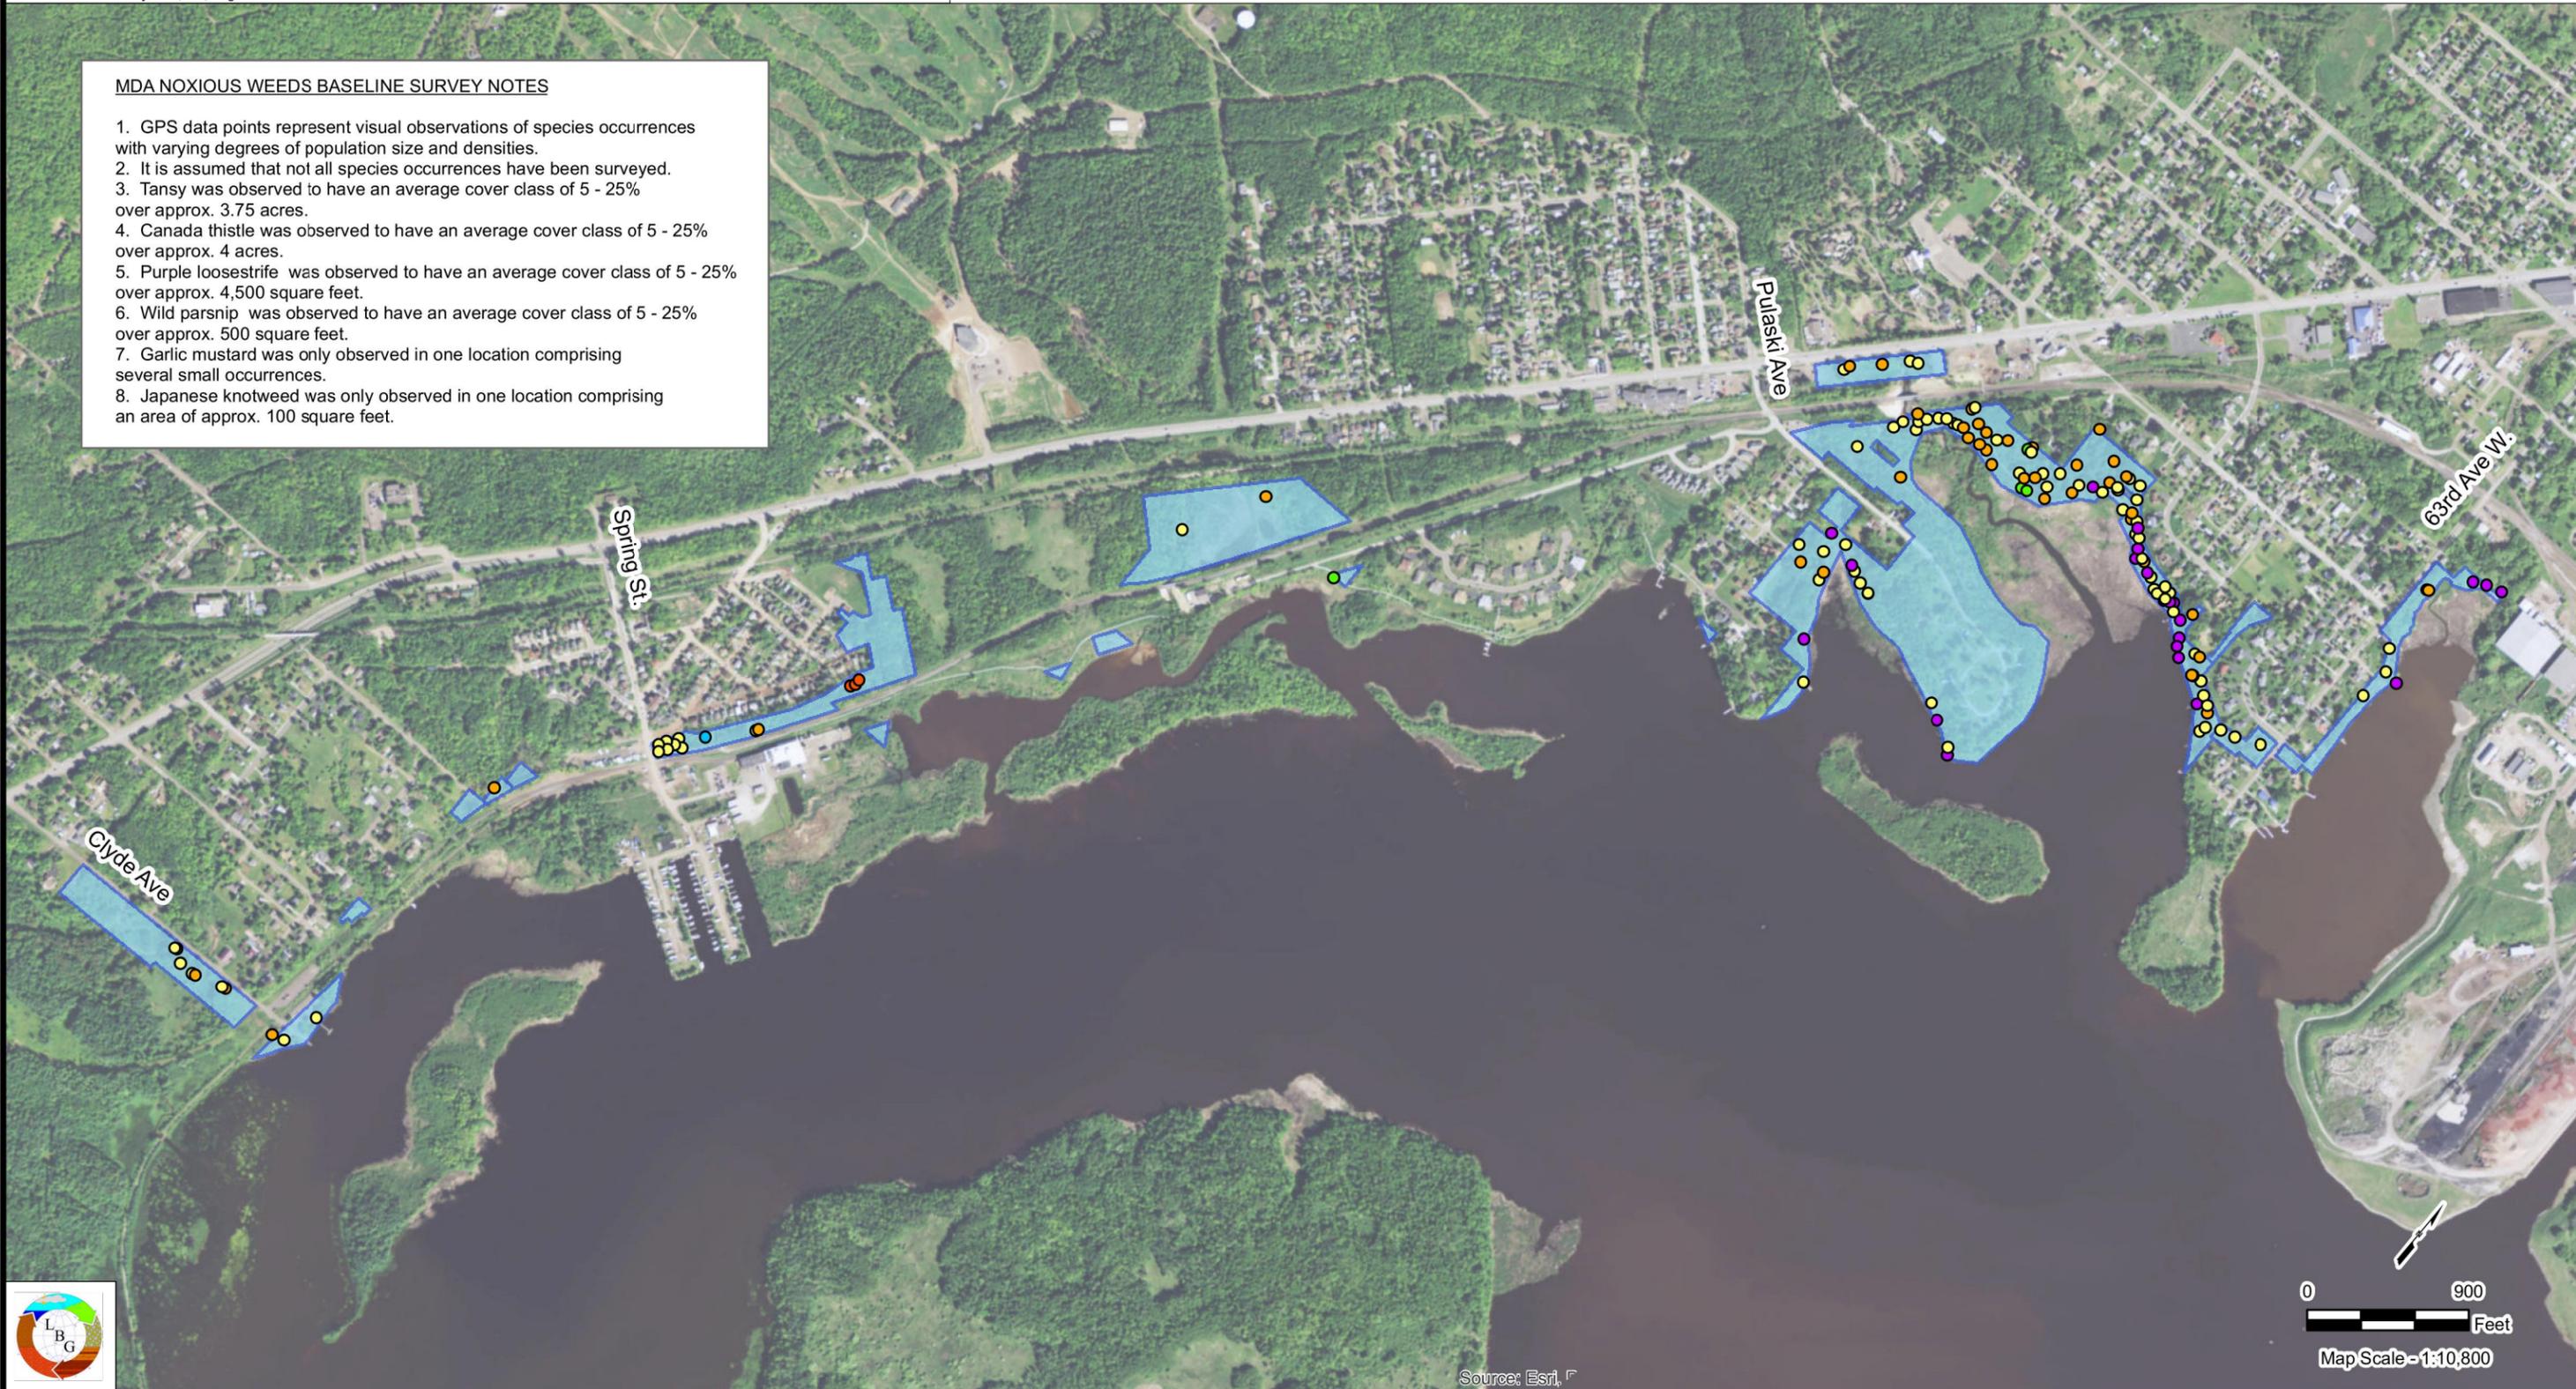
MDA NOXIOUS WEED REMOVAL

- Tansy (*Tanacetum vulgare*)
- Canada Thistle (*Cirsium arvense*)
- Purple Loosestrife (*Lythrum salicaria*)
- Wild Parsnip (*Pastinaca sativa*)
- Garlic Mustard (*Alliaria petiolata*)
- Japanese Knotweed (*Polygonum cuspidatum*)
- Western Waterfront Restoration Area

MDA NOXIOUS WEEDS BASELINE SURVEY NOTES

1. GPS data points represent visual observations of species occurrences with varying degrees of population size and densities.
2. It is assumed that not all species occurrences have been surveyed.
3. Tansy was observed to have an average cover class of 5 - 25% over approx. 3.75 acres.
4. Canada thistle was observed to have an average cover class of 5 - 25% over approx. 4 acres.
5. Purple loosestrife was observed to have an average cover class of 5 - 25% over approx. 4,500 square feet.
6. Wild parsnip was observed to have an average cover class of 5 - 25% over approx. 500 square feet.
7. Garlic mustard was only observed in one location comprising several small occurrences.
8. Japanese knotweed was only observed in one location comprising an area of approx. 100 square feet.

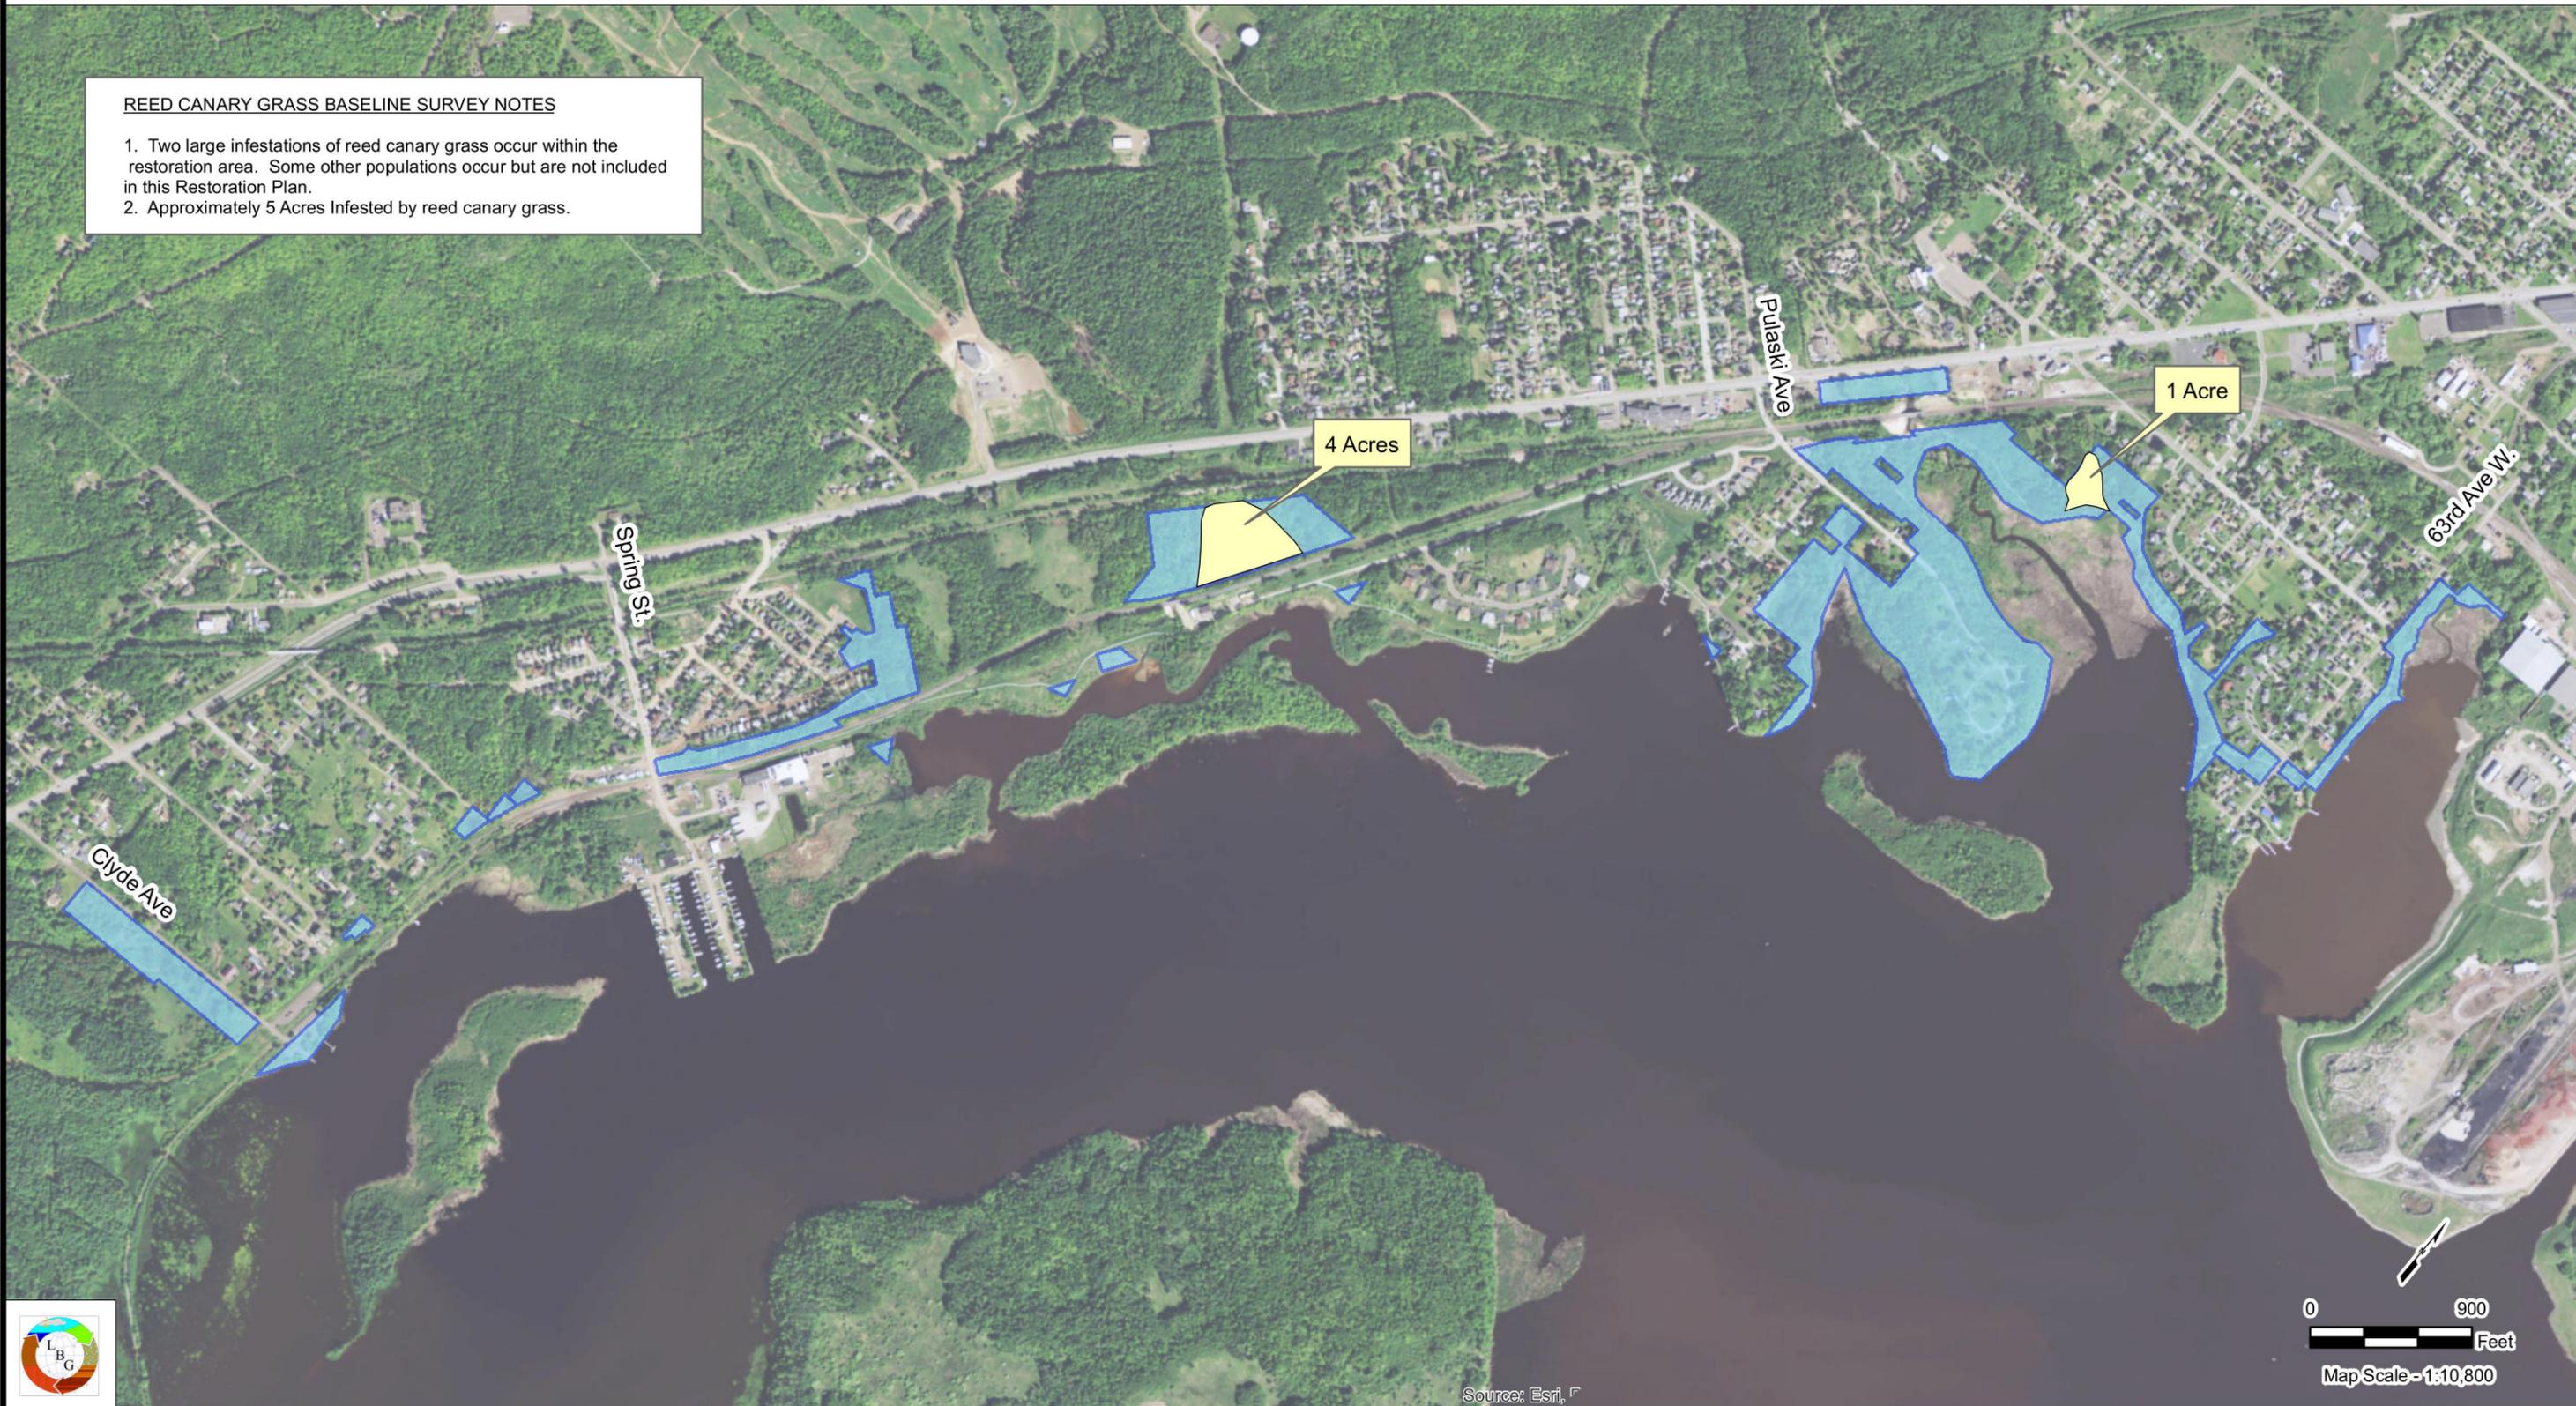
REED CANARY GRASS REMOVAL

- Greatest Reed Canary Grass Infestations
- Western Waterfront Restoration Area

REED CANARY GRASS BASELINE SURVEY NOTES

1. Two large infestations of reed canary grass occur within the restoration area. Some other populations occur but are not included in this Restoration Plan.
2. Approximately 5 Acres Infested by reed canary grass.
