WESTERN WATERFRONT HABITAT RESTORATION PROJECT

WESTERN WATERFRONT HABITAT RESTORATION PROJECT	
DULUTH	MINNESOTA
CLIENT NO.	MSA NO.

TITLE SHEET

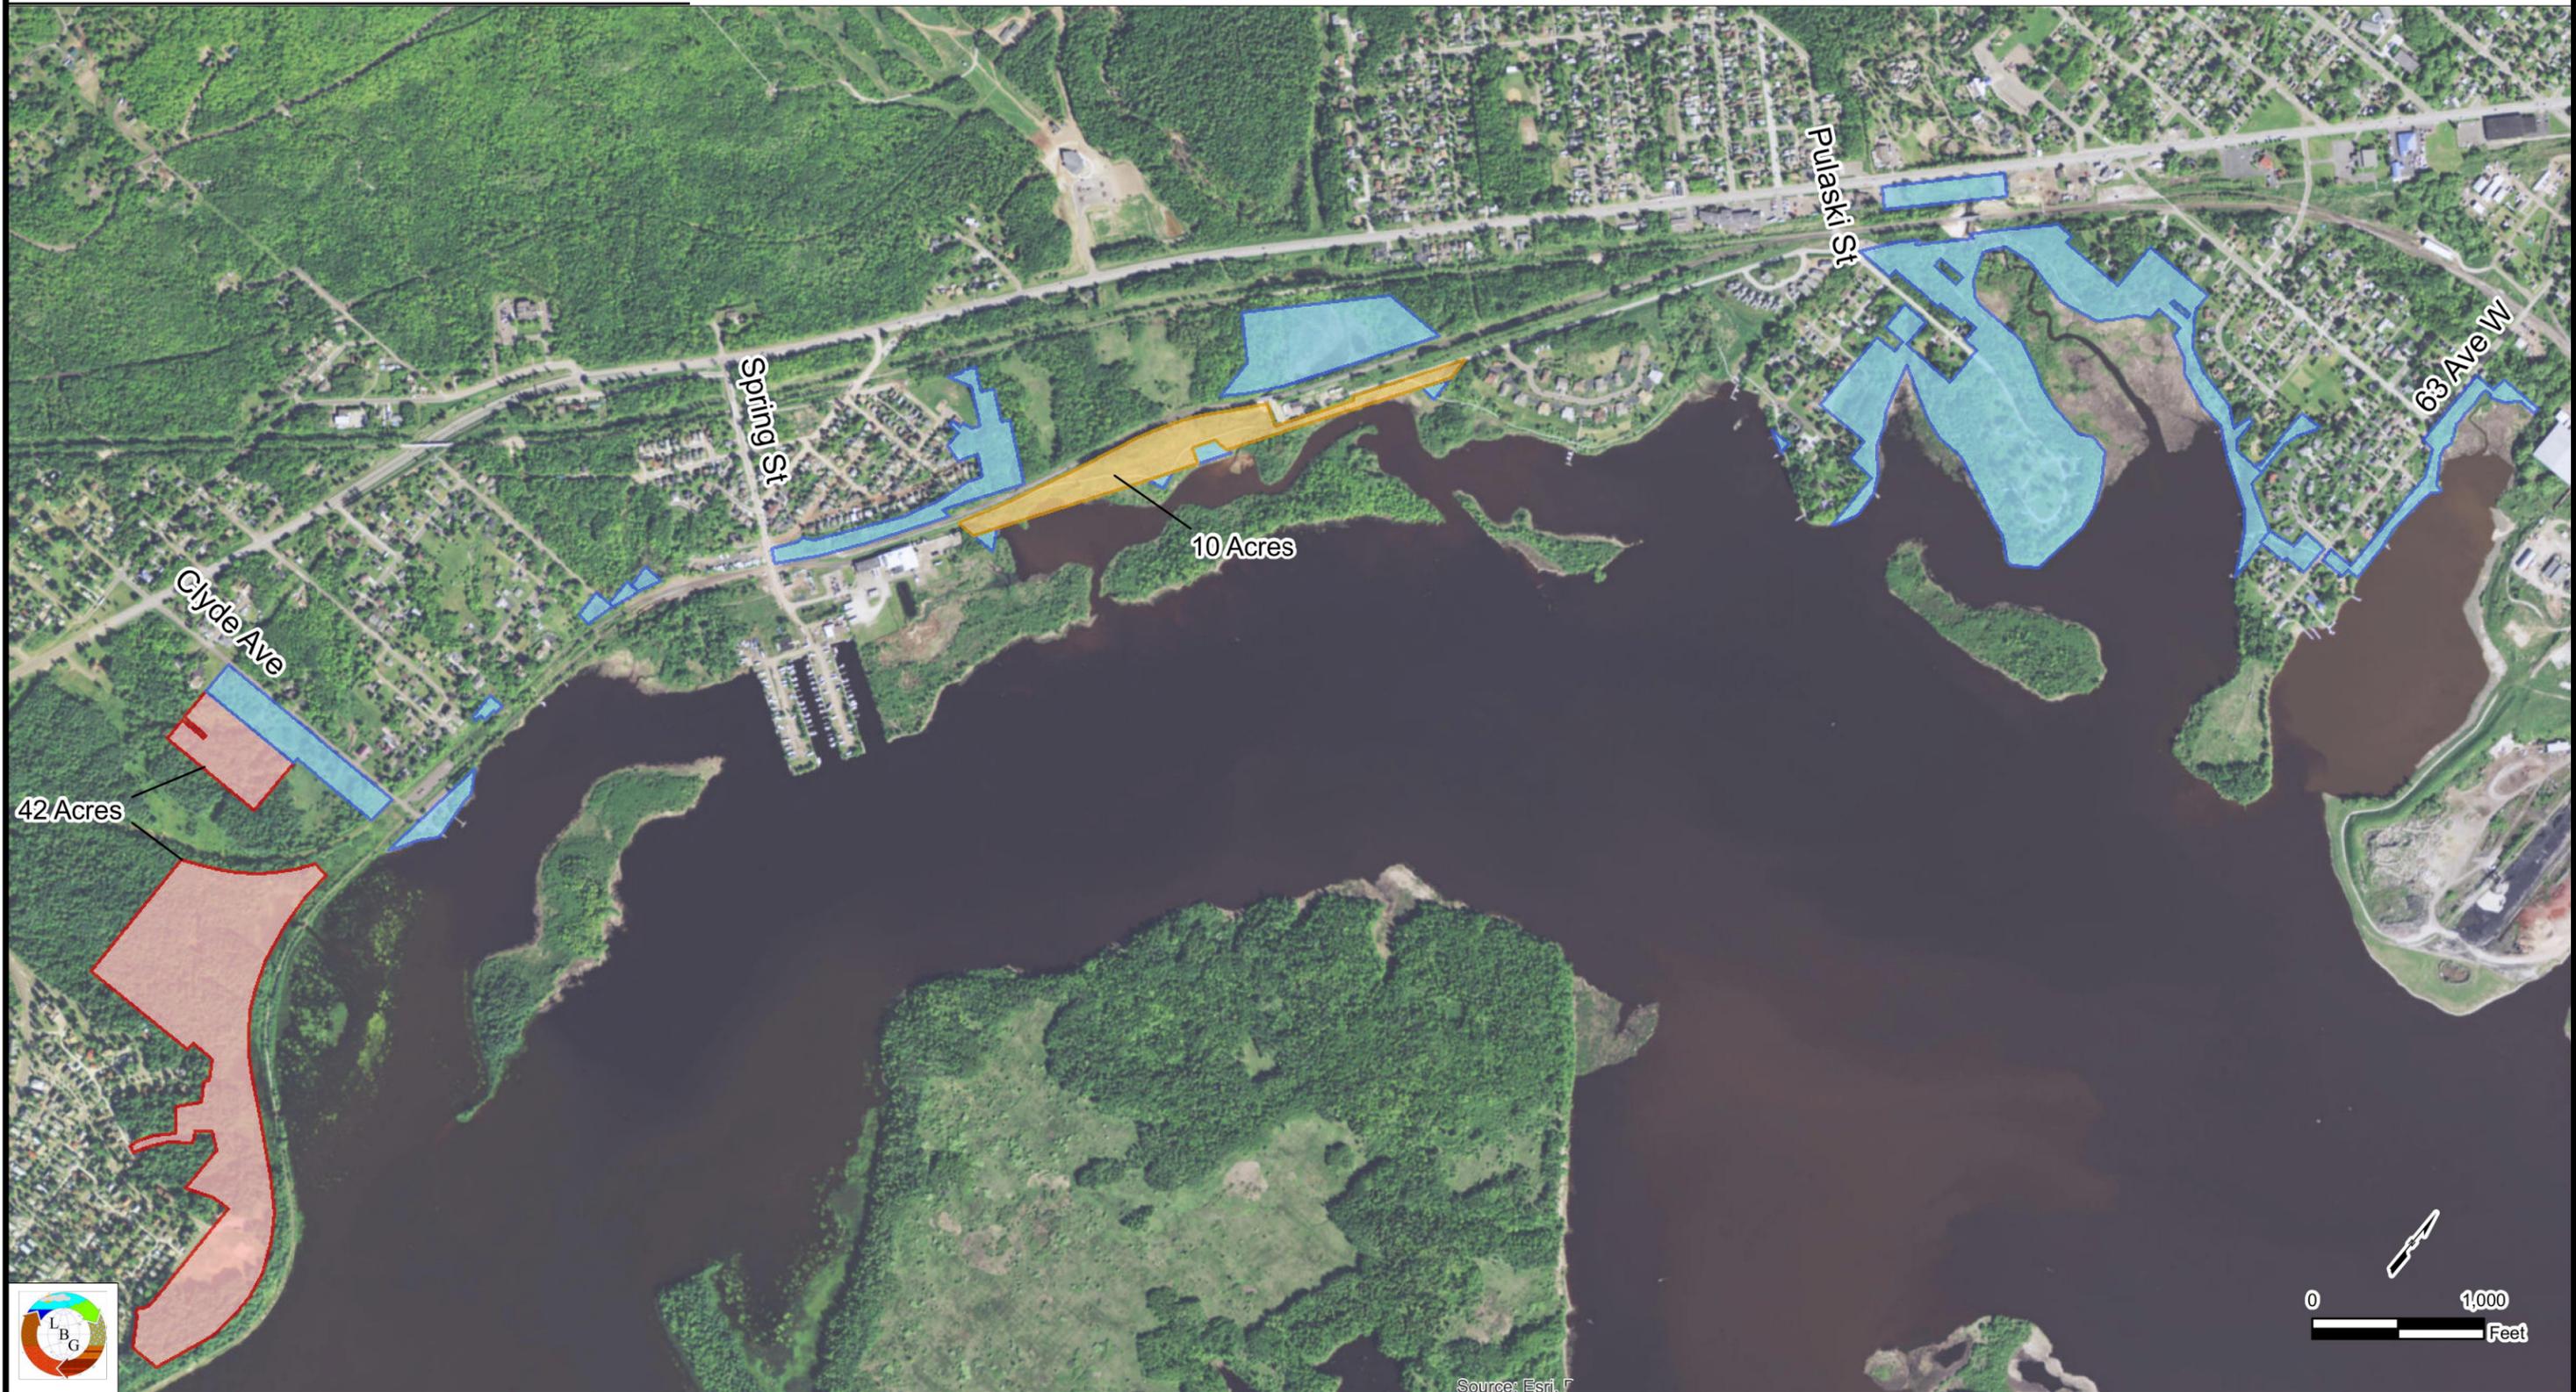
BID ALTERNATE ADDITIONAL TREATMENT AREAS
--

- 73 Acre Restoration Area (City of Duluth Property)
- Additional 42 Acre Restoration Area (Add Alt. 2)
- Additional 10 Acre Restoration Area (Add. Alt. 3)

ALTERNATE BID #2: REMOVE AND CONTROL INVASIVE TREES AND SHRUBS, MDA NOXIOUS WEEDS, AND MNDNR INVASIVE SPECIES (NO REED CANARY GRASS) ON ADDITIONAL 42 ACRES

ALTERNATE BID #3: REMOVE AND CONTROL INVASIVE TREES AND SHRUBS, MDA NOXIOUS WEEDS, AND MNDNR INVASIVE SPECIES (NO REED CANARY GRASS) ON ADDITIONAL 10 ACRES

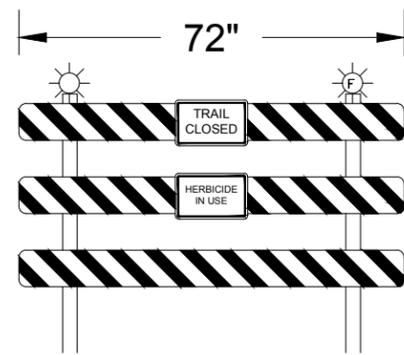
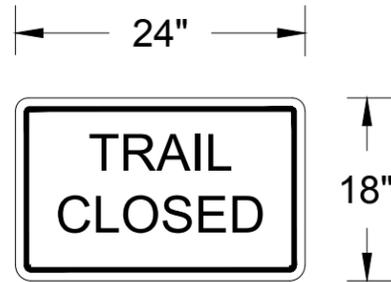
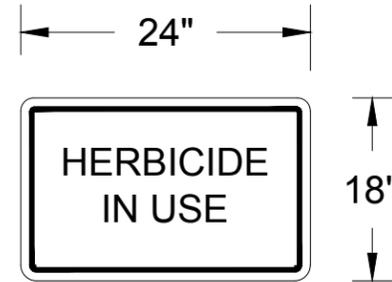
1 TRAFFIC CONTROL SIGNS
11

TYPE III BARRICADE

TYPE R9-9a
