MODIFICATION TO THE DEVELOPMENT PROGRAM

Establishment of Tax Increment Financing District No. 39 -
The Armory (a redevelopment district)

REPORT OF INSPECTION PROCEDURES AND RESULTS FOR
DETERMINING QUALIFICATIONS OF A
TAX INCREMENT FINANCING DISTRICT AS A REDEVELOPMENT DISTRICT

DULUTH ARMORY REDEVELOPMENT TIF DISTRICT
DULUTH, MINNESOTA

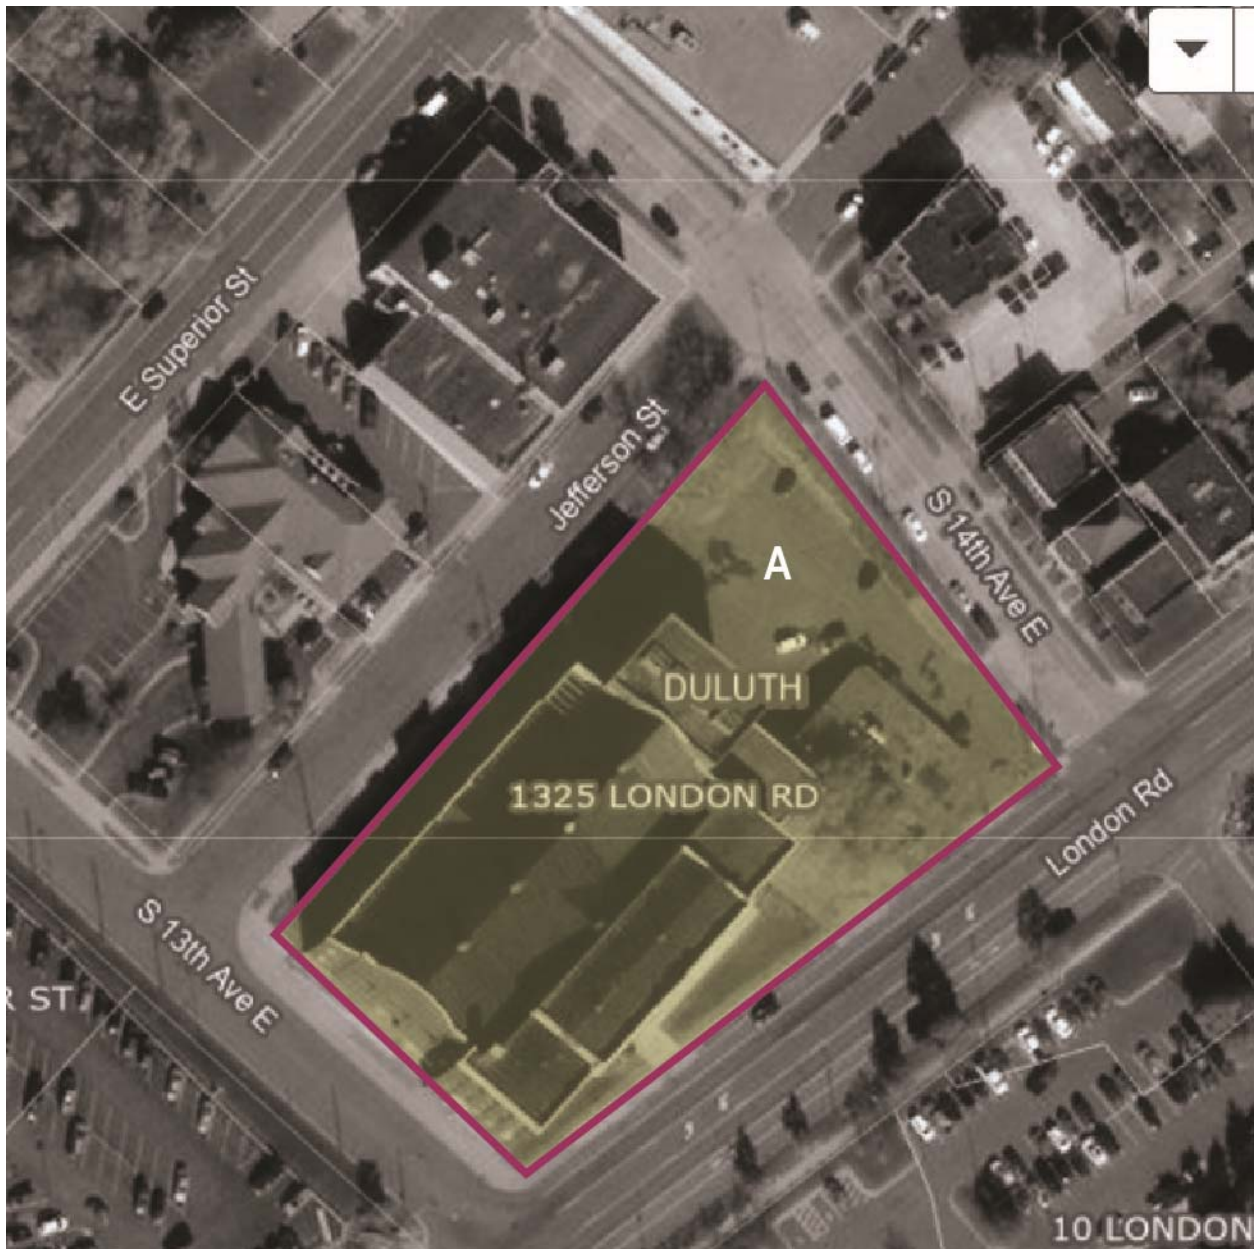
Diagram 2 – Coverage Diagram

The proposed TIF District met the coverage test under *Minnesota Statutes, Section 469.174, Subdivision 10(e)*, which resulted in parcel consisting of 100 percent of the area of the proposed TIF District being occupied by buildings, streets, utilities, paved or gravel parking lots, or other similar structures (Diagram 2). This exceeds the 70 percent area coverage requirement for the proposed TIF District under Minnesota Statutes, Section 469.174, Subdivision (a) (1).

Shaded area depicts a parcel more than 15 percent occupied by buildings, streets, utilities, paved or gravel parking lots or other similar structures

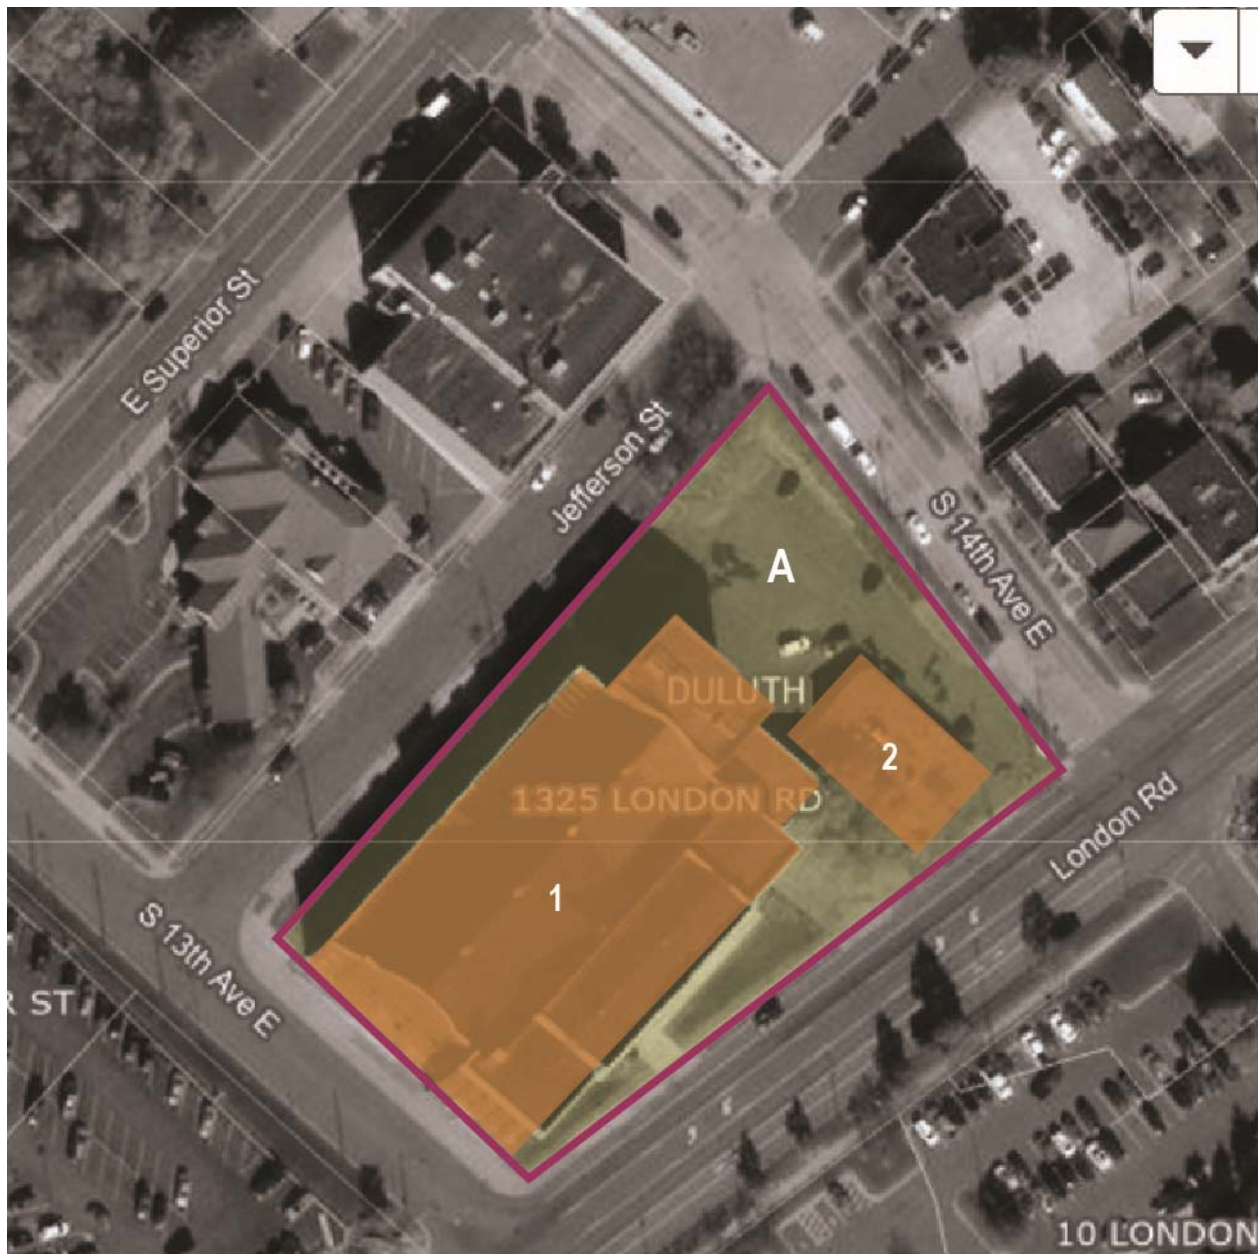
Diagram 3 – Substandard Buildings

The parcels with substandard buildings are reasonably distributed compared to all parcels that contain buildings.

Shaded green area depicts parcels with buildings.
Shaded orange area depicts substandard buildings.
