DESIGN SERVICES PROPOSAL PREPARED FOR THE CITY OF DULUTH

Lake Superior Zoo

POLAR SHORES / BEAR COUNTRY PROJECT RFP NUMBER 19-08AA

Polar Shores Exhibit at Lake Superior Zoo Structural Assessment of Flood Damage

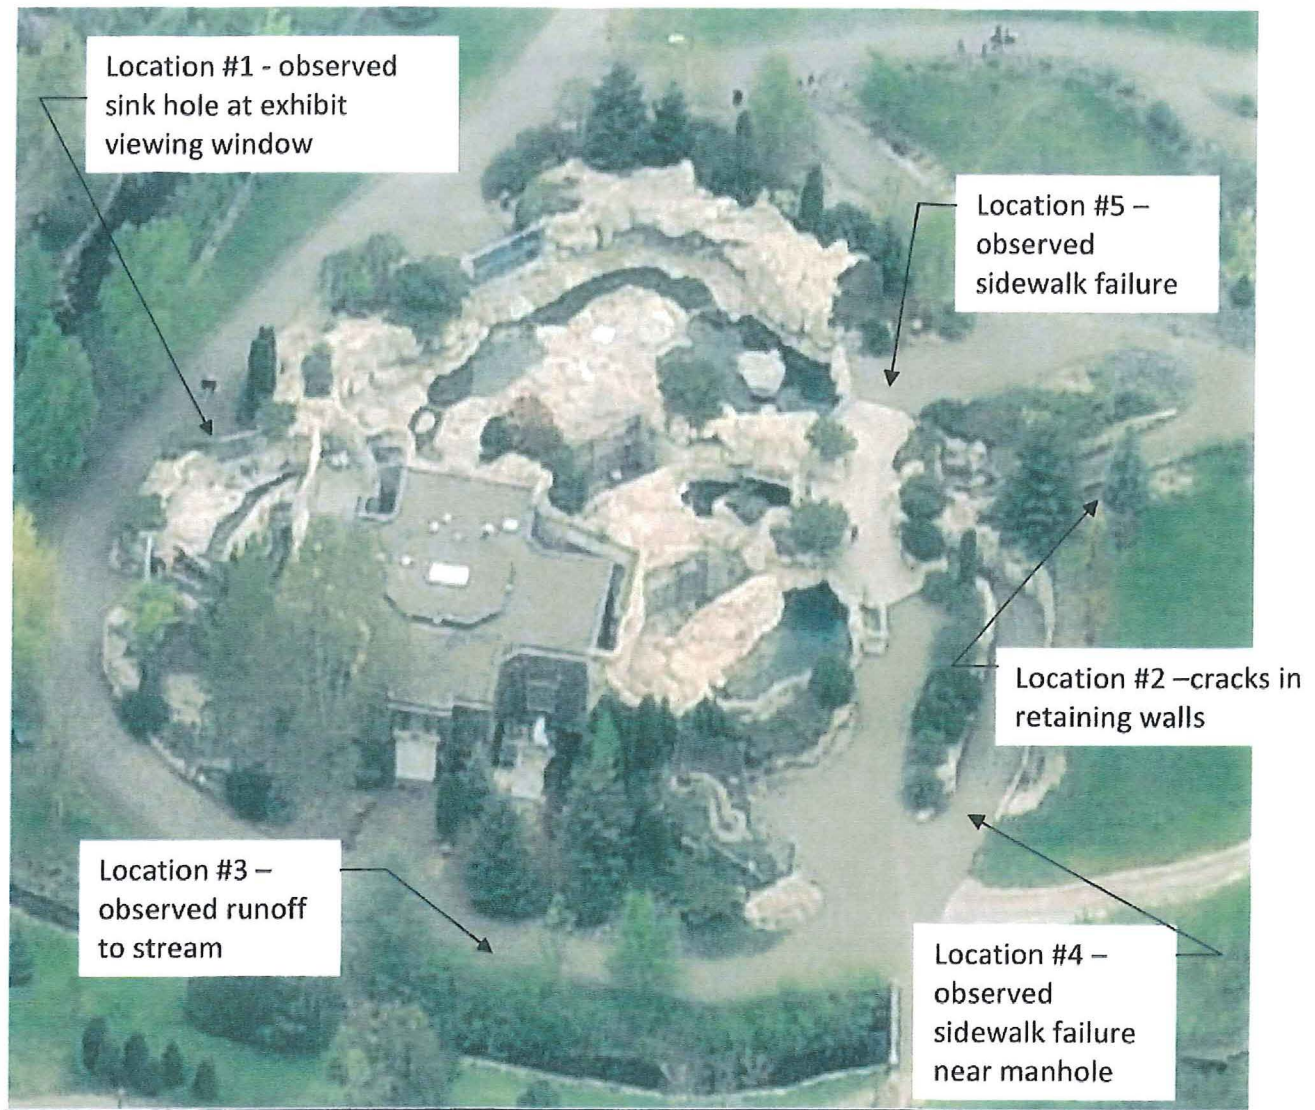
Figure 1 is an isometric aerial photo of the Polar Shore Exhibit at the Lake Superior Zoo. It is included for an overall reference to show the locations of witnessed sidewalk failures and sinkholes and to note locations of excavation. Please note that the photo is slightly outdated, since the cold-formed steel addition on the south west corner of the building is not shown, however it is a clear view of the exhibit for general reference and discussion.

Figure 1 – Isometric Photo of the Polar Shore Exhibit at the Lake Superior Zoo

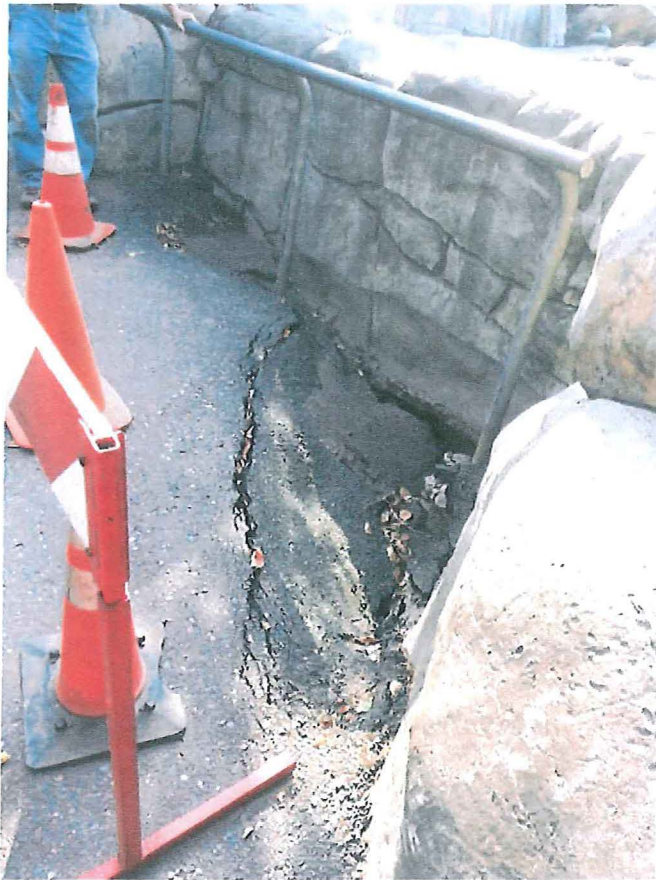
At Location #1 in Figure 1, a sink hole of the asphalt sidewalk was visible after the flood waters receded. Figure 2 shows the sidewalk after the flood. The visible rock work walls in the photo consist of shotcrete applied to a surface created by a welded-wire type mesh. The rock work was designed to considerably overhang the structural foundation by varying distances. It was not designed to be ground-supported.

Figure 2: Sidewalk Failure

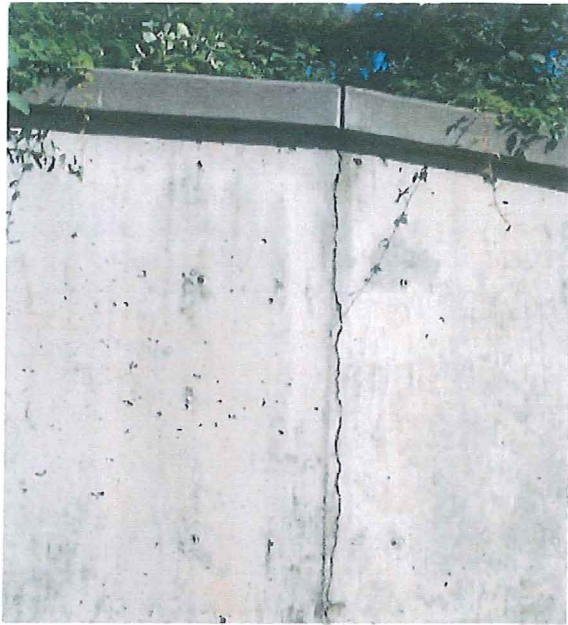
Figure 4 – Vertical cracks in retaining wall

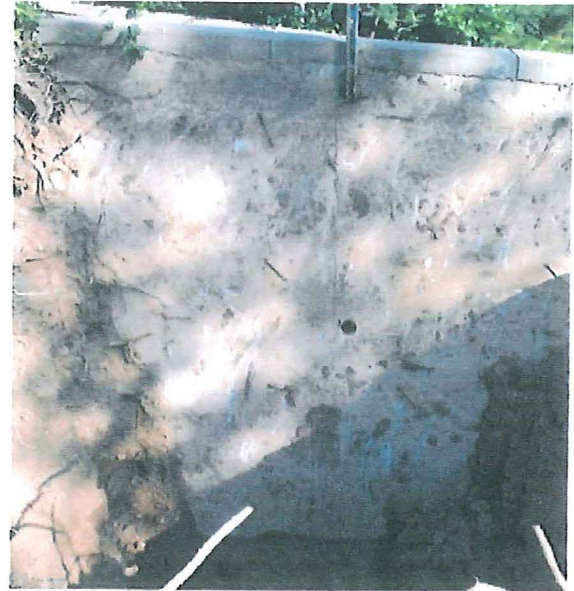
Figure 5 – Backside of retaining wall after excavation

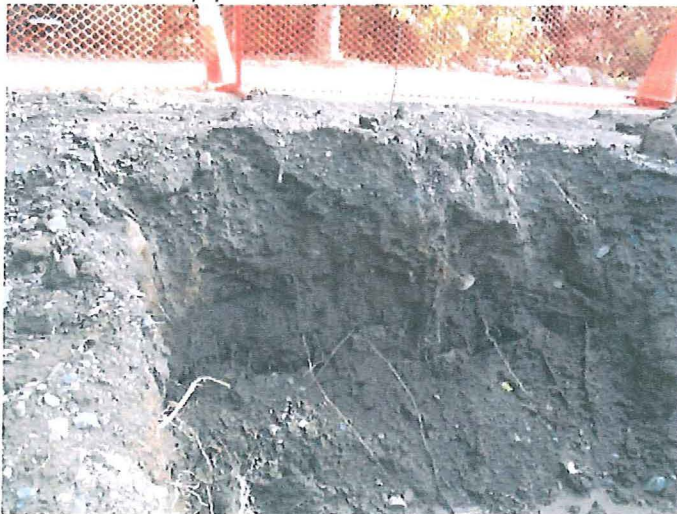
Zoo personnel had shared witnessing water coming out the stream bank into the stream. We excavated a small section behind the stream bank to see if there was a broken water pipe in this area. No pipe was observed and the soil was well compacted. See Figure 6.

Figure 6 – Excavation near stream

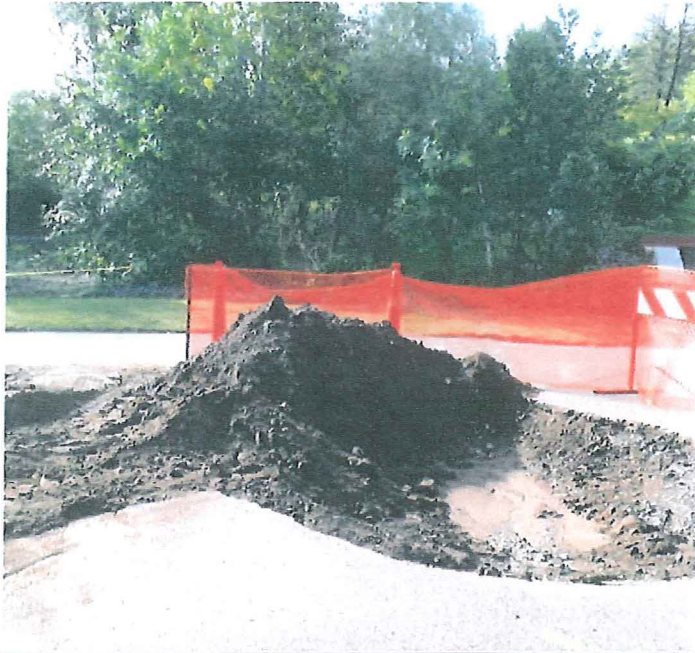
The asphalt sidewalk settled in these areas. Excavations were done to see the extent of the soil erosion. Location #4 was chosen since it was near a manhole. Location #5 was chosen because it was near the edge of the structural concrete supporting the upper exhibit viewing area. Figures 7 and 8 show these areas. In neither of the areas did the extent of soil erosion continue to adjacent structures causing structural concern.

Figure 7 – Location #4 excavation near manhole

After all the areas were observed, the fill was replaced and compacted to create a level walking surface. Any broken asphalt sidewalk pieces were removed. However, the sidewalk was not replaced.

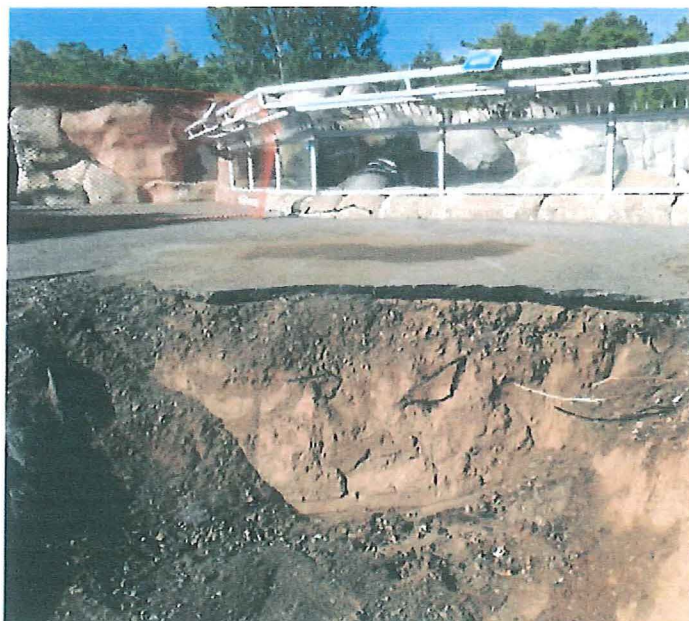
Figure 8 – Location #5 excavation upper viewing area
