## **MODIFICATION TO THE DEVELOPMENT PROGRAM**

Establishment of Tax Increment Financing District No. 39 -  
The Armory (a redevelopment district)

REPORT OF INSPECTION PROCEDURES AND RESULTS FOR  
DETERMINING QUALIFICATIONS OF A  
TAX INCREMENT FINANCING DISTRICT AS A REDEVELOPMENT DISTRICT

**DULUTH ARMORY REDEVELOPMENT TIF DISTRICT**  
DULUTH, MINNESOTA

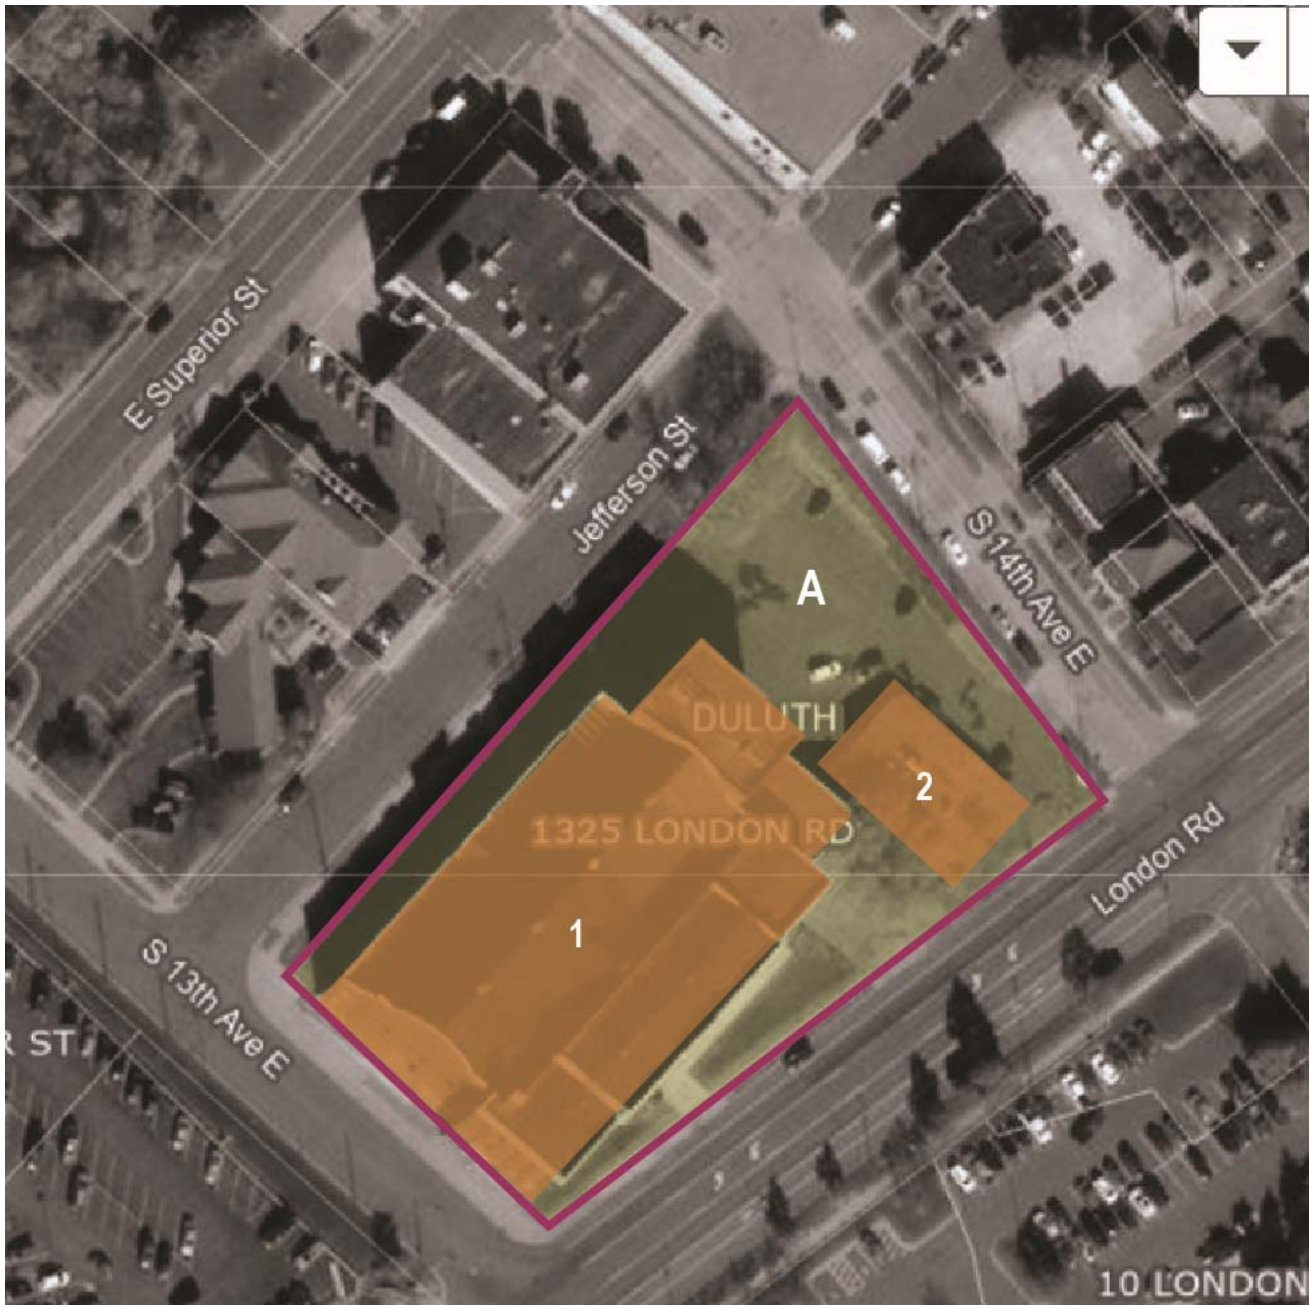
Diagram 1: Proposed TIF District

The proposed TIF District consists of one (1) parcel with two (2) structures. Two (2) buildings were inspected on January 18, 2022. A Building Code and Condition Deficiency reports for the buildings that were inspected and found substandard are located in Appendix B.

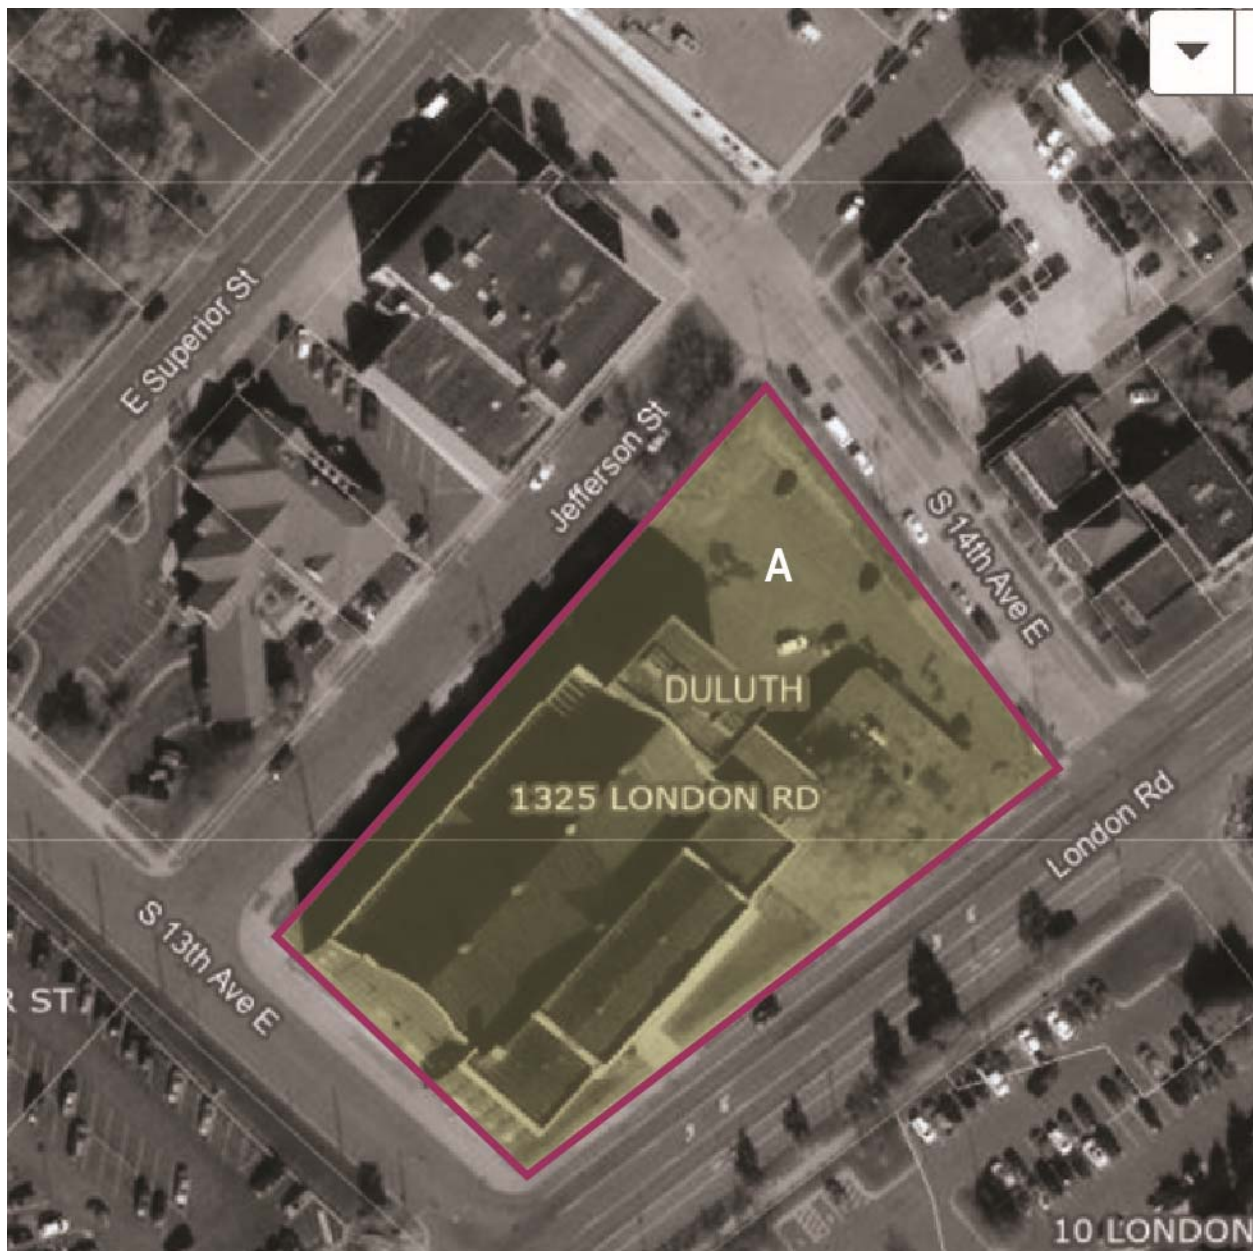
**Diagram 2 – Coverage Diagram**

The proposed TIF District met the coverage test under *Minnesota Statutes, Section 469.174, Subdivision 10(e)*, which resulted in parcel consisting of 100 percent of the area of the proposed TIF District being occupied by buildings, streets, utilities, paved or gravel parking lots, or other similar structures (Diagram 2). This exceeds the 70 percent area coverage requirement for the proposed TIF District under Minnesota Statutes, Section 469.174, Subdivision (a) (1).

Shaded area depicts a parcel more than 15 percent occupied by buildings, streets, utilities, paved or gravel parking lots or other similar structures

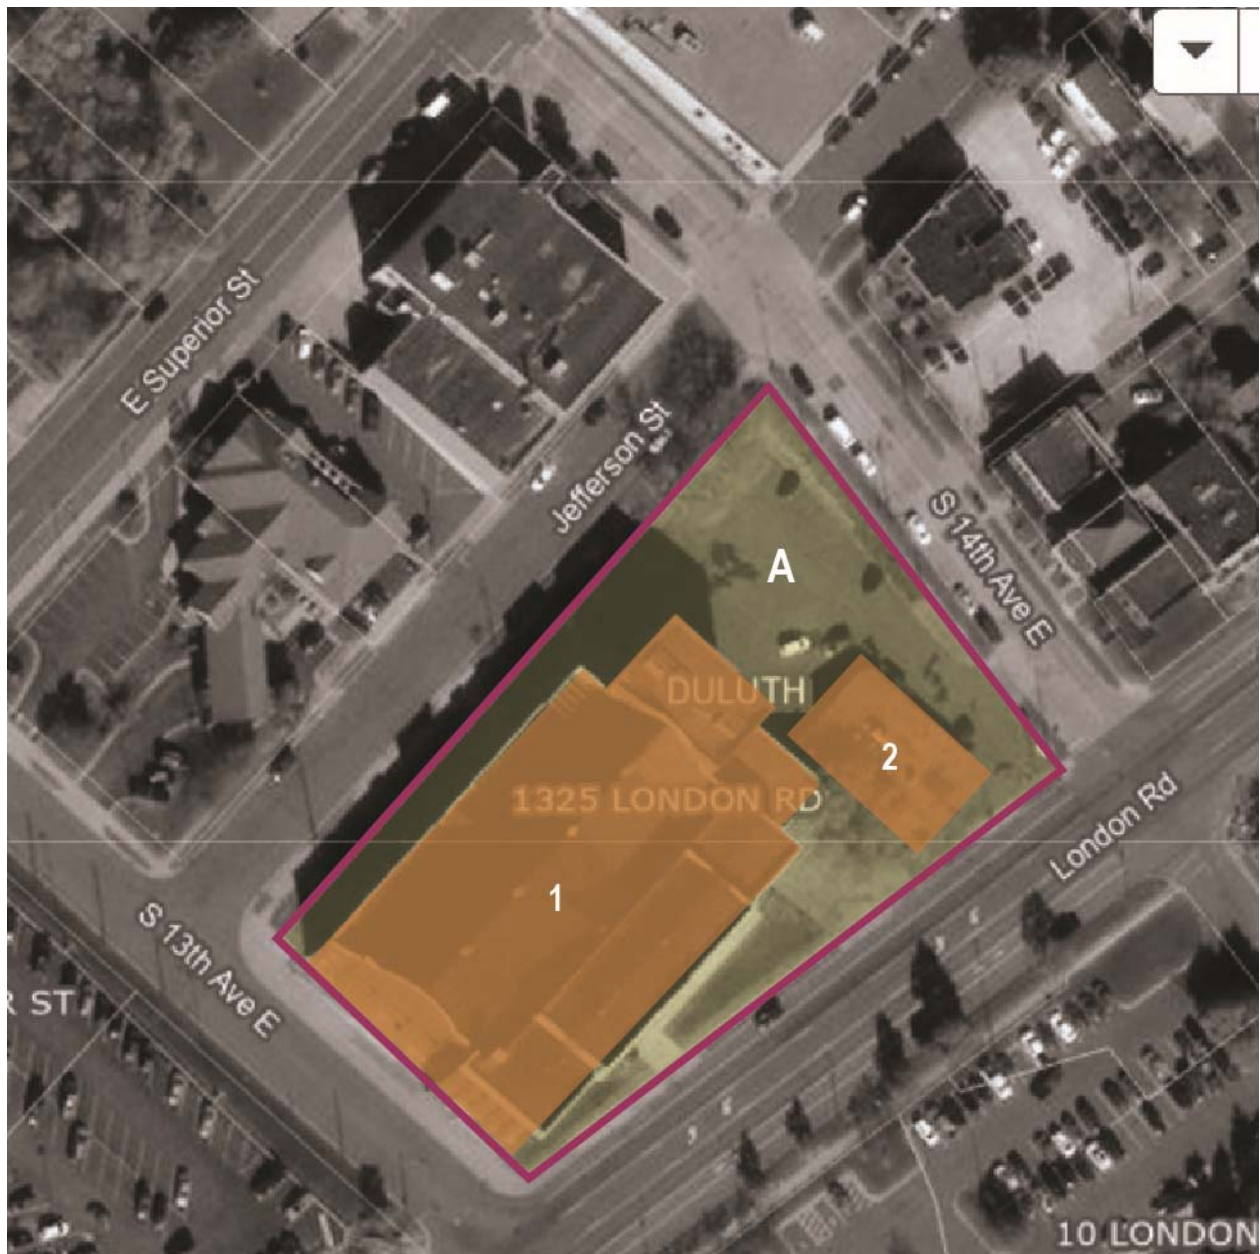
**Diagram 3 – Substandard Buildings**

The parcels with substandard buildings are reasonably distributed compared to all parcels that contain buildings.

Shaded green area depicts parcels with buildings.  
Shaded orange area depicts substandard buildings.
