**DATE:** June 8, 2022  
**TO:** Heritage Preservation Commission  
**FROM:** Steven Robertson, Senior Planner  
**RE:** PL 22-090, Application for the Demolition of a Contributing Structure to the Duluth Commercial Historic District

## Structural Engineering Report

**Project:** 102 E Superior Street – Bullseye Bldg- Condition Review

### Regarding: Structural and Envelope Condition Review

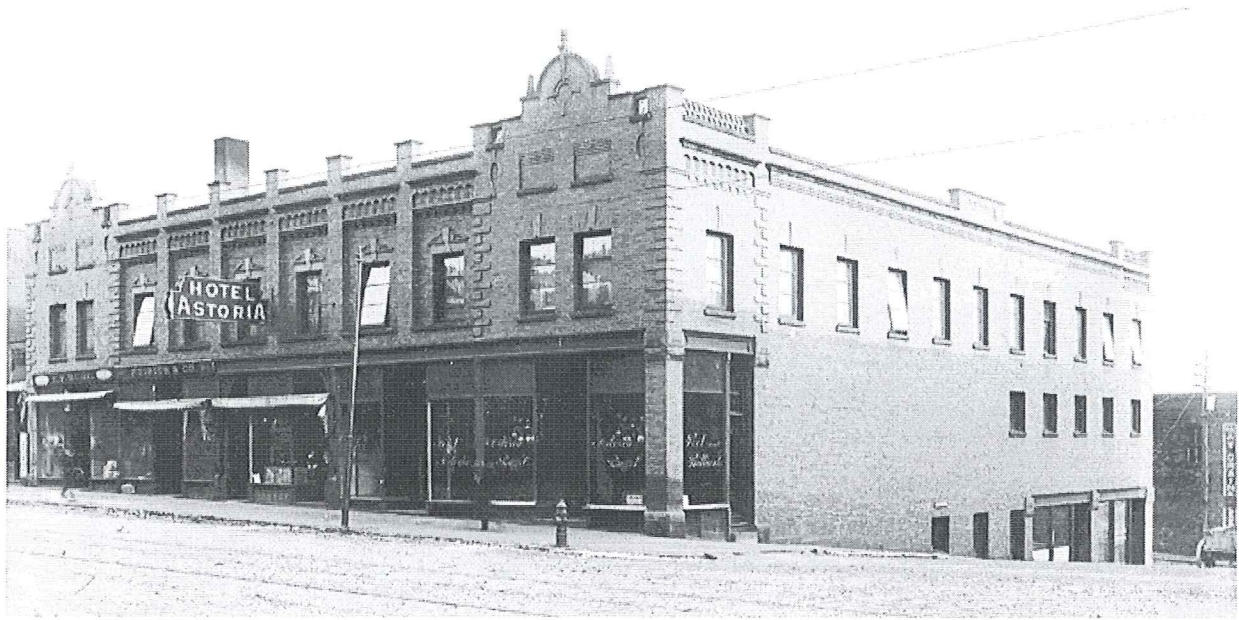
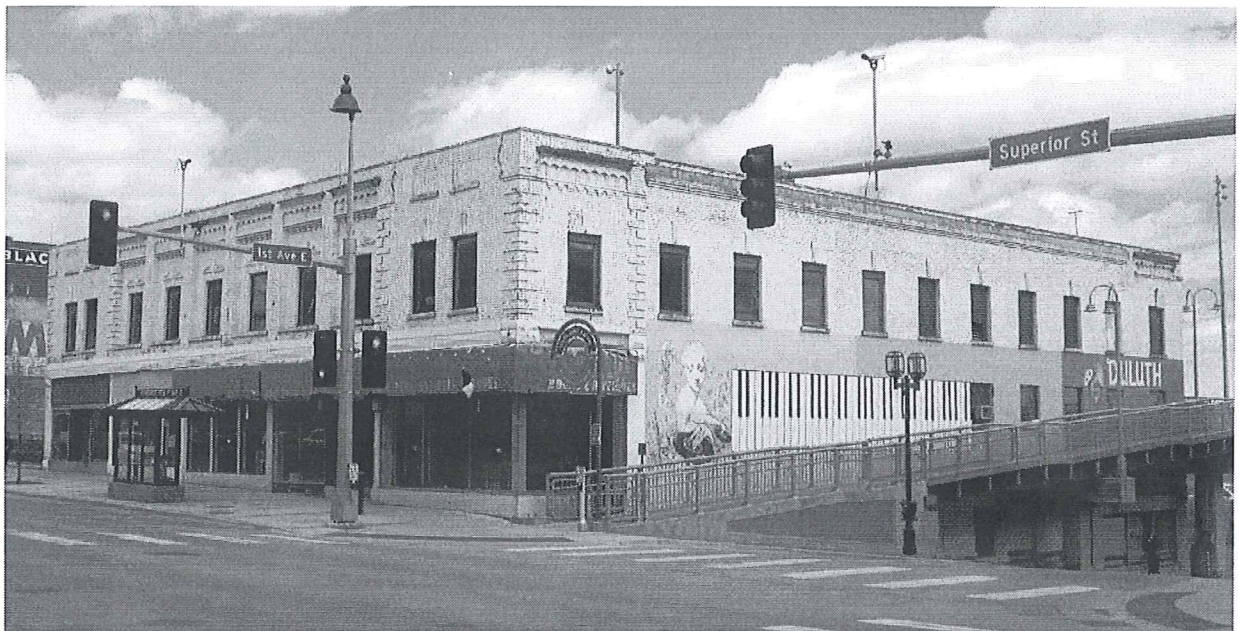
Over the years, as businesses have taken up residence, changes were made to the interior. Very little if anything from its days as the Hotel Astoria still exists. Many windows have been removed and/or boarded up due to damage, decay or just not being where the current tenant of the building needed them at that time. The store fronts on Superior Street have been altered

over the years. The store front on Michigan Street has also changed significantly with the installation of four garage doors. Currently, all three Superior Street store front doors have been broken as well as a second story window on the Michigan Street side.
