Management Report

DEDA
AAR - Duluth Airbus Facility
4600 Stebner Rd., Duluth, MN

Prepared For
DEDA

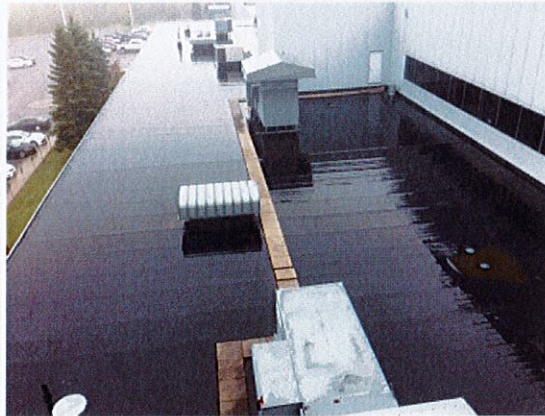
Several areas of siding are still in need of replacement on this level

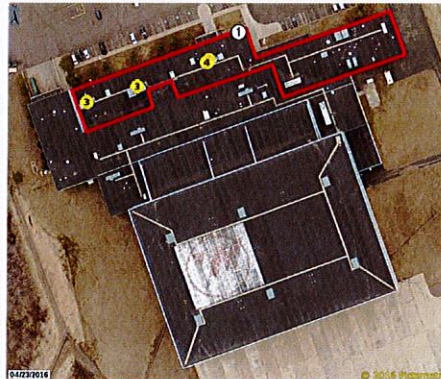
General - Deteriorated Curb Flashing (Remedial)

Flashing details are starting to deteriorate and should be reinforced before they fail completely.

Strip in flashing with new pressure sensitive cover tape to ensure a long term watertight condition.

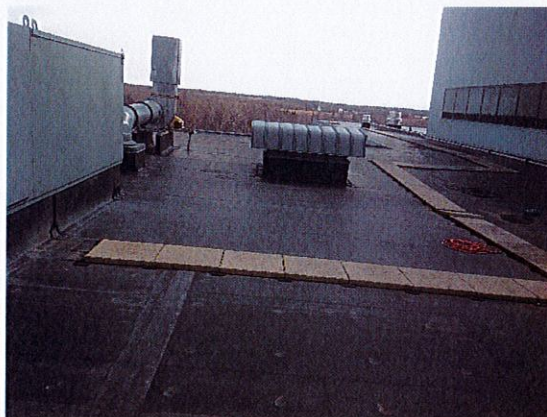
Observation #2
Siding should be installed on these walls to eliminate leaking

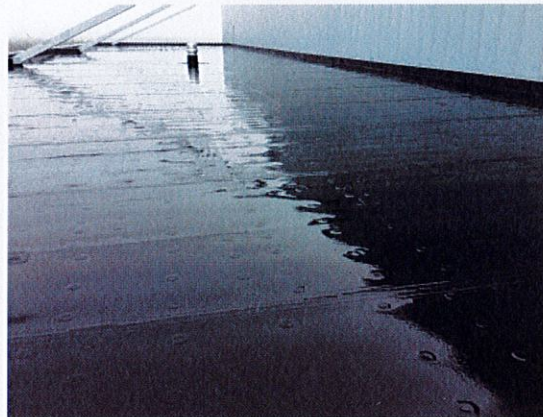
Observation #1

All the field seams have been stripped in on this section

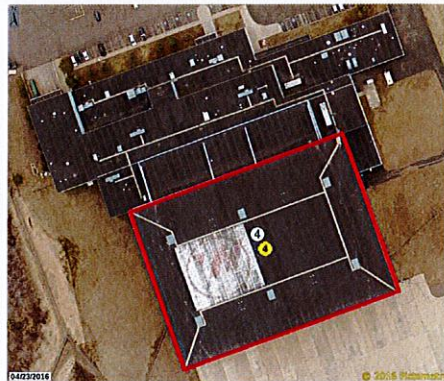
General - Window and siding Sealant Failure (Emergency)

Windows and siding sealant has failed and is allowing water into the building.

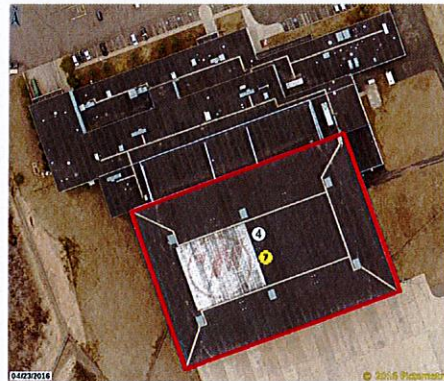
General - Annual Roof Maintenance & Repairs (Remedial)

Roof system is in need of general roof maintenance and repair. We recommend yearly inspections and repairs to prolong the life of the roof system.

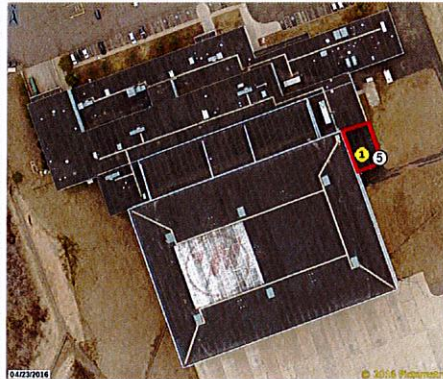
General - Roof Maintenance Program (Remedial)

We highly recommend starting an annual Roof Maintenance Program. Routine roof maintenance helps prolong the life of the roof system.

Visually inspect the entire roof. Repair minor deficiencies as necessary. Check and clear all drains & scuppers. Clean roof surface of all nature's debris (leaves, branches, dirt). Remove and dispose of any foreign debris (screws, trash, filters, belts, etc.) Check and caulk all vent stacks & storm collars as necessary. If any major issues are found, we will provide a proposal for repair.
