DATE: June 8, 2022
TO: Heritage Preservation Commission
FROM: Steven Robertson, Senior Planner
RE: PL 22-090, Application for the Demolition of a Contributing Structure to the Duluth Commercial Historic District

Structural Engineering Report

Project: 102 E Superior Street – Bullseye Bldg- Condition Review

Regarding: Structural and Envelope Condition Review

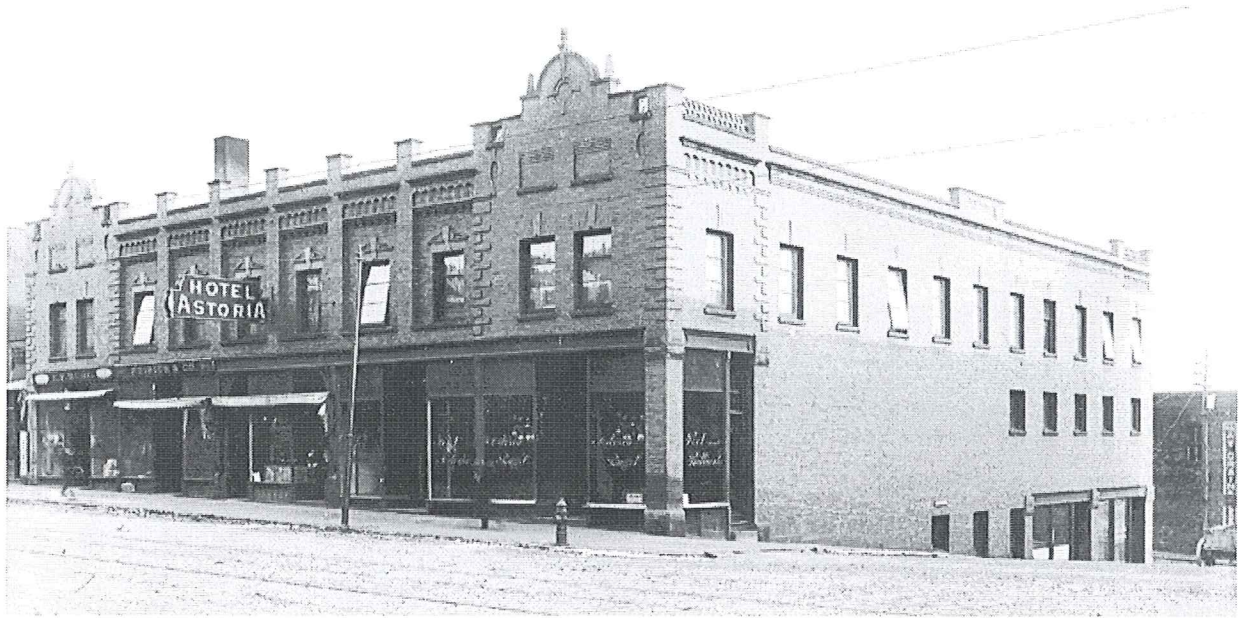
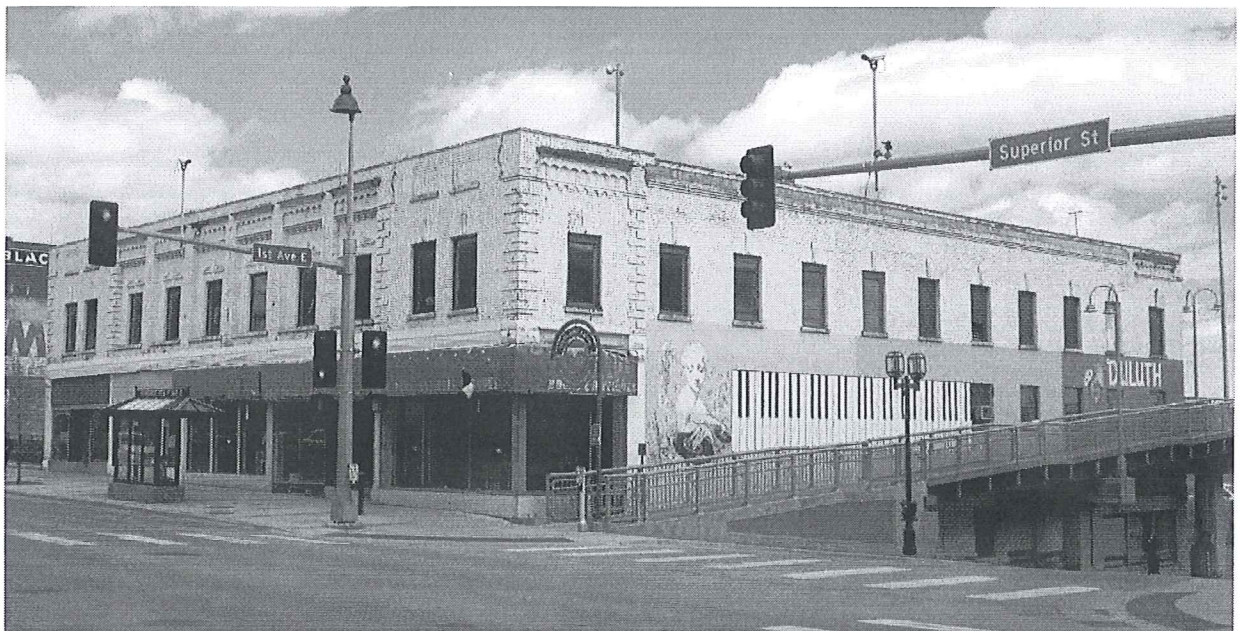
Over the years, as businesses have taken up residence, changes were made to the interior. Very little if anything from its days as the Hotel Astoria still exists. Many windows have been removed and/or boarded up due to damage, decay or just not being where the current tenant of the building needed them at that time. The store fronts on Superior Street have been altered

over the years. The store front on Michigan Street has also changed significantly with the installation of four garage doors. Currently, all three Superior Street store front doors have been broken as well as a second story window on the Michigan Street side.
