Tax Increment Financing Plan
for the establishment of
Tax Increment Financing District No. 30 (Ramsey V)
(a redevelopment district)
within
Development District No. 17

Duluth Economic Development Authority
City of Duluth
St. Louis County
State of Minnesota

Report of Inspection Procedures and Results for
Determining Qualifications of a
Tax Increment Financing District as a Redevelopment District

Ramsey V – Redevelopment TIF District Duluth, Minnesota

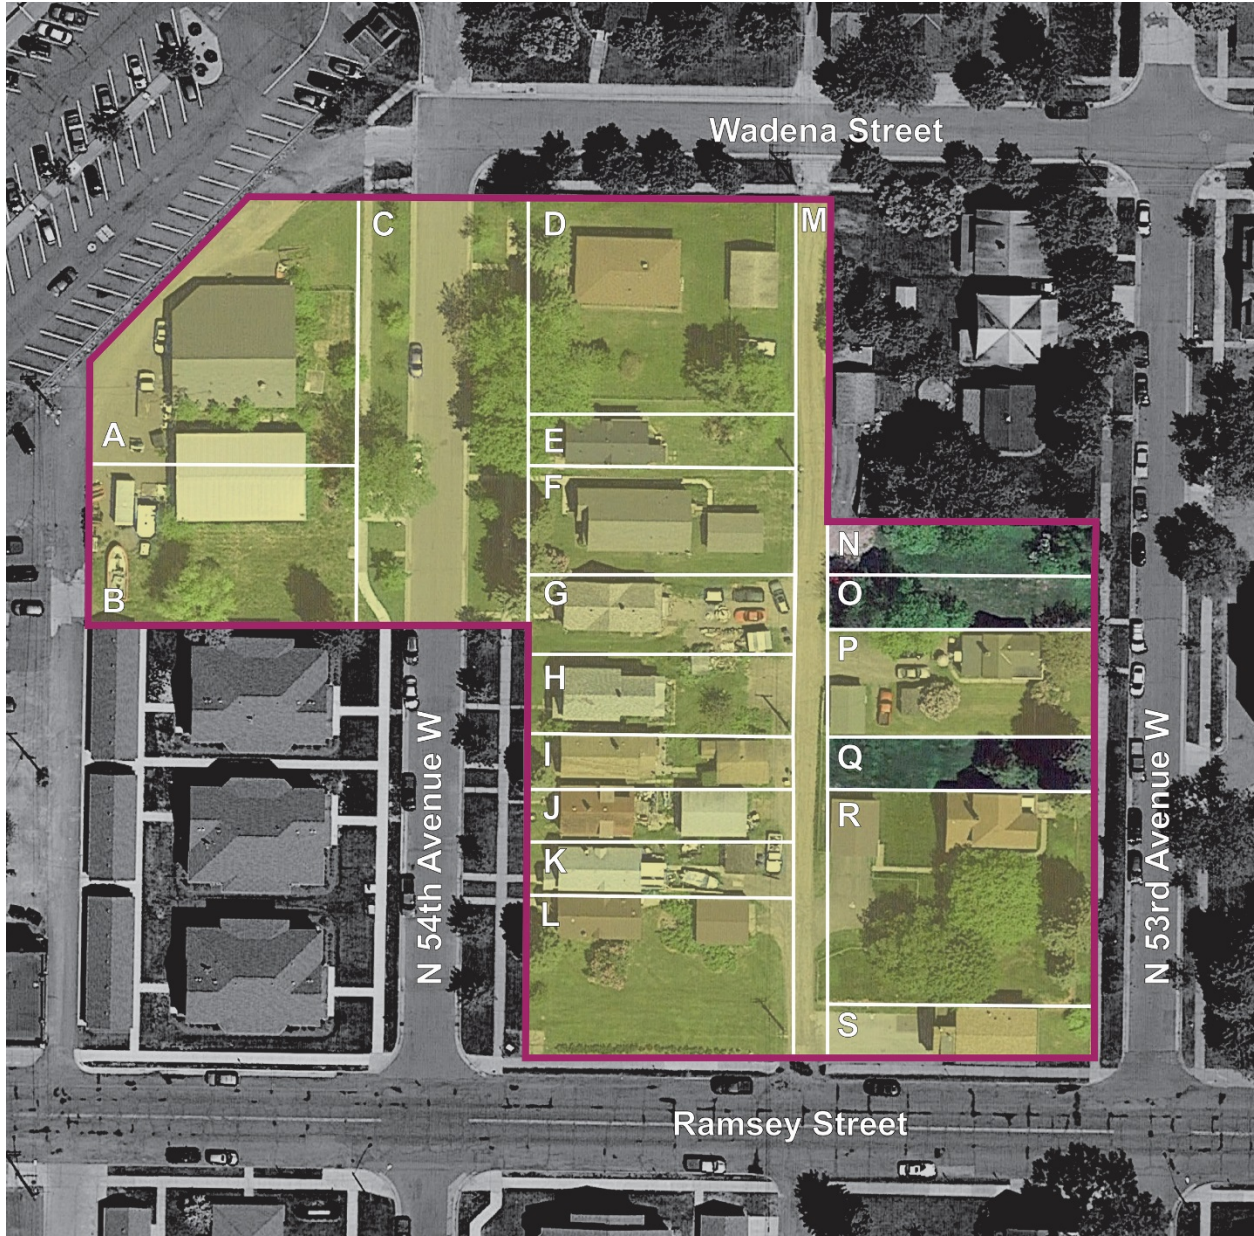
Diagram 2 – Coverage Diagram

Shaded area depicts a parcel more than 15 percent occupied by buildings, streets, utilities, paved or gravel parking lots or other similar structures

The proposed TIF District met the coverage test under *Minnesota Statutes, Section 469.174, Subdivision 10(e)*, which resulted in parcels consisting of 92.7 percent of the area of the proposed TIF District being occupied by buildings, streets, utilities, paved or gravel parking lots, or other similar structures (Diagram 2). This exceeds the 70 percent area coverage requirement for the proposed TIF District under *Minnesota Statutes, Section 469.174, Subdivision (a) (1)*.
