REPORT OF INSPECTION PROCEDURES AND RESULTS
FOR
DETERMINING QUALIFICATIONS
OF A
TAX INCREMENT FINANCING DISTRICT

131 WEST 1st STREET
REDEVELOPMENT TIF DISTRICT

Prepared for
CITY OF DULUTH, MINNESOTA
November 22, 2022

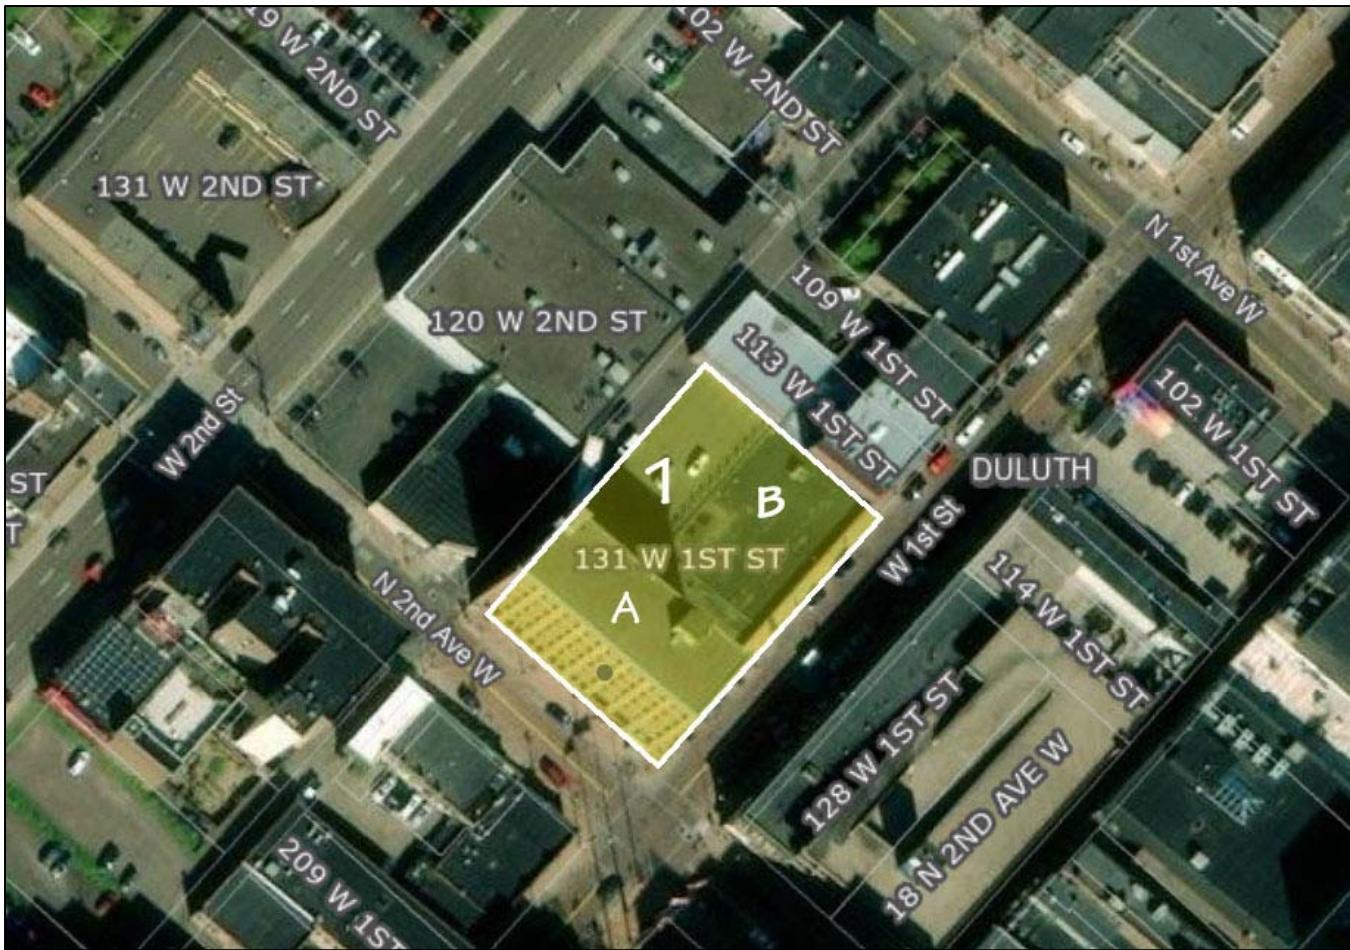
Diagram 2 – Coverage Diagram

Shaded area depicts a parcel more than 15 percent occupied by buildings, streets, utilities, paved or gravel parking lots or other similar structures

The proposed TIF District met the coverage test under *Minnesota Statutes, Section 469.174, Subdivision 10(e)*, which resulted in parcels consisting of 100 percent of the area of the proposed TIF District being occupied by buildings, streets, utilities, paved or gravel parking lots, or other similar structures (Diagram 2). This exceeds the 70 percent area coverage requirement for the proposed TIF District under Minnesota Statutes, Section 469.174, Subdivision (a) (1).

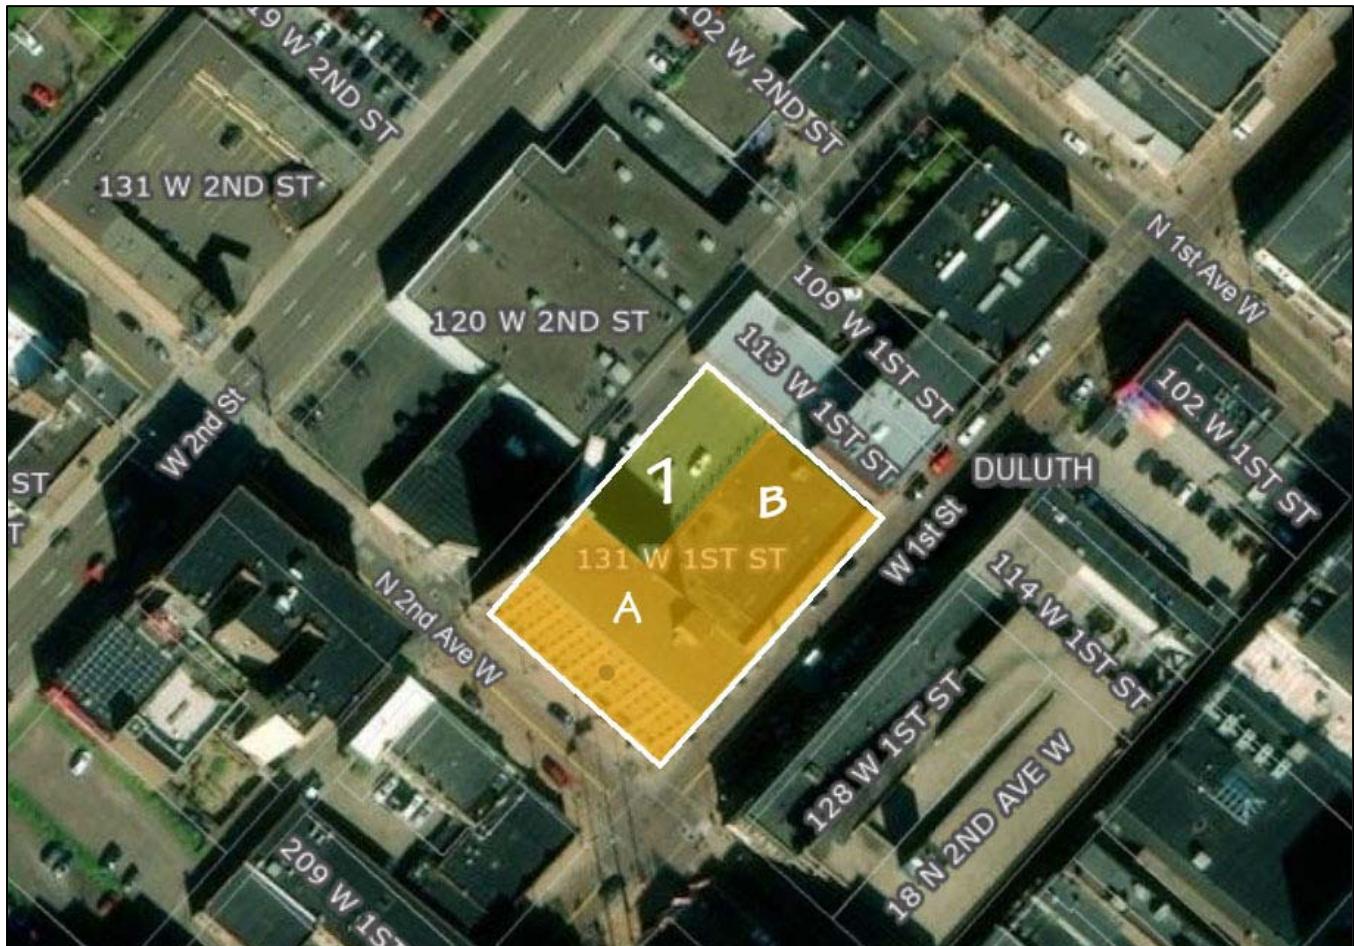
Diagram 3 – Substandard Buildings

Shaded green area depicts parcels with buildings.
Shaded orange area depicts substandard buildings.

The parcels with substandard buildings are reasonably distributed compared to all parcels that contain buildings.
