REPORT OF INSPECTION PROCEDURES AND RESULTS
FOR
DETERMINING QUALIFICATIONS
OF A
TAX INCREMENT FINANCING DISTRICT

DULUTH INCLINE LAKEVIEW
REDEVELOPMENT TIF DISTRICT

CITY OF DULUTH, MINNESOTA
January 24, 2024

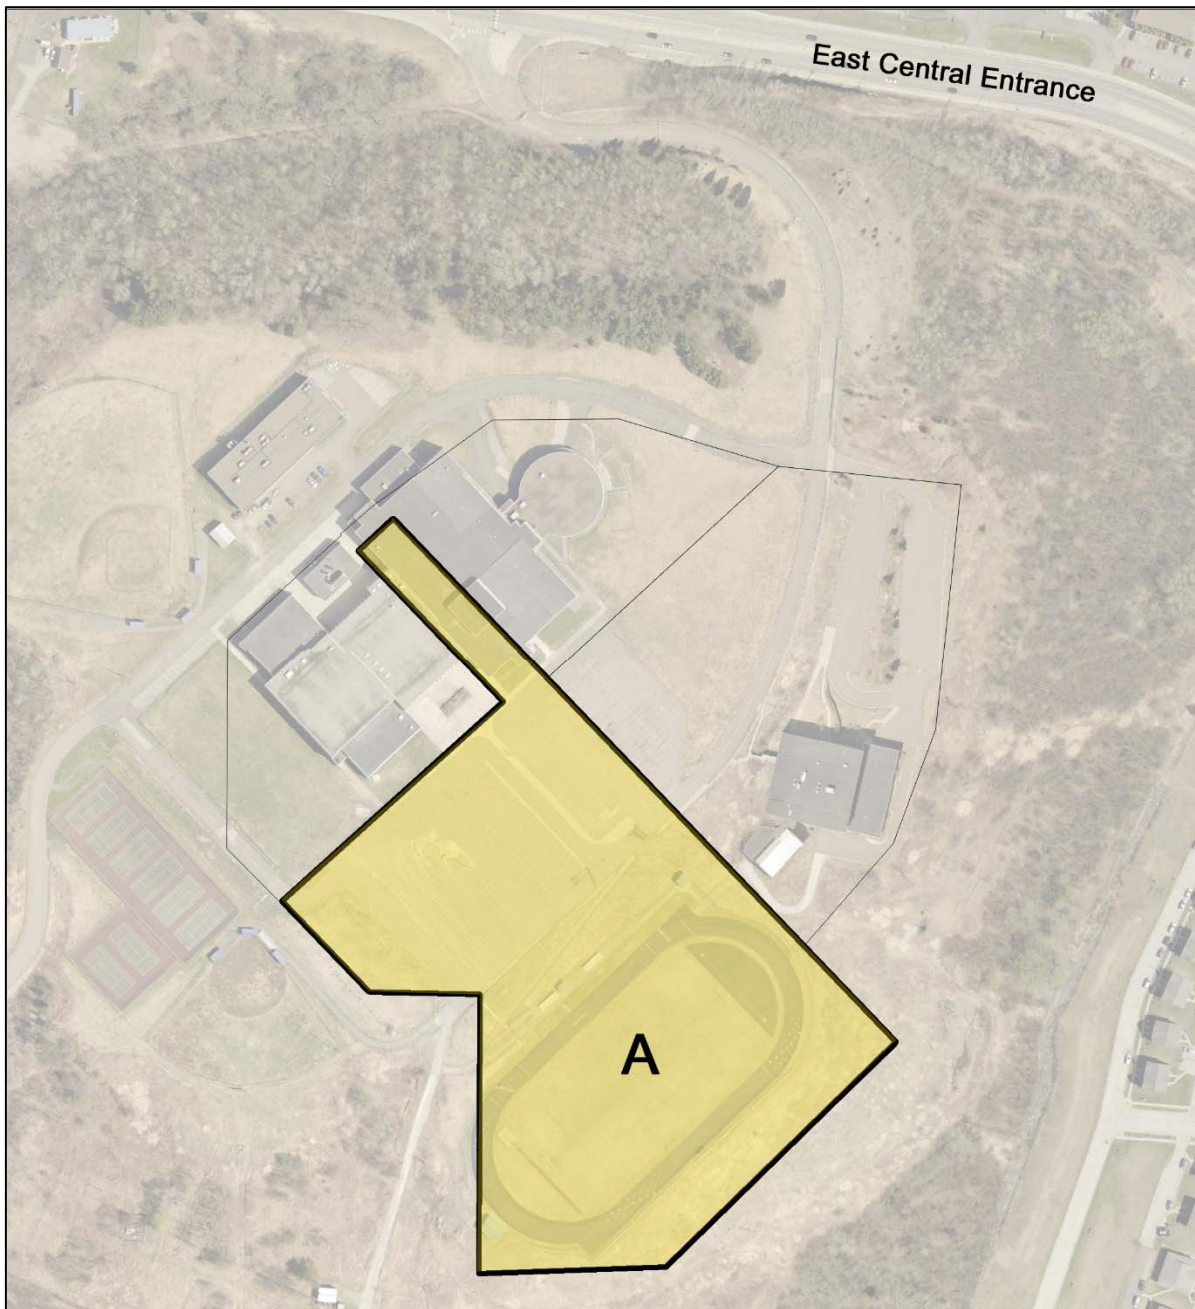
Diagram 1: Proposed TIF District

LHB was hired by the City of Duluth to inspect and evaluate the properties within a Tax Increment Financing Redevelopment District ("TIF District") proposed to be established by the City. The proposed TIF District is located at the former Central High School site south of East Central Entrance Road (Diagram 1). The purpose of LHB's work is to determine whether the proposed TIF District meets the statutory requirements for coverage, and whether one building on one parcel, located within the proposed TIF District, meets the qualifications required for a Redevelopment District.

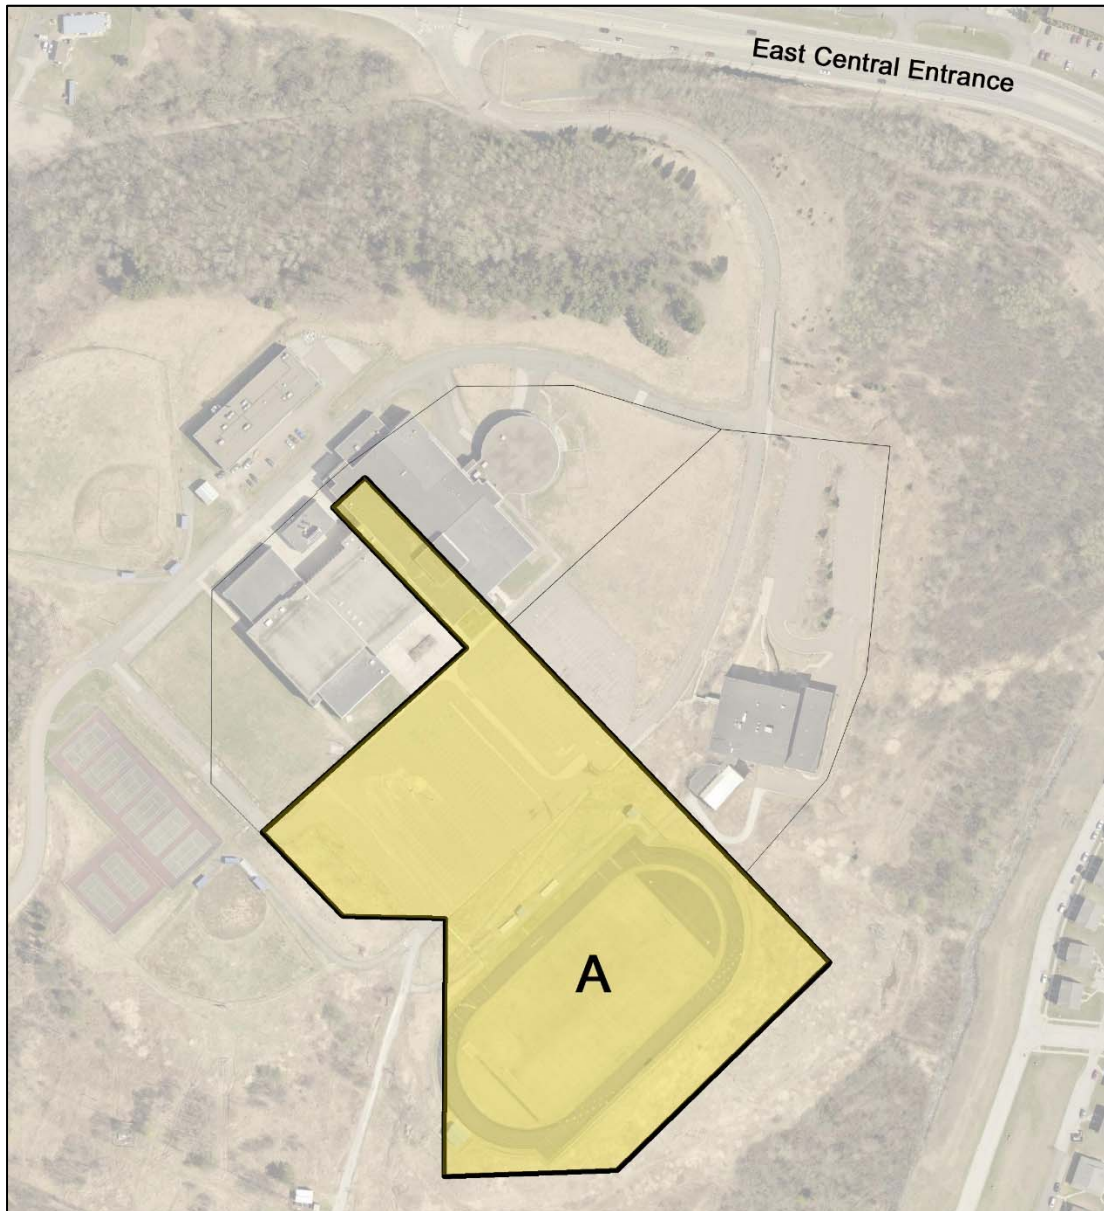
Diagram 2 – Coverage Diagram

Shaded area depicts a parcel more than 15 percent occupied by buildings, streets, utilities, paved or gravel parking lots or other similar structures

The proposed TIF District met the coverage test under *Minnesota Statutes, Section 469.174, Subdivision 10(e)*, which resulted in parcels consisting of 100 percent of the area of the proposed TIF District being occupied by buildings, streets, utilities, paved or gravel parking lots, or other similar structures (Diagram 2). This exceeds the 70 percent area coverage requirement for the proposed TIF District under Minnesota Statutes, Section 469.174, Subdivision (a) (1).

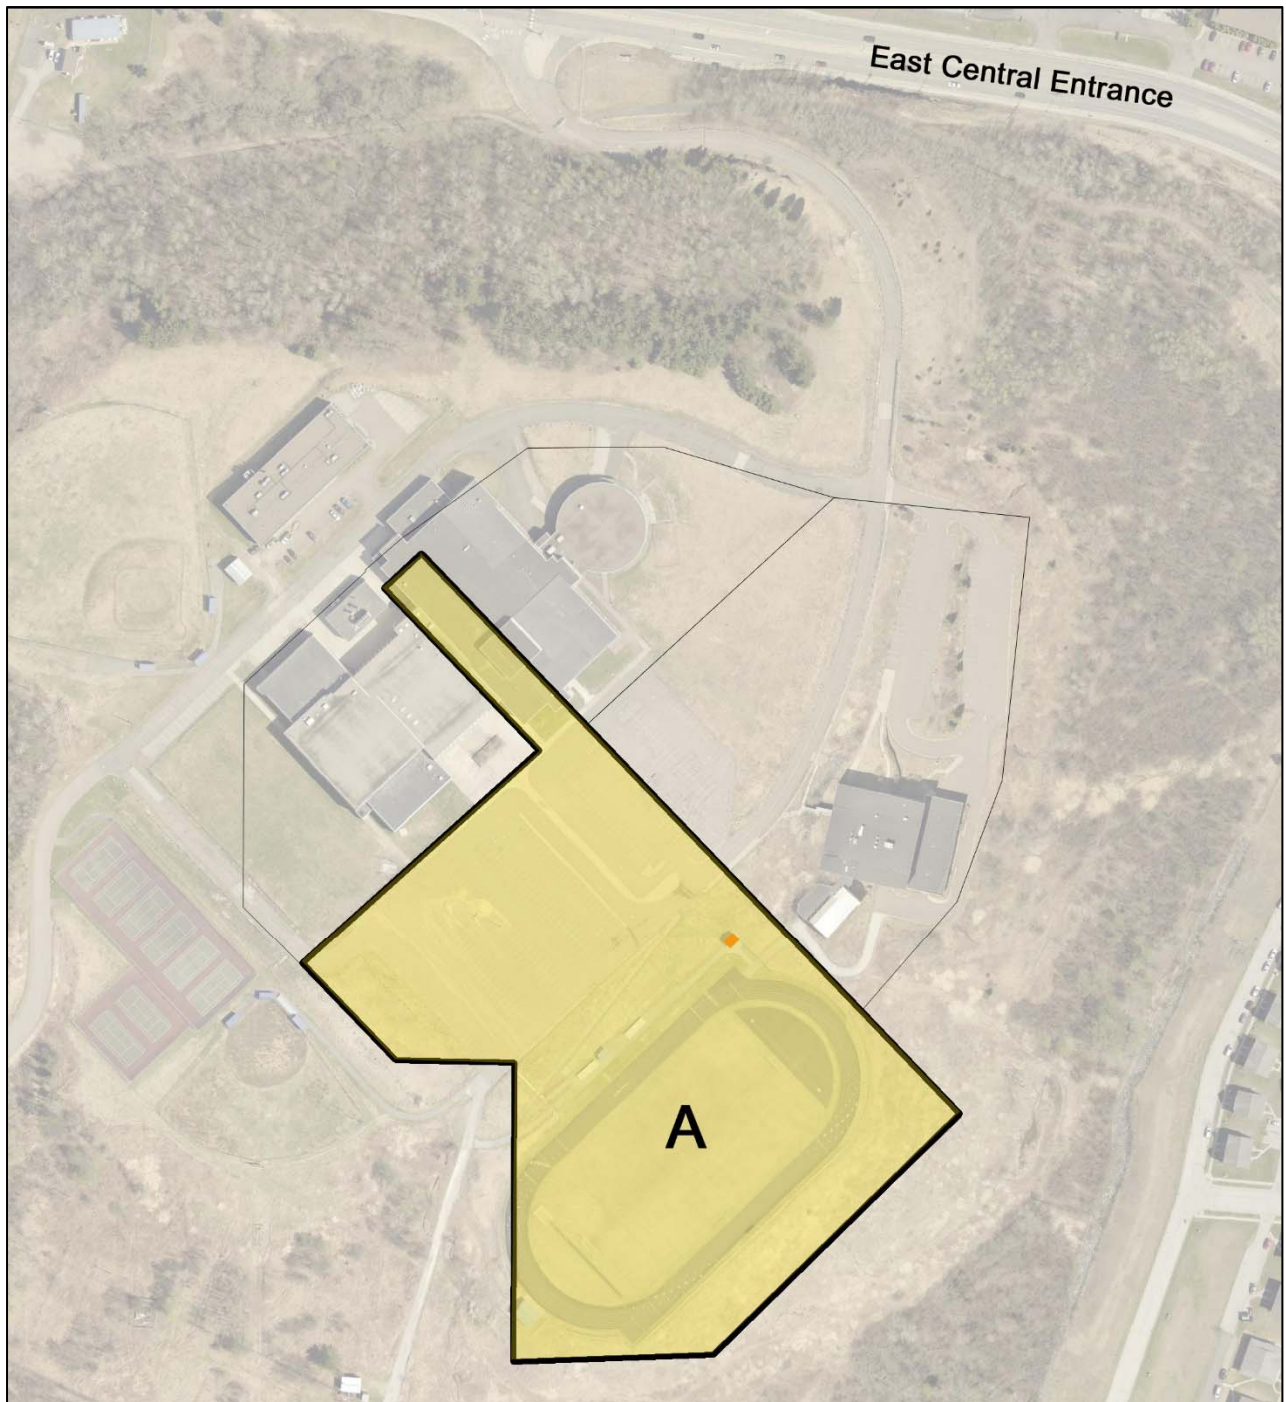
Diagram 3 – Substandard Buildings

Shaded yellow area depicts parcels with buildings.
Shaded orange area depicts substandard buildings.

The parcels with substandard buildings are reasonably distributed compared to all parcels that contain buildings.
