Lincoln Park | Mini Master Plan

City of Duluth | February 12, 2016

History/Background

FEMA 2016 Restoration Plan

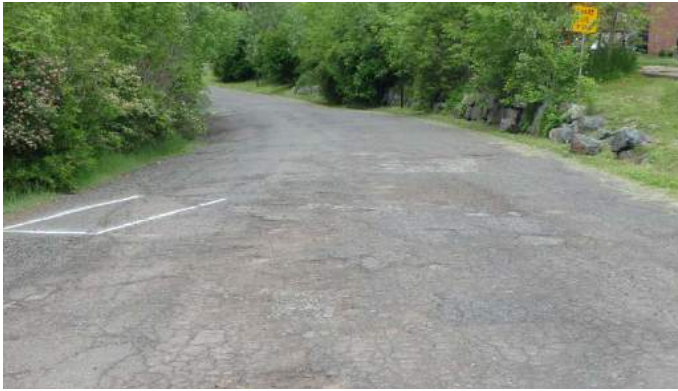
Roadway paving and shoulders in poor condition throughout park

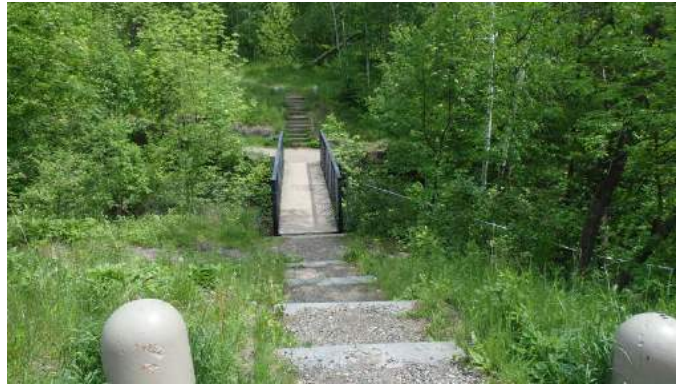
Lack of wayfinding and well defined trail access points within park

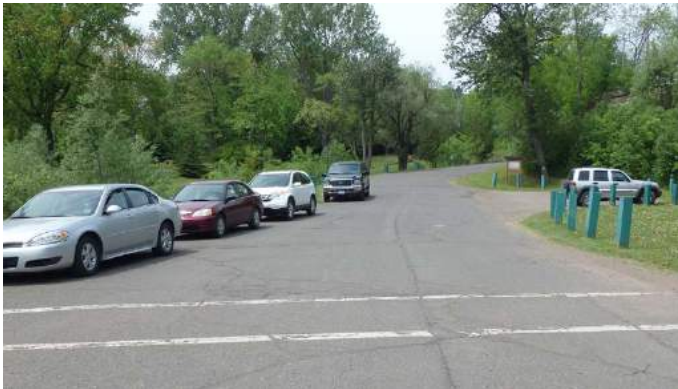
Lack of defined parking areas and pedestrian circulation along Lincoln Park Drive

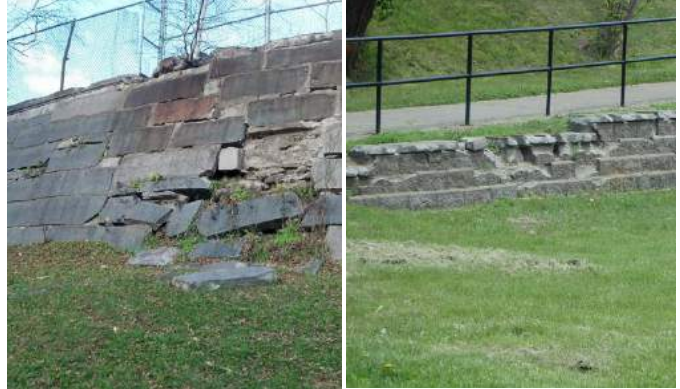
Retaining wall Infrastructure in need of tuck pointing repair or replacement

The upper terrace athletic field area on the east side of the park is somewhat disconnected from the rest of the park because of its higher elevation and primary access along 25th Avenue. The existing stone clad retaining wall is also failing and in need of short term repair or long term replacement. Other recommendations call for an expanded parking lot which can support overflow parking for the rest of the park, restoration of the athletic field turf area, the addition of half court basketball, and establishing a new, more direct stair connection to the lower parking lot and adjacent park amenities.

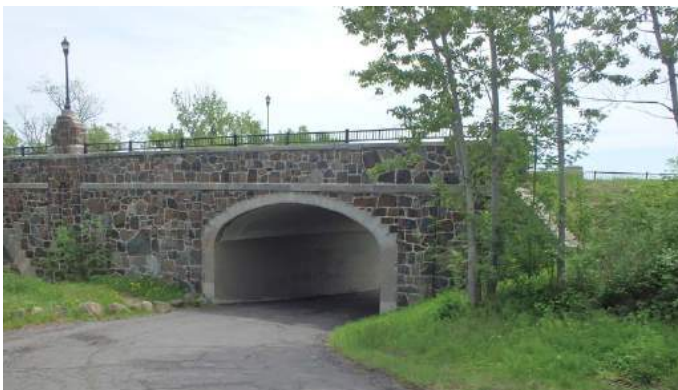
Poor approach sight lines for vehicular and pedestrian traffic at 10th Street bridge underpass

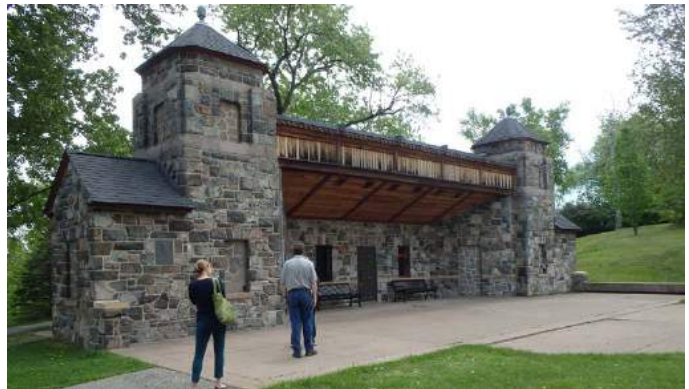
No operational restroom facilities in pavilion building

With a desire to attract more visitors, providing running water and flush toilet facilities should be addressed at the park. The existing restroom facilities located in the WPA pavilion have not been used since the 2014 arson fire and efforts should be made to complete repairs or incorporate new restrooms in a new picnic shelter adjacent to the playground. After the pavilion is repaired, efforts should continue to place the building on the National Register of Historic Places. To minimize risks for future vandalism at the restroom building, the addition of security lighting and highly visible cameras will help prevent unwanted after hours activities in the park. Organizing volunteer neighborhood watch group patrols can also help deter crime and illegal dumping activities occurring in the park.

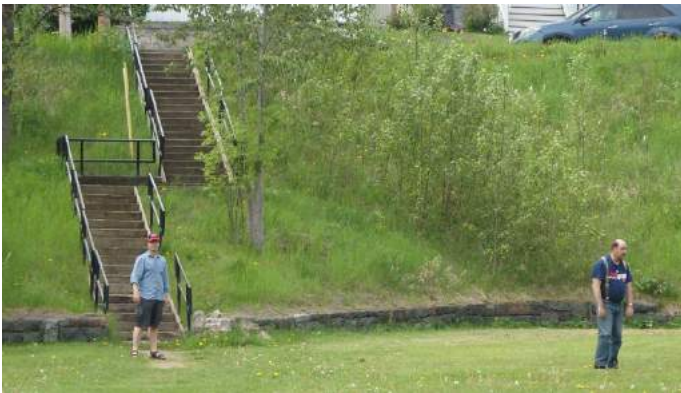
Steep grades around perimeter of park limit ADA access opportunities from surrounding neighborhoods

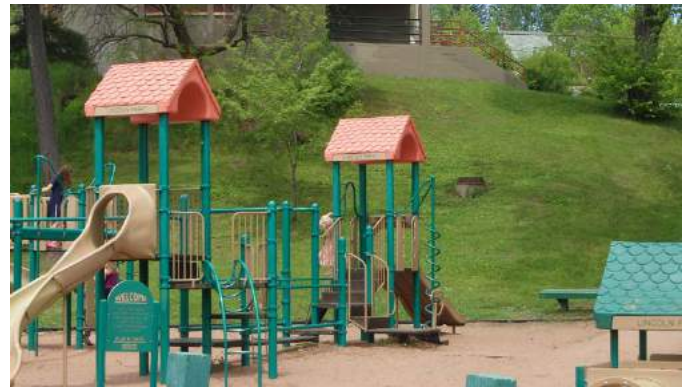
Existing playground does not meet ADA accessibility requirements

A new and more expansive playground area is proposed on the south side of Miller Creek to better integrate it with the existing picnic open space and shelter, restroom facilities, and trail circulation connected to a new natural play area with climbing boulders, tree fort building area, and informal picnic area with a small shelter near elephant rock.

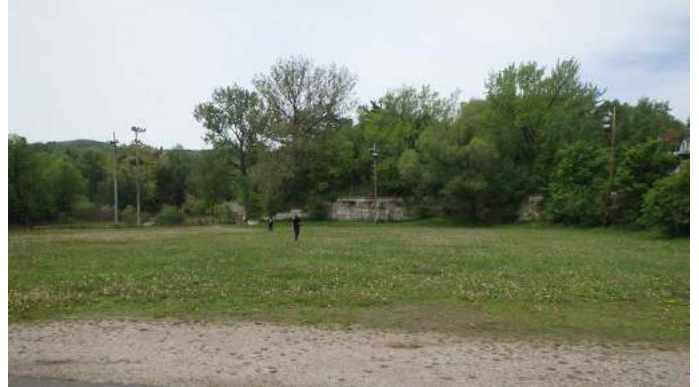
Upper terrace athletic field in poor condition and is disconnected from other park amenities and activities

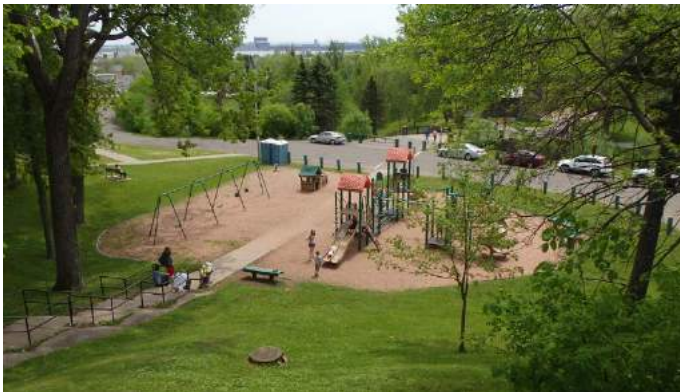
Existing playground is separated from existing gathering and picnic areas

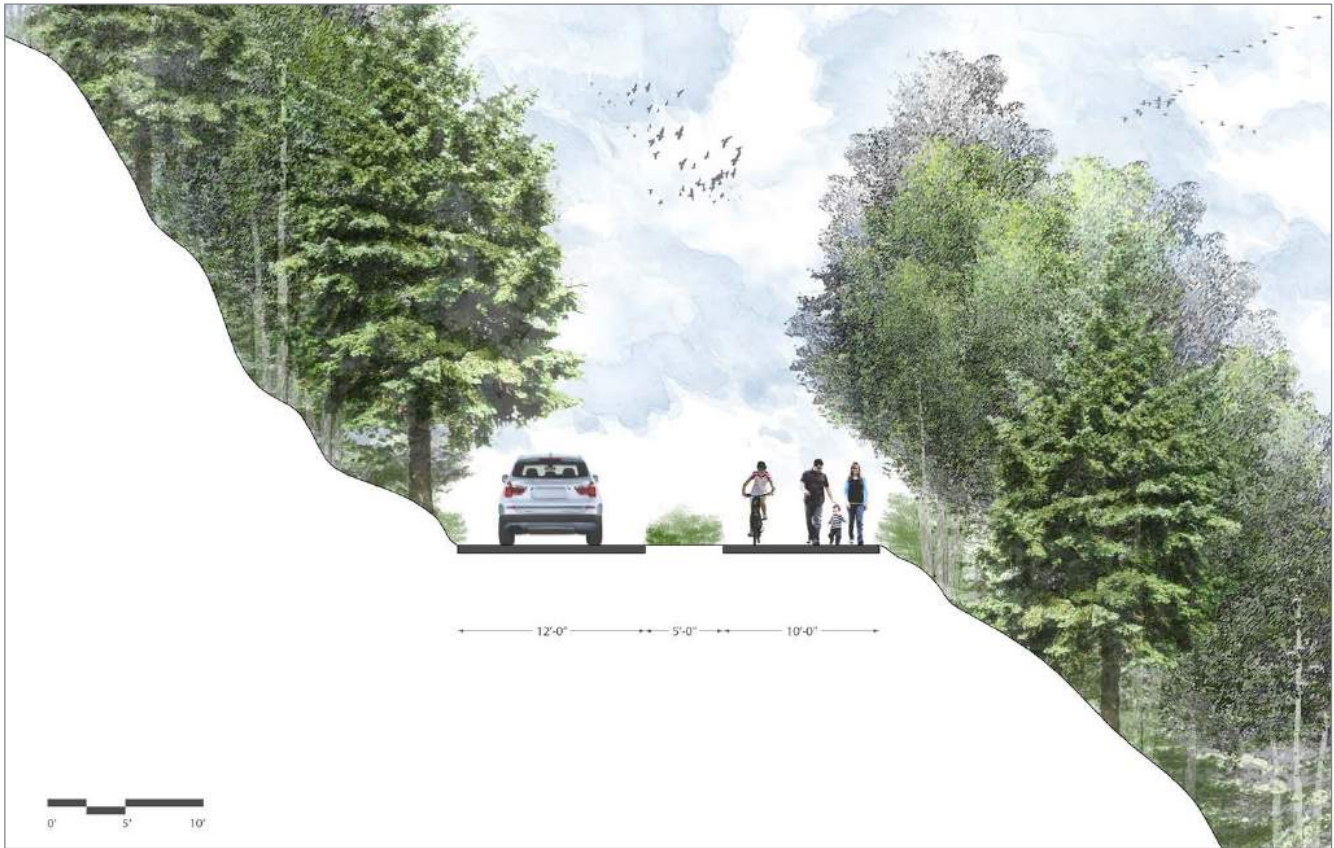
This option considers converting Lincoln Park Drive to a one way road (direction to be determined by additional traffic study) and dedicating a separated trail to accommodate bike and pedestrian traffic.

OPTION A: One-way vehicle traffic, vegetated buffer, and combined bicycle/pedestrian trail

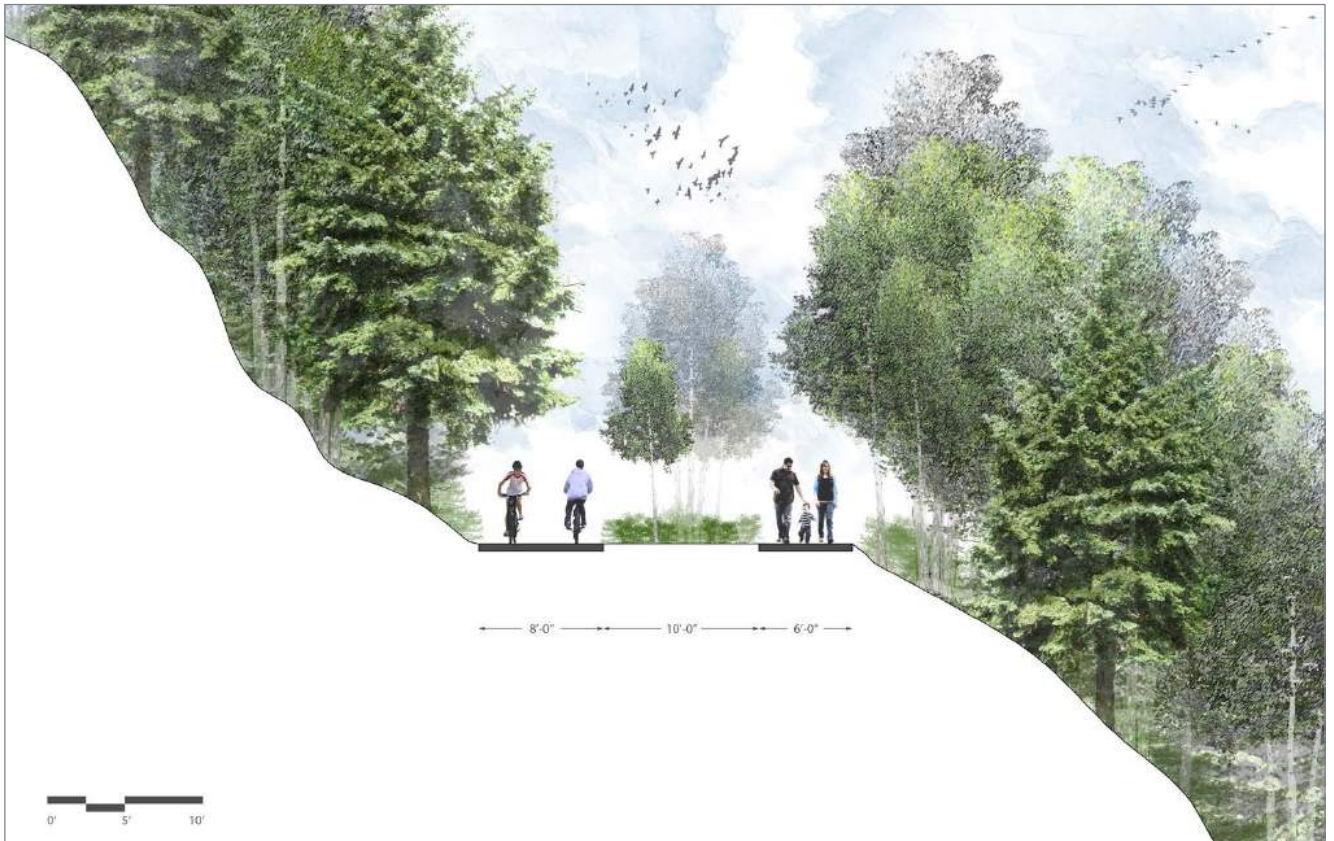
This option considers converting Lincoln Park Drive to a designated bike and pedestrian trail system with the bike trail designed to accommodate police and fire emergency vehicle use.

OPTION B: Bicycle trail, vegetated buffer, and pedestrian trail
