Lincoln Park | Mini Master Plan City of Duluth | February 12, 2016

EXHIBIT A - 16-0453R Mini Master Plan Recommendations North Segment

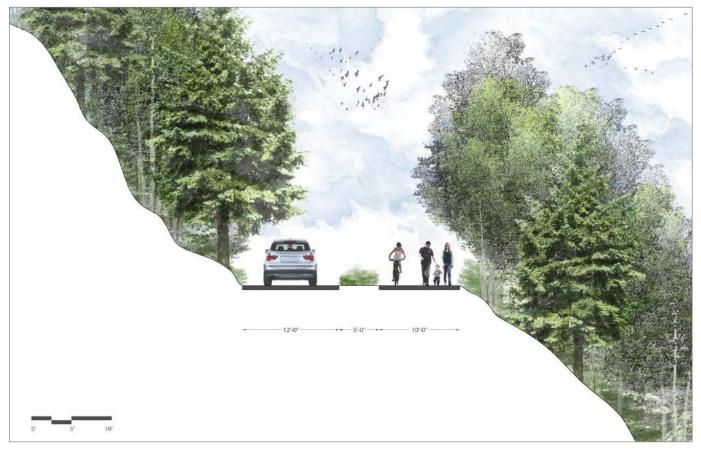
OPTION A: One-way vehicle traffic, vegetated buffer, and combined bicycle/pedestrian trail

This option considers converting Lincoln Park Drive to a one way road (direction to be determined by additional traffic study) and dedicating a separated trail to accommodate bike and pedestrian traffic.

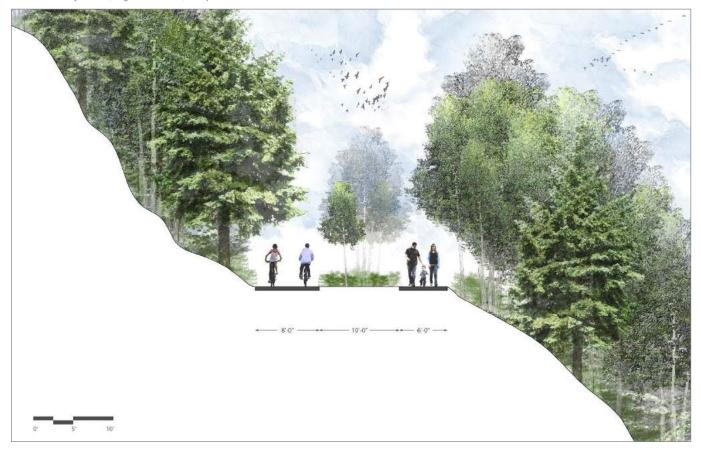
OPTION B: Bicycle trail, vegetated buffer, and pedestrian trail

This option considers converting Lincoln Park Drive to a designated bike and pedestrian trail system with the bike trail designed to accommodate police and fire emergency vehicle use.
