ST. LOUIS RIVER CORRIDOR PARKS MINI-MASTER PLANS

JUNE 2016

This document is a compilation of mini-master plans for 11 neighborhood and multi-use parks in the St. Louis River Corridor. Each park's mini-master plan is a chapter in the document. The parks, from west to east, are: Historical Park, Fond du Lac Park, Blackmer Park, Riverside Park, Smithville Park, Norton Park, Grassy Point Park, Keene Creek Park, Merritt Community Recreation Area, Harrison Community Recreation Area, and Piedmont Community Recreation Area. Each park is unique in setting, context, use, issues, and needs.

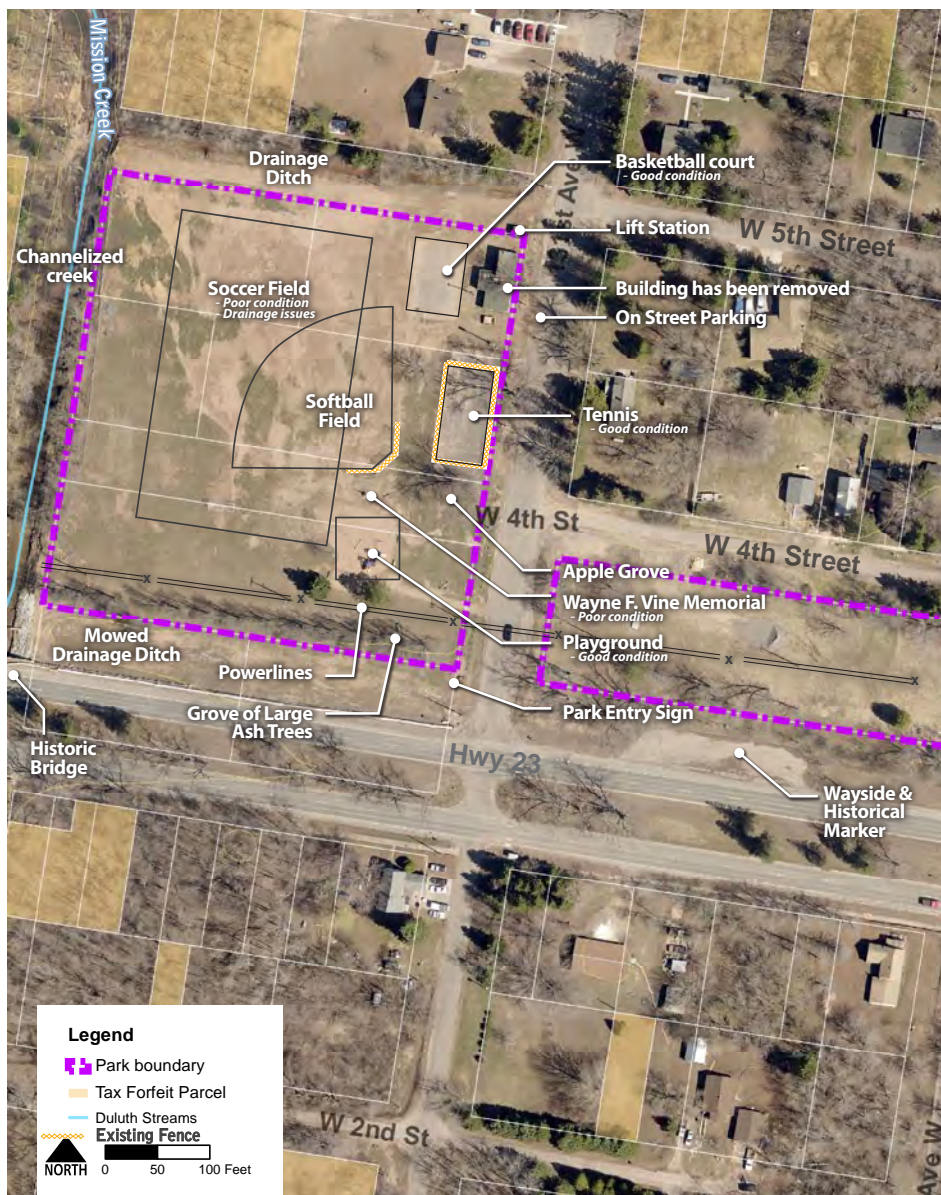
FOND DU LAC PARK SITE INVENTORY

Fond du Lac Park contains a playground, basketball court, and tennis court, which are all in good condition. Overlapping soccer and softball fields are in need of regrading and improved turf conditions. A park building was recently removed. An apple tree grove and memorial are located near the playground. The park has good vehicle access from Hwy 23 and pedestrian access for residents who live north of Hwy 23. Powerlines and poles run along the southern edge of the park between the recreation area and Hwy 23. An existing wayside and historical marker along Hwy 23 are part of the eastern portion of the park, which is unused today. Hwy 23 is currently being reconstructed by MNDOT.

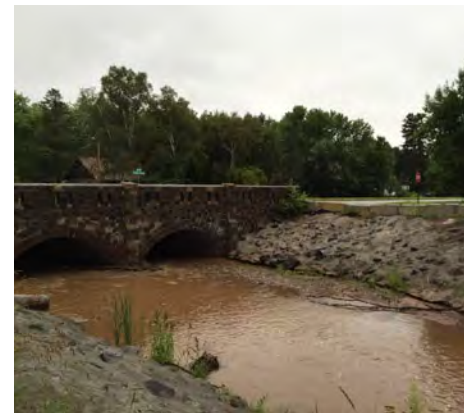
The historic bridge over Mission Creek will be replaced with the Hwy 23 reconstruction in 2016

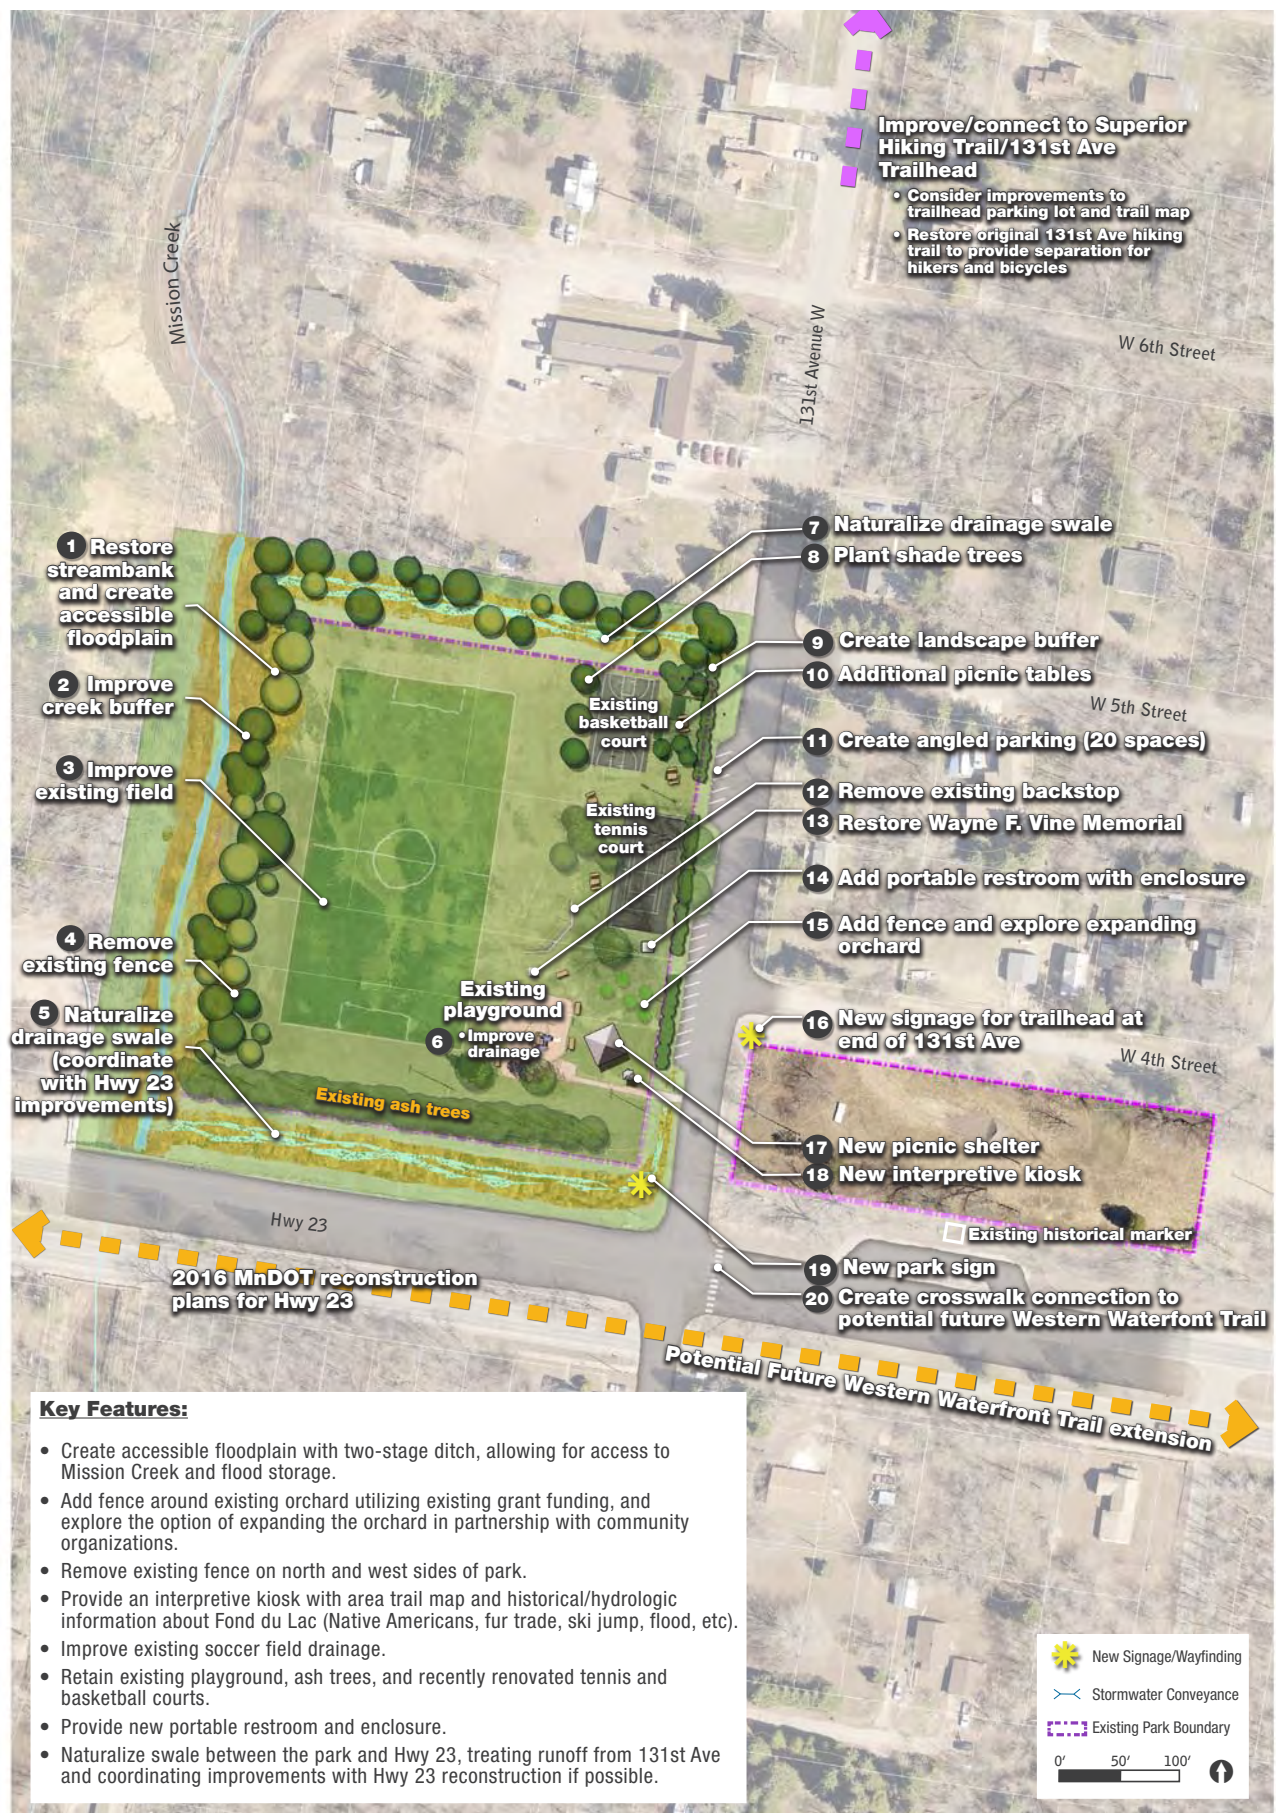
FIGURE 2.4 FOND DU LAC PARK
MINI-MASTER PLAN

Concept Plan & Recommendations

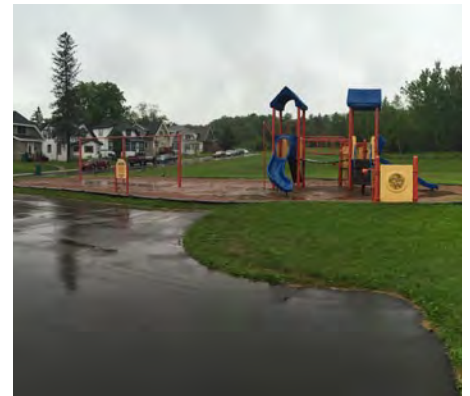
The existing playground is in fair condition

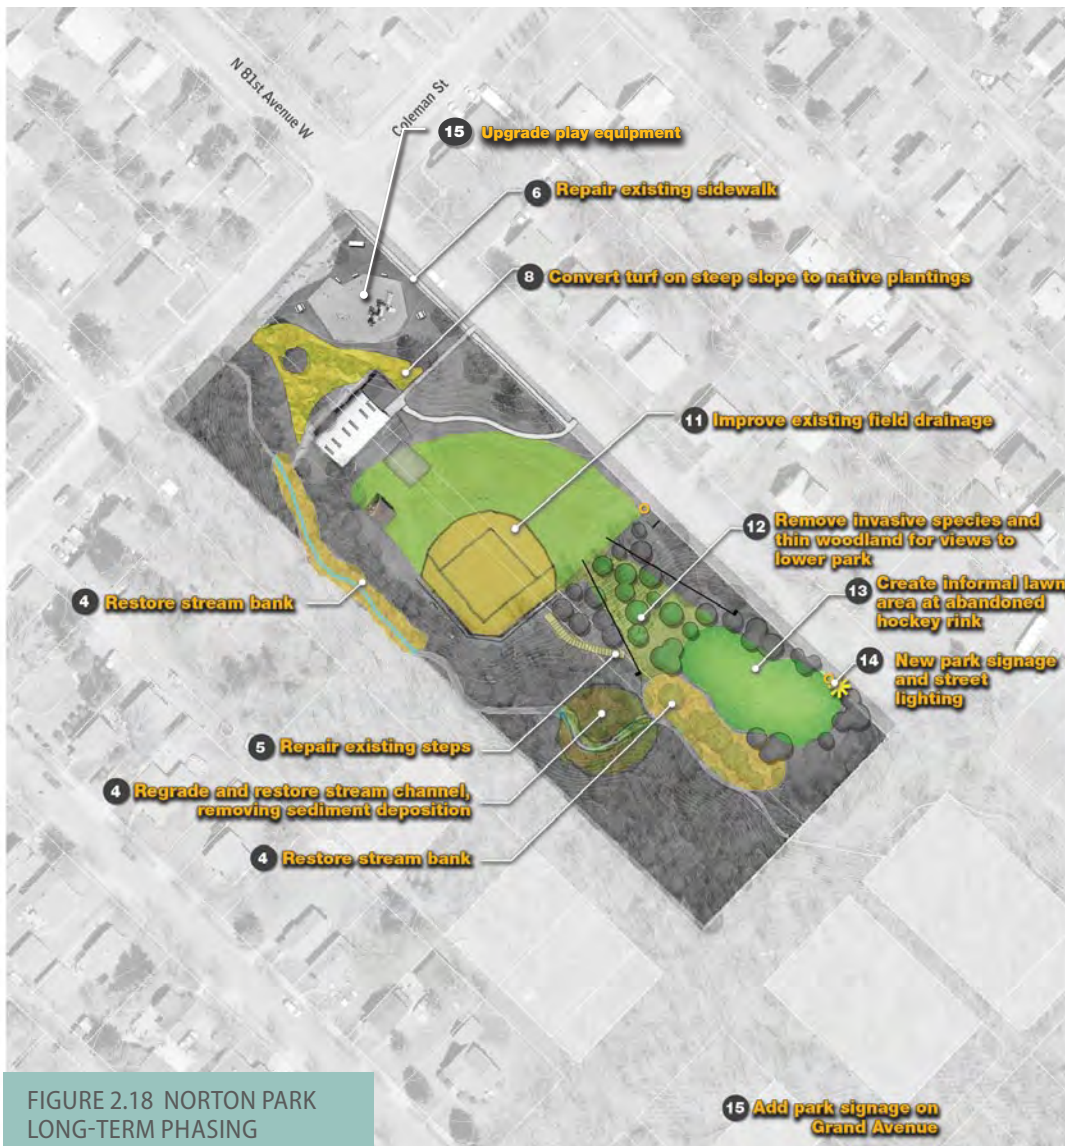
FIGURE 2.18 NORTON PARK
LONG-TERM PHASING

ACTION				COST
#	CATEGORY	DESCRIPTION		
4	Natural Resources	Stream Restoration Work at Norton		\$55,000
5	Circulation	Repair Existing Steps		\$10,000
6	Circulation	Replace and Extend Existing Sidewalk - 6' concrete trail		\$12,450
8	Vegetation	Convert Turf on Steep Slope to Native Plantings		\$50,400
11	Recreation	Improve Drainage		\$50,000
12	Vegetation	Remove Invasive Species and Thin Woodland		\$800
13	Vegetation	Create Informal Lawn Area		\$22,000
14	Circulation	New Park Signage		\$1,000
14	Lighting	New Street Lighting		\$6,000
15	Recreation	Upgrade play equipment		\$75,000
Total Long-Term Improvement Costs				\$282,650
Total Short-Term Improvement Costs				\$ 50,250
Total Improvement Costs				\$332,900

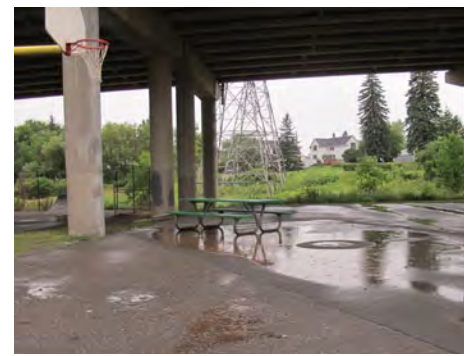
The existing surface of the basketball court is in poor condition

- » Basketball court surface is uneven
- » Tennis courts are underutilized and in disrepair
- » Paved trails are in poor condition, sagging and eroding from stormwater issues
- » Lack of access from Grand Avenue
- » Lack of drinking water and restrooms
- » 2012 flood damage is still visible in the park – more cleanup is needed
- » Lack of shelter/pavilion for picnic tables and gathering
- » Lack of lighting for night time safety
- » Lack of ADA accessibility throughout the park
- » Garbage and park furnishings are sometimes found in the creek
- » Weedy/unkempt areas of the park are unsightly

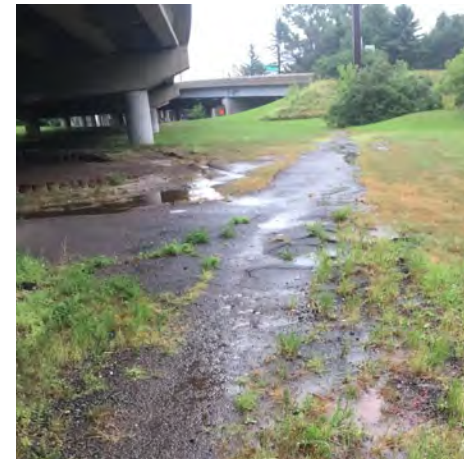
Many existing trail surfaces are in poor condition

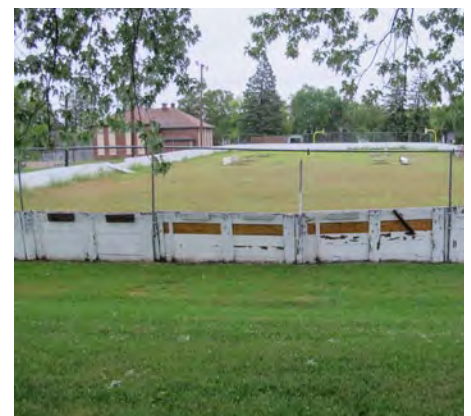
Boards at the existing broomball rink are in fair condition

Overall, updates to the existing park features are necessary to continue the functionality of the park. The softball field needs resurfacing, drainage pipe in the outfield, and a second dugout. The hockey rink needs new boards and better managed lighting for dark winter nights. The hockey rink is voluntarily maintained by Northwoods Children's Services. A shade structure with benches and picnic tables is desired near the existing playground. The playground container and equipment needs to be updated to remove safety hazards.

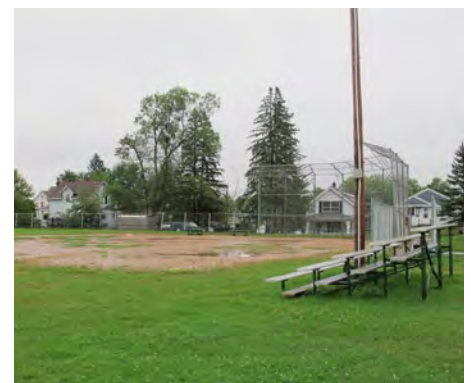
The ballfield lacks a second dugout

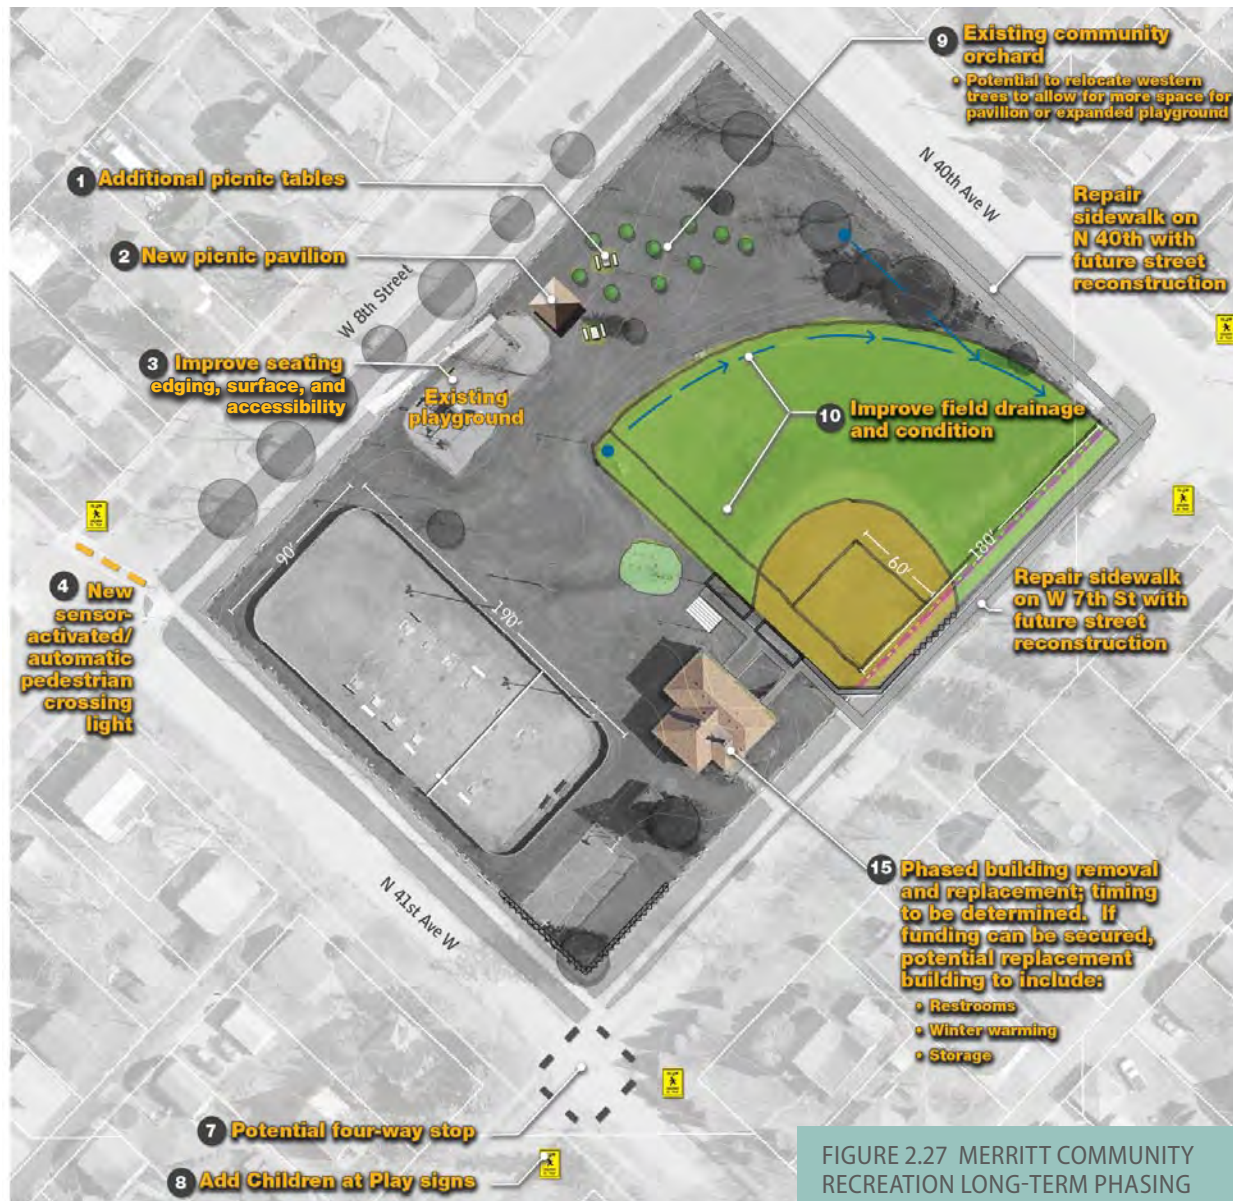
FIGURE 2.27 MERRITT COMMUNITY RECREATION LONG-TERM PHASING

ACTION			COST
#	CATEGORY	DESCRIPTION	
1	Furnishings	Add Picnic Tables (2)	\$4,000
2	Buildings	Build New Picnic Shelter	\$30,000
3	Furnishings	Improve Seating - New Benches (3)	\$3,600
4	Circulation	New Sensor-Activated/Automatic Pedestrian Crossing	\$10,000
7	Circulation	New Four-Way Stop - Signs	\$4,000
8	Circulation	Add Children At Play Signs	\$5,000
9	Demolition	Relocate Existing Apple Trees (3)	\$750
10	Recreation	Improve Field Drainage & Condition	\$50,000
10	Stormwater	Install New Raingarden	\$25,500
15	Demolition	Remove Existing Building	TBD
15	Buildings	Build New Community Building	\$500,000
Total Long-Term Improvement Costs			\$632,850
Total Short-Term Improvement Costs			\$63,160
Total Improvement Costs			\$696,010

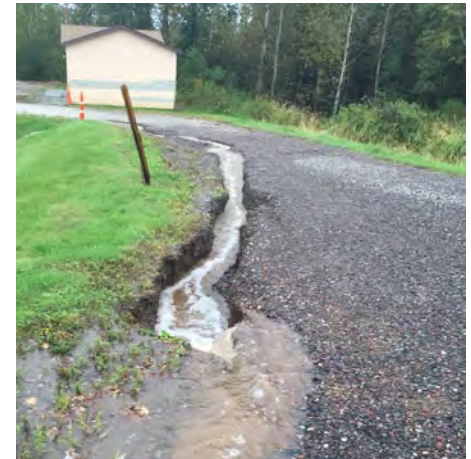
Erosion in the park is a major concern and poses a threat to public safety and water quality

- » Major stormwater drainage issues exist throughout the park—during rain events, water creates deep channels, which undercuts and damages paved driveways and surfaces
- » Lack of parking for events, cars park on the alley between N 22nd and 23rd Avenues
- » Invasive tansy covers the upper slope between the softball field and pleasure skate/playground area
- » Softball field fencing is leaning
- » Softball field has poor drainage
- » Lack of recreation opportunities beyond hockey and softball
- » Lack of ADA accessibility throughout the park
- » Playground lacks sight lines from softball and hockey areas
- » Circulation and access for vehicles and pedestrians within the park need improvement

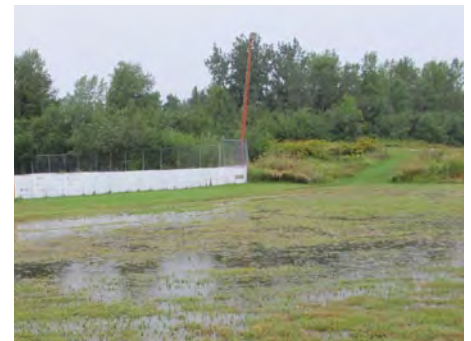
Poor stormwater management results in saturated conditions and unusable space

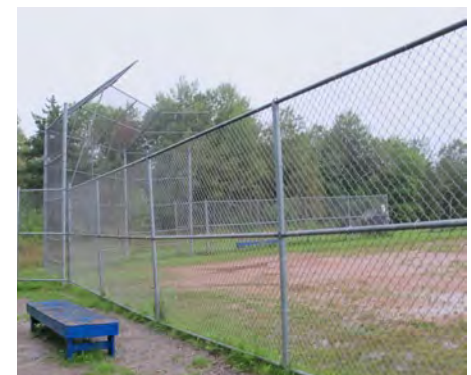
The softball field currently lacks dugouts
